ARBORIST TREE ASSESSMENT REPORT

**MEMORIAL CARE
SENIOR RESIDENTIAL DEVELOPMENT PROJECT
SAN CLEMENTE, CALIFORNIA**

LSA Project No. MEA2203

August 2022

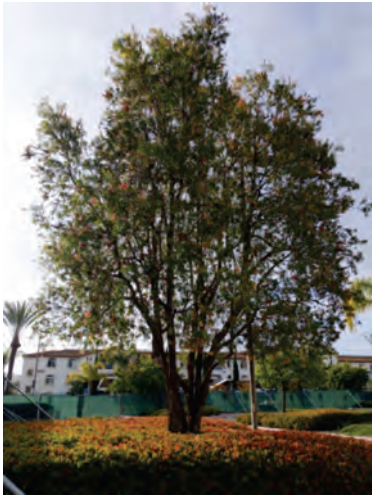
Tree 1 – Thirty-foot-tall crimson bottlebrush in good condition.

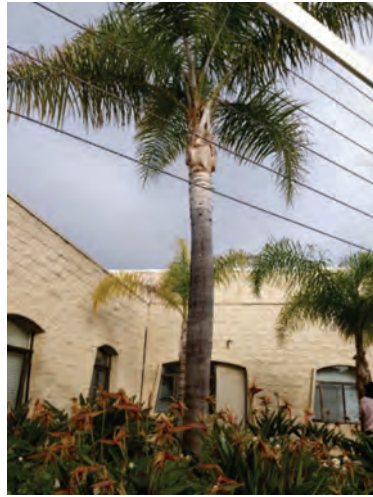
Tree 2 – Thirty-foot-tall queen palm in good condition.

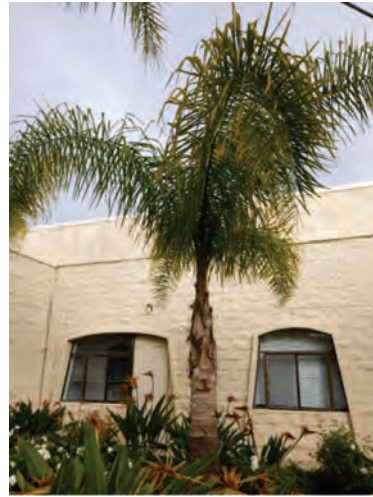
Tree 3 – Fifteen-foot-tall queen palm in good condition.

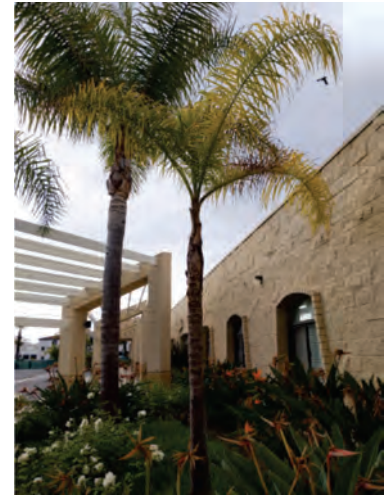
Tree 4 – Twelve-foot-tall queen palm in fair condition.

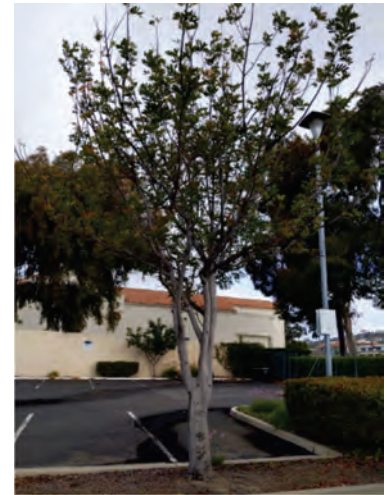
Tree 8 – Twenty-foot-tall carrotwood tree in poor condition.

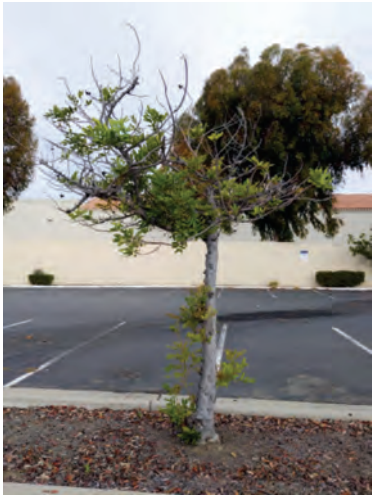
Tree 9 – Eight-foot-tall carrotwood tree in poor condition.

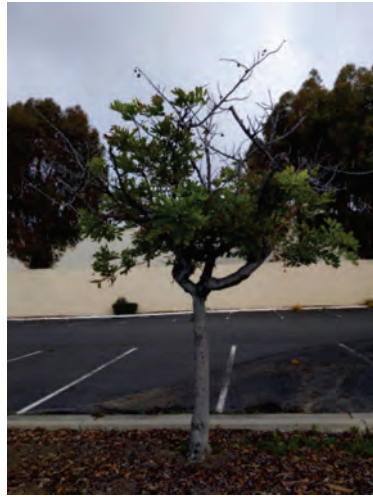
Tree 10 – Eight-foot-tall carrotwood tree in poor condition.

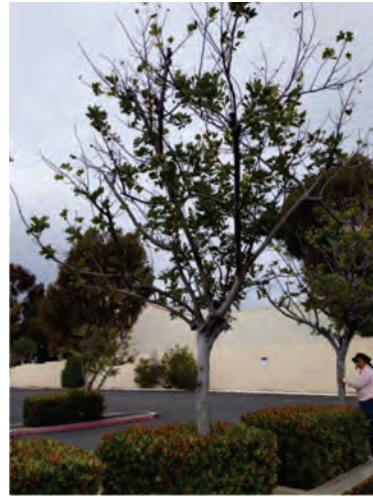
Tree 11 – Fifteen-foot-tall carrotwood tree in poor condition.

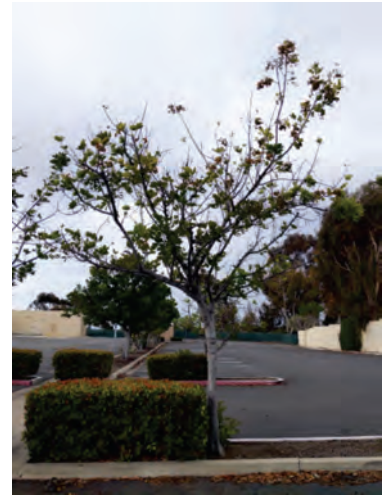
Tree 12 – Fifteen-foot-tall carrotwood tree in poor condition.

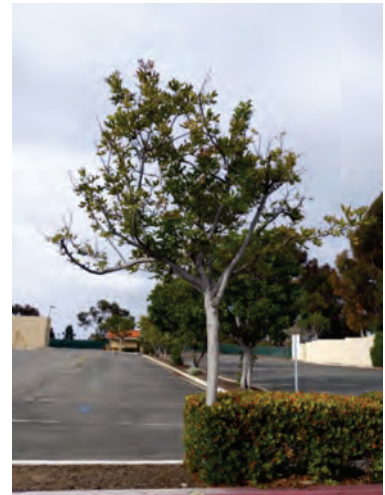
Tree 16 – Ten-foot-tall carrotwood tree in fair condition.

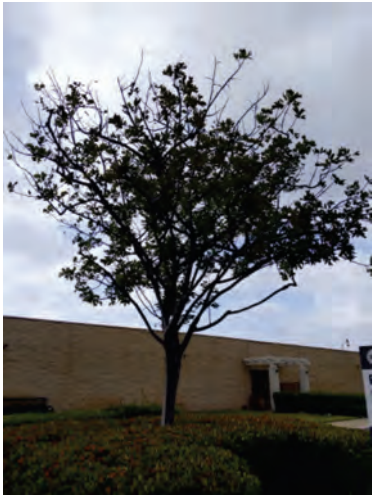
Tree 17 – Fifteen-foot-tall carrotwood tree in fair condition.

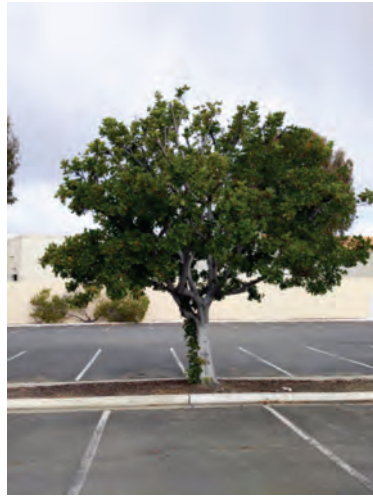
Tree 18 – Twenty-foot-tall carrotwood tree in fair condition.

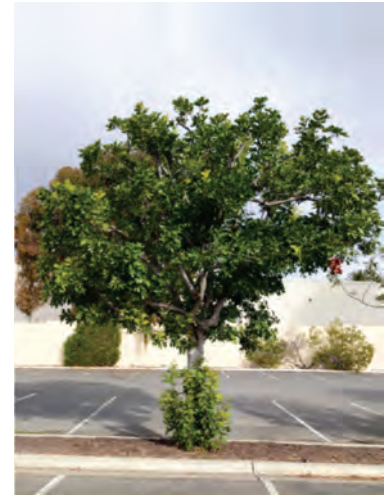
Tree 20 – Twenty-foot-tall carrotwood tree in fair condition.

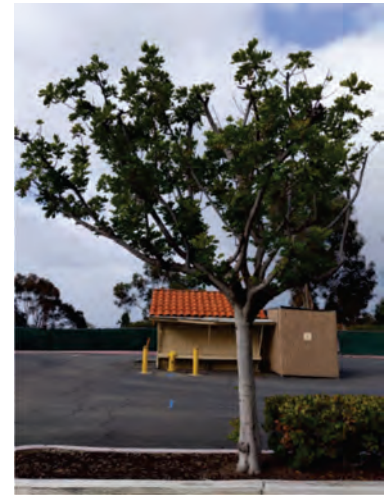
Tree 24 – Ten-foot-tall carrotwood tree in fair condition.

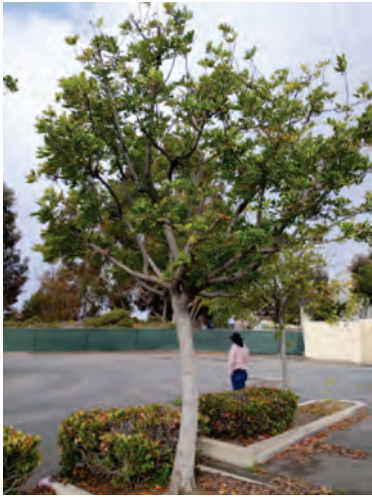
Tree 25 – Fifteen-foot-tall carrotwood tree in fair condition.

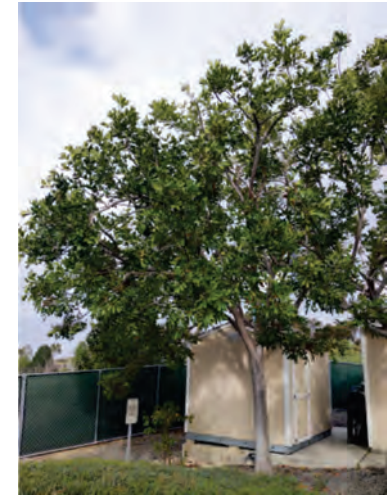
Tree 28 – Twenty-foot-tall carrotwood tree in fair condition.

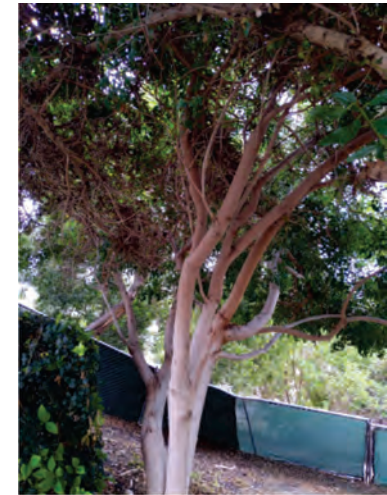
Tree 32 – Six-foot-tall Mousehole tree in fair condition. Cal-IPC invasive species list.

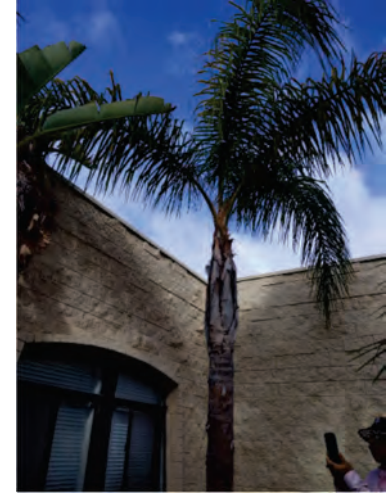
Tree 36 – Twenty-foot-tall queen palm in fair condition.

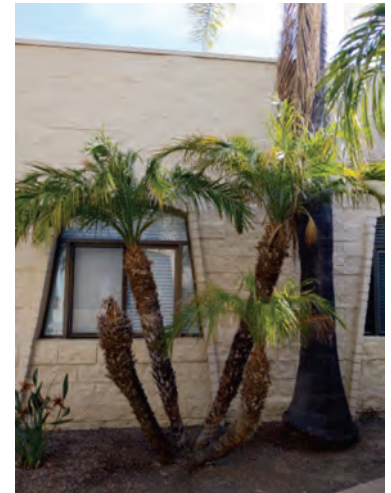
Tree 42 – Eight-foot-tall pigmy date palm in good condition.

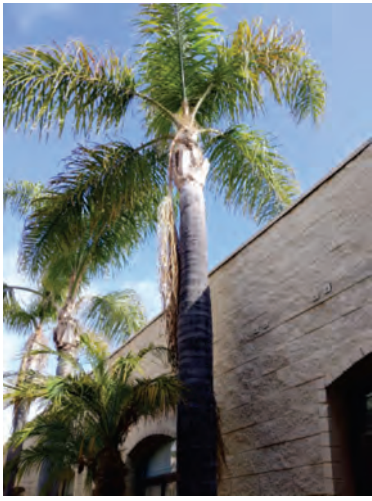
Tree 43 – Thirty-foot-tall queen palm in good condition.

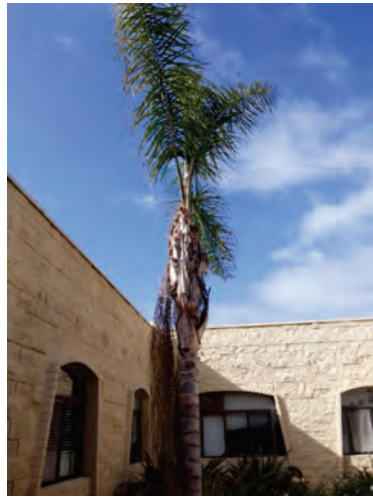
Tree 44 – Thirty-foot-tall queen palm in poor condition.

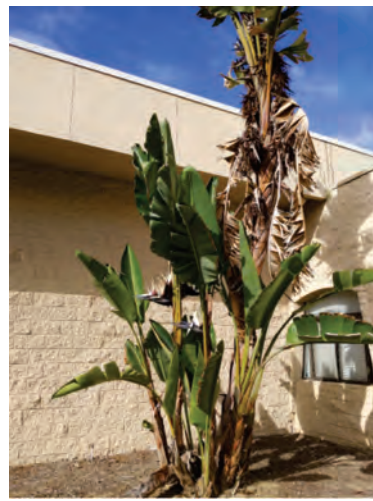
Tree 45 – Twenty-foot-tall traveler's palm in fair condition.

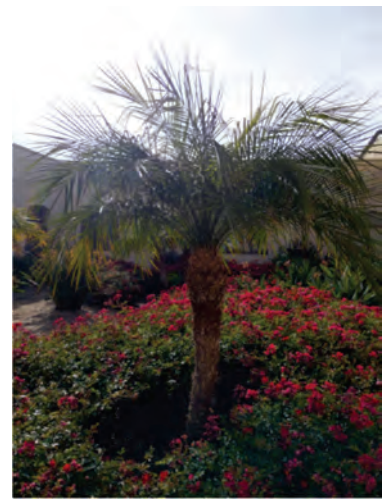
Tree 46 – Six-foot-tall pigmy date palm in good condition.

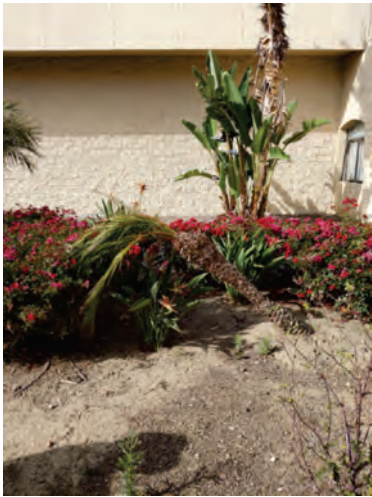
Tree 47 – Four-foot-tall pigmy date palm in poor condition.

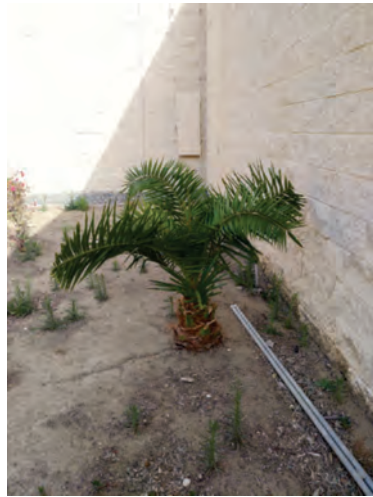
Tree 48 – Five-foot-tall Canary Island date palm in good condition. Cal-IPC invasive species list.

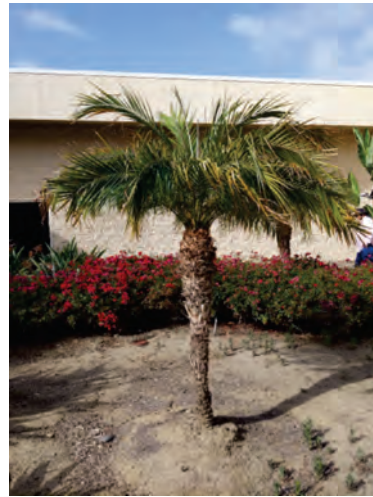
Tree 49 – Six-foot-tall pigmy date palm in fair condition.

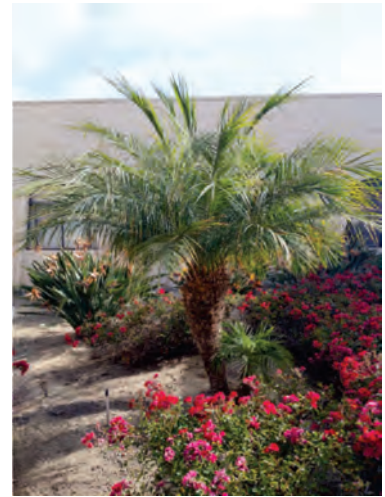
Tree 50 – Six-foot-tall pigmy date palm in good condition.

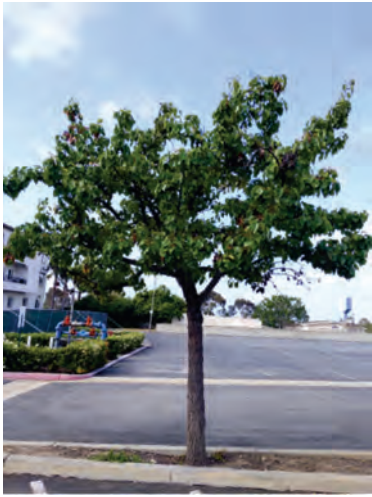
Tree 51 – Fifteen-foot-tall flowering pear tree in fair condition.

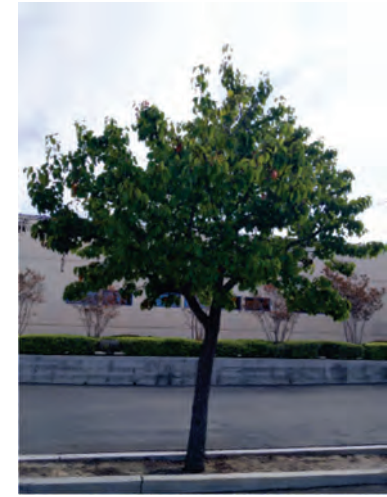
Tree 54 – Fifteen-foot-tall flowering pear tree in fair condition.

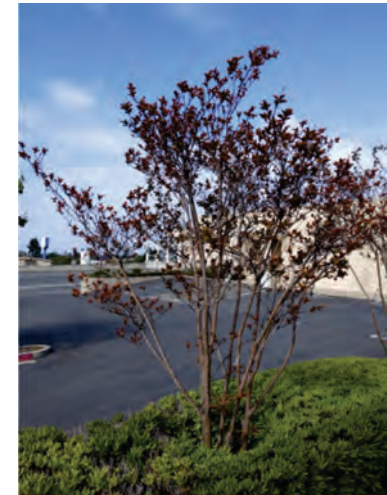
Tree 58 – Six-foot-tall crape myrtle tree in fair condition.

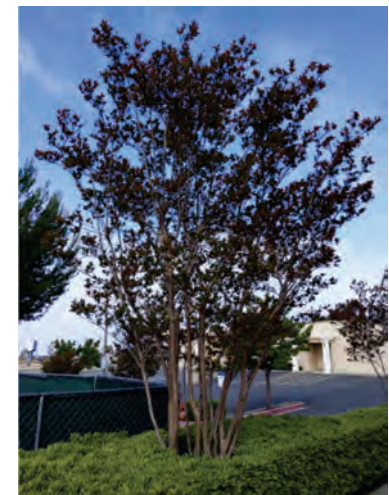
Tree 62 – Fifteen-foot-tall crape myrtle tree in fair condition.

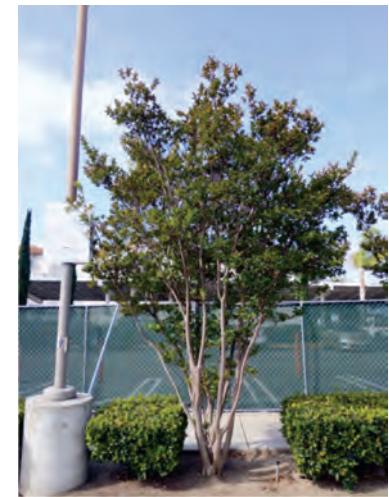
Tree 66 – Ten-foot-tall crape myrtle tree in fair condition.

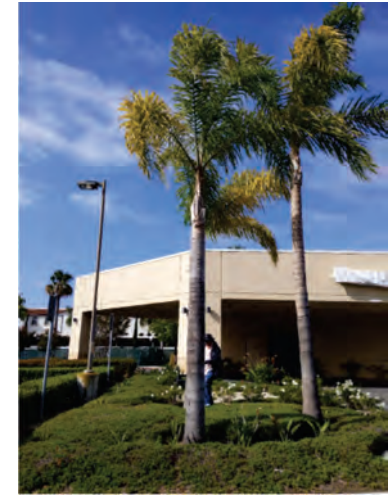
Tree 70 – Twenty-foot-tall queen palm in good condition.

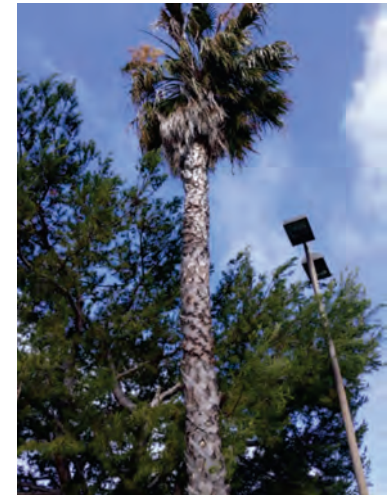
Tree 74 – Thirty-five-foot-tall Mexican fan palm in fair condition. Cal-IPC invasive species list.

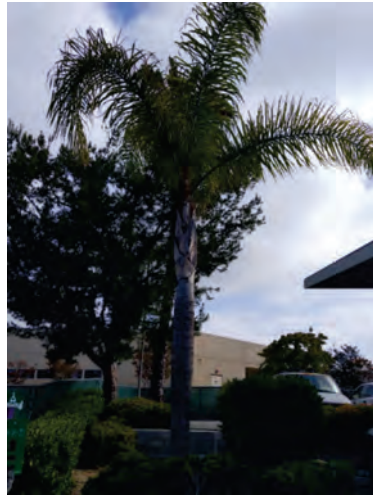
Tree 76 – Twenty-foot-tall queen palm in good condition.

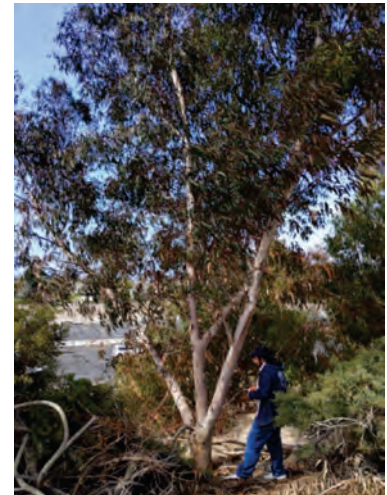
Tree 82 – Thirty-foot-tall spotted gum tree in fair condition.

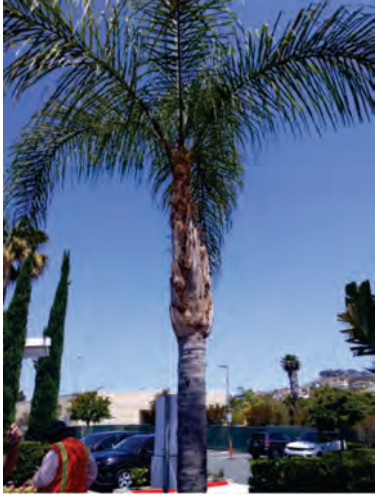
Tree 83 – Twenty-foot-tall queen palm in good condition.

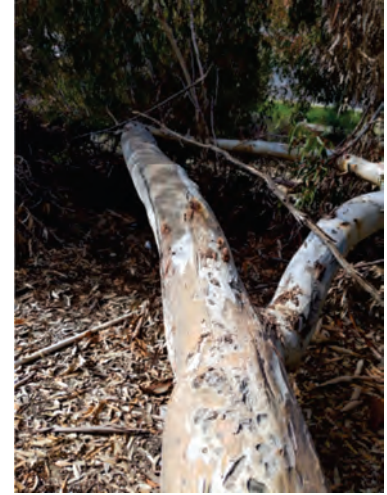
Tree 86 – Four-foot-tall spotted gum tree in poor condition, down live.

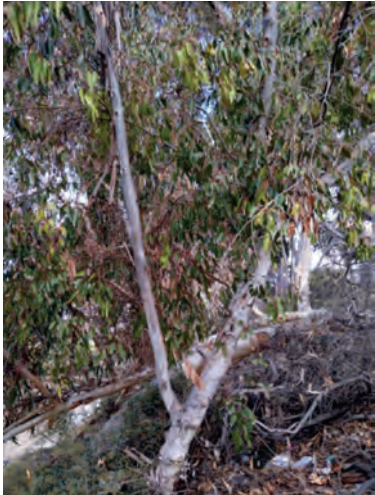
Tree 87 – Twenty-foot-tall spotted gum tree in poor condition.

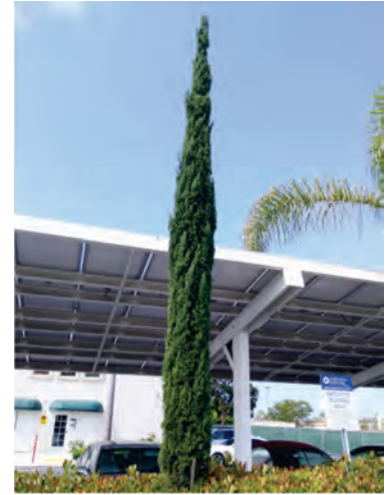
Tree 90 – Twenty-five-foot-tall Italian cypress in good condition.

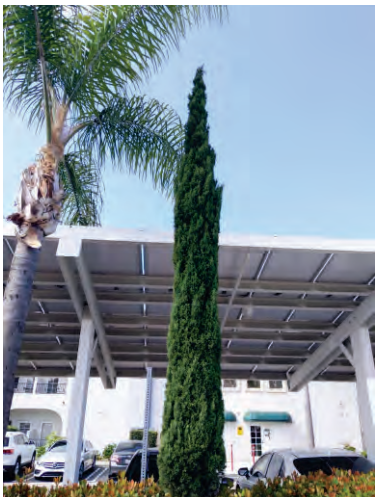
Tree 91 – Twenty-five-foot-tall Italian cypress in good condition.

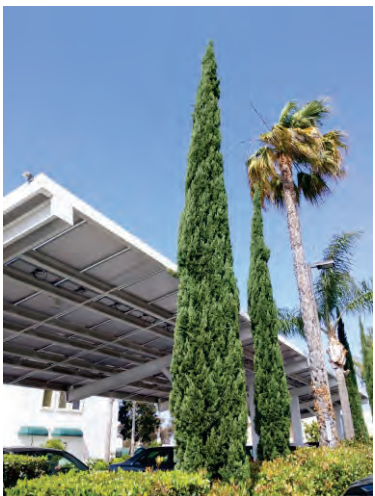
Tree 95 – Thirty-five-foot-tall Italian cypress in good condition.

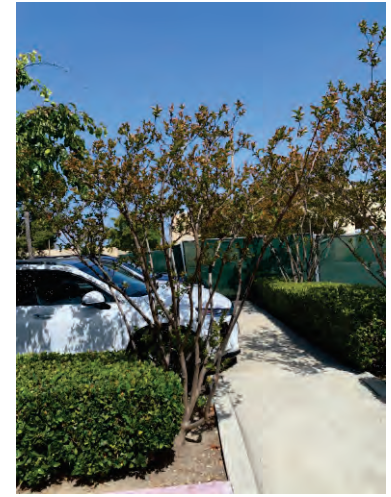
Tree 102 – Eight-foot-tall crape myrtle tree in poor condition.

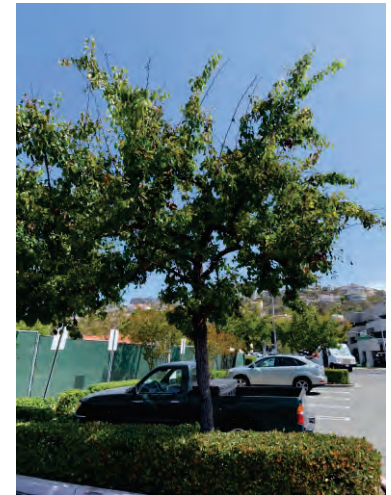
Tree 106 – Eighteen-foot-tall flowering pear tree in fair condition.

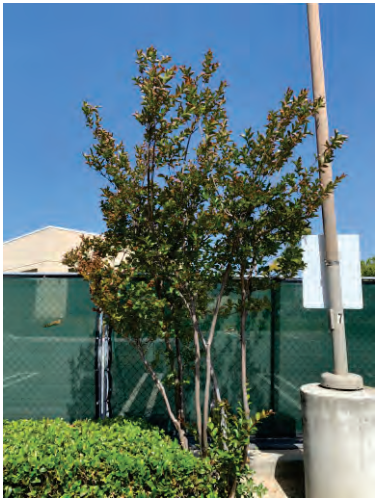
Tree 107 – Eight-foot-tall crape myrtle tree in fair condition.

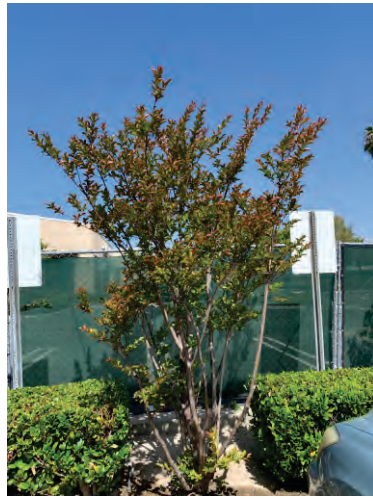
Tree 108 – Eight-foot-tall crape myrtle tree in fair condition.

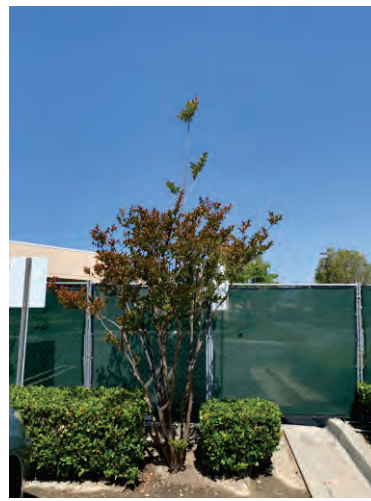
Tree 109 – Ten-foot-tall crape myrtle tree in poor condition.

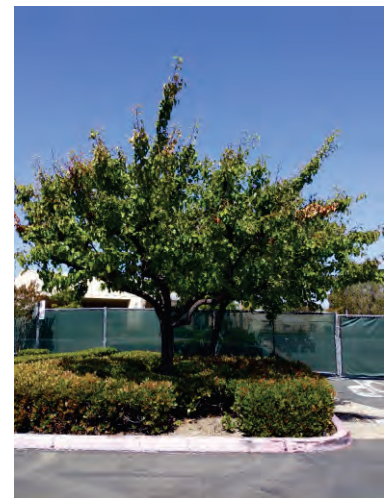
Tree 110 – Fifteen-foot-tall flowering pear tree in fair condition.

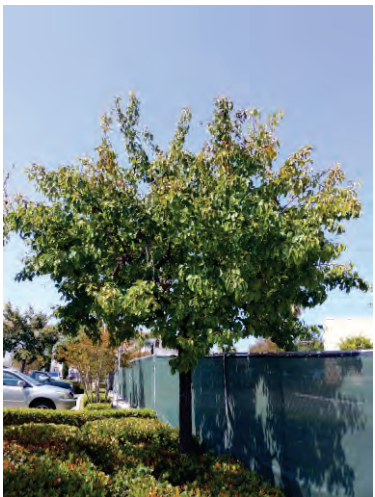
Tree 111 – Fifteen-foot-tall flowering pear tree in fair condition.

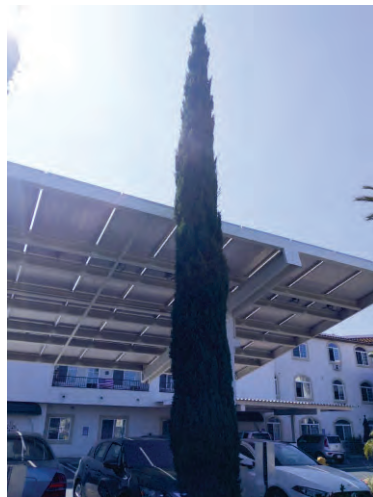
Tree 112 – Thirty-foot-tall Italian cypress in good condition.

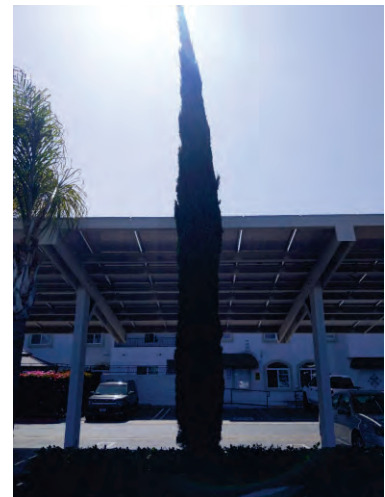
Tree 115 – Twenty-five-foot-tall Italian cypress in good condition.

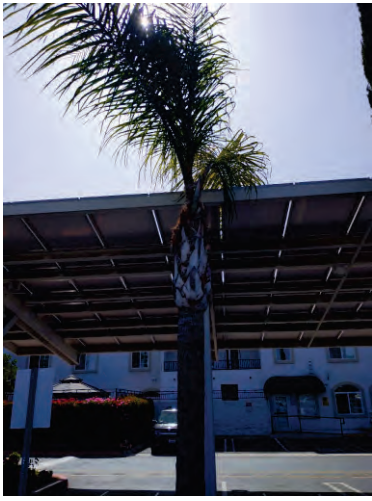
Tree 116 – Twenty-five-foot-tall queen palm in fair condition.

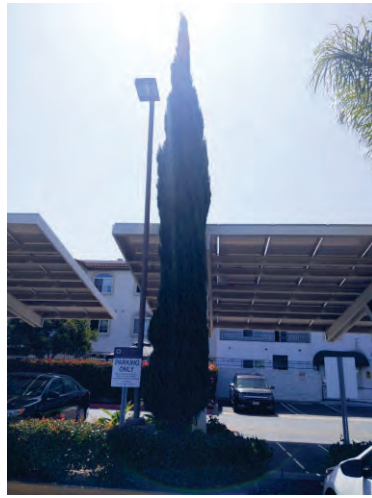
Tree 117 – Twenty-five-foot-tall Italian cypress in good condition.

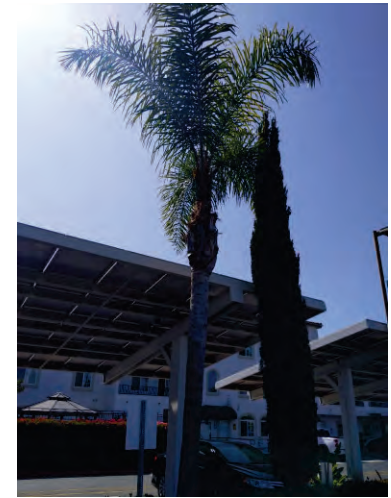
Tree 119 – Twenty-five-foot-tall queen palm in fair condition.

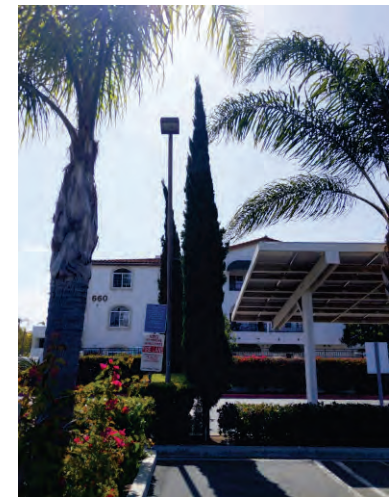
Tree 123 – Twenty-five-foot-tall Italian cypress in good condition.

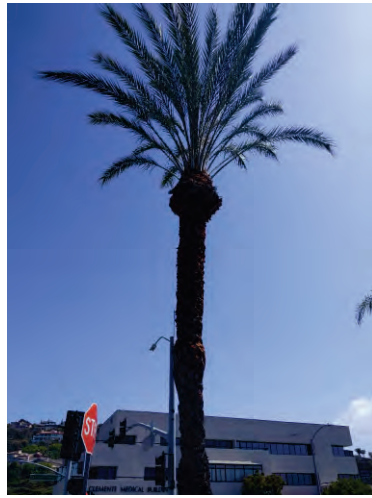
Tree 125 – Thirty-foot-tall date palm in good condition.

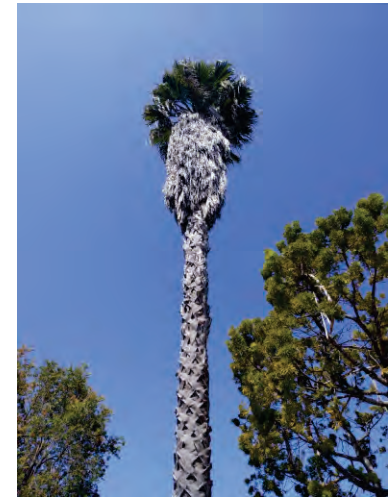
Tree 127 – Forty-foot-tall Mexican fan palm in fair condition. Cal-IPC invasive species list.

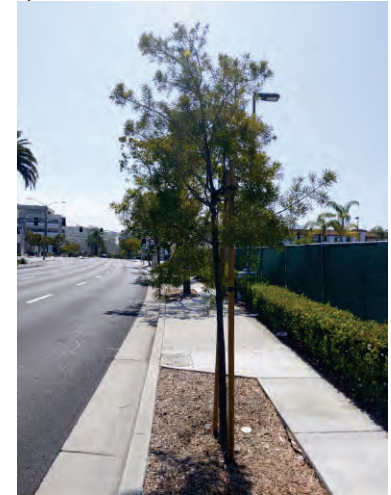
Tree 131 – Ten-foot-tall yew pine in good condition.

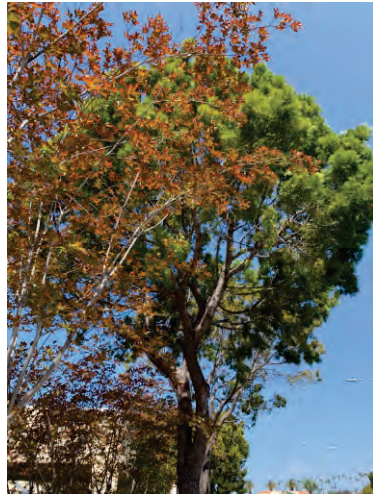
Tree 133 – Thirty-five-foot-tall yew pine in good condition.

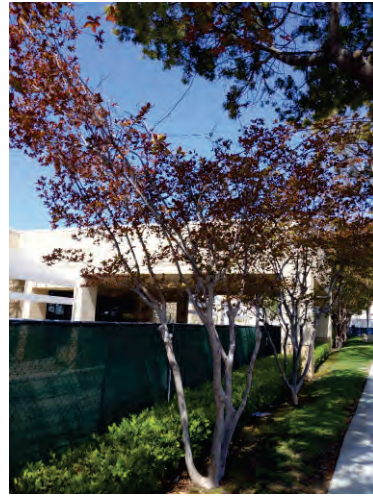
Tree 134 – Fifteen-foot-tall crape myrtle tree in fair condition.

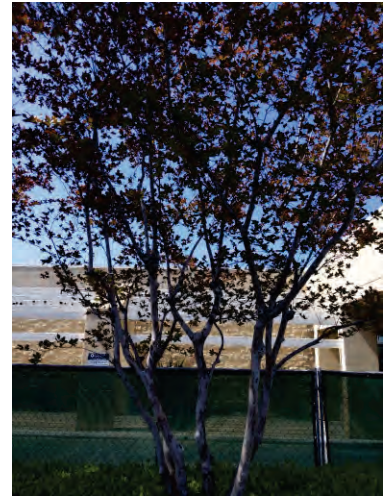
Tree 135 – Fifteen-foot-tall crape myrtle tree in good condition.

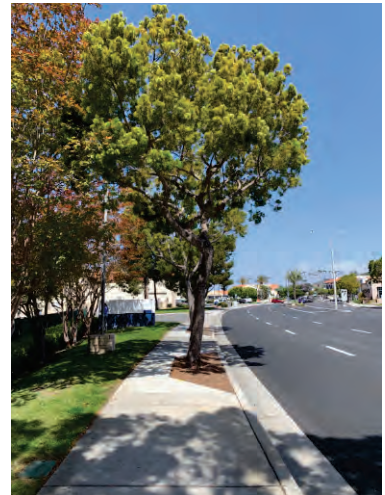
Tree 139 – Thirty-foot-tall yew pine in good condition.

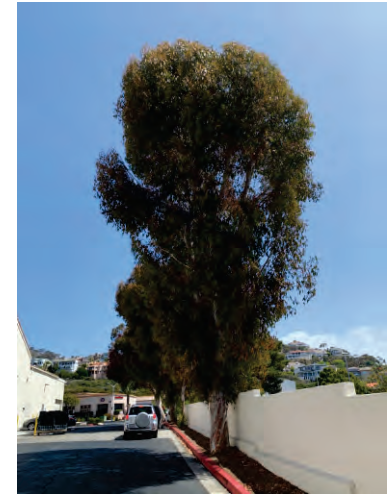
Tree 151 – Seventy-foot-tall spotted gum tree in fair condition.

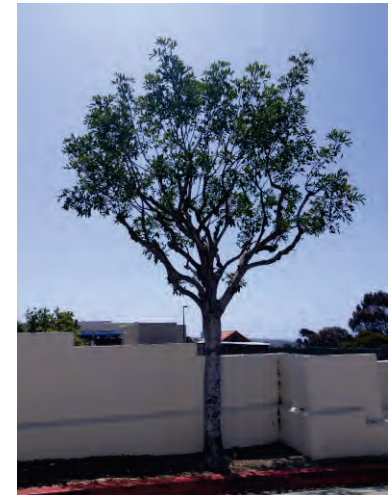
Tree 155 – Twenty-foot-tall carrotwood tree in fair condition.

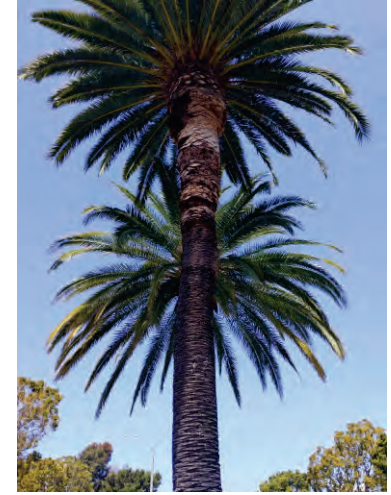
Tree 159 – Thirty-five-foot-tall Canary Island date palm in good condition. Cal-IPC invasive species list.

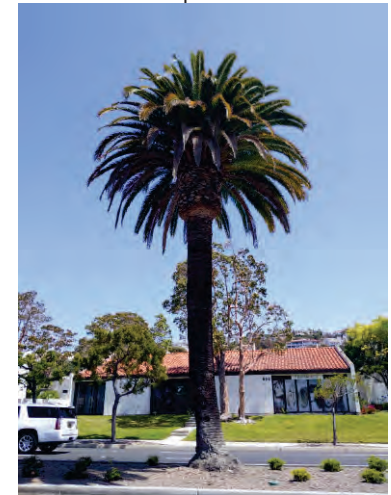
Tree 163 – Thirty-five-foot-tall Canary Island date palm in good condition. Cal-IPC invasive species list.

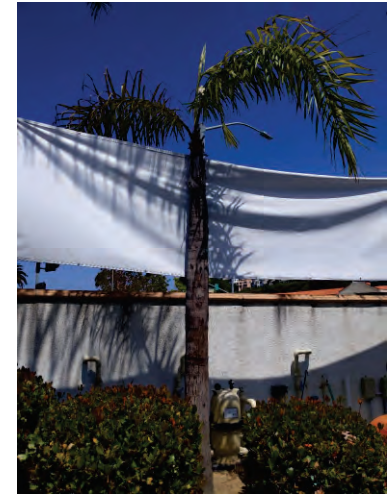
Tree 167 – Ten-foot-tall queen palm in fair condition.

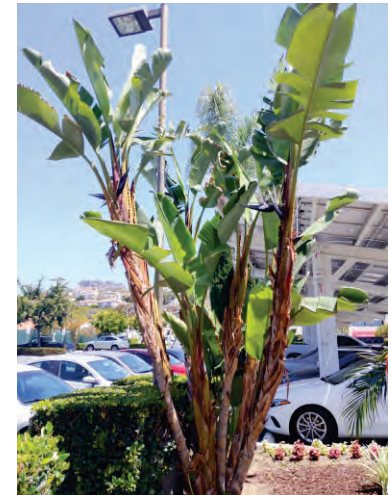
Tree 171 – Fifteen-foot-tall traveler's palm in good condition.

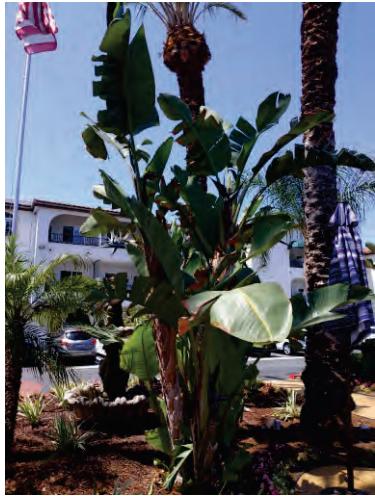
Tree 172 – Ten-foot-tall traveler's palm in good condition.

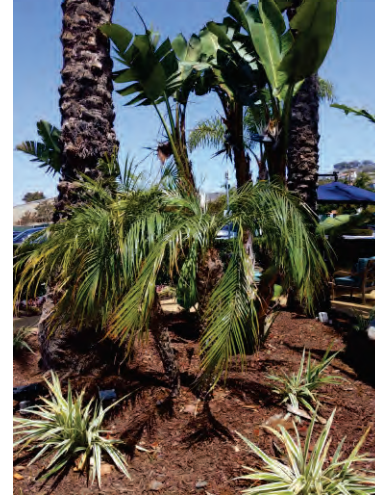
Tree 175 – Forty-foot-tall date palm in good condition.
