VISTA DE LAS OLAS

402 PASADENA COURT, SAN CLEMENTE

HISTORIC PRESERVATION REPORT

November 2002

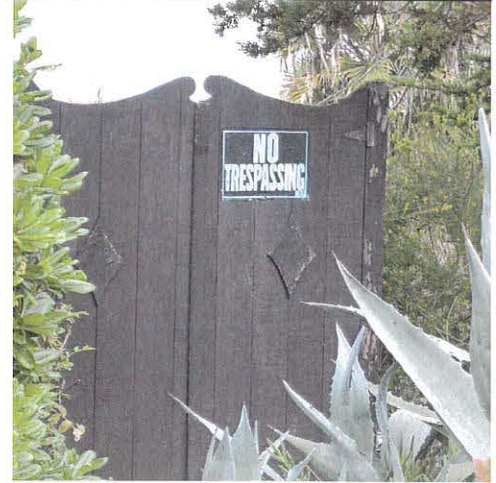
-CURRENT CONDITION FAIR

-DESCRIPTION-THIS GATE PROVIDES ACCESS FROM PASADENA COURT TO THE NORTH APARTMENTS. IT WAS MOST LIKELY INSTALLED WHEN THE HOME WAS DIVIDED INTO APARTMENTS.

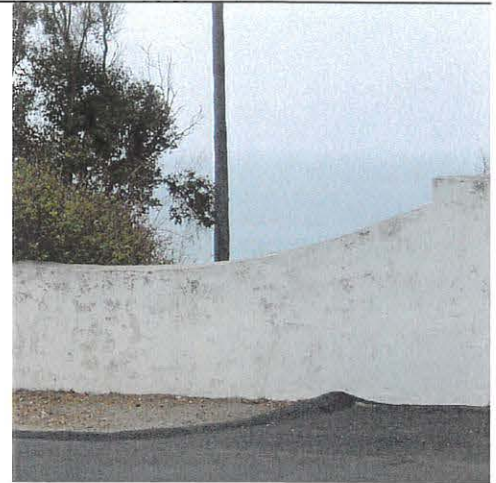
2 ENTRY WALL-PASADENA COURT

-CURRENT CONDITION GOOD

-DESCRIPTION-PART OF THE ORIGINAL LANDSCAPE CONSTRUCTION,THIS WALL IS THE PRIMARY ENTRYWAY TO THE REAR GARDENS. THE WALL FORM "SCALLOPED" IS TYPICAL OF SPANISH COLONIAL ARCHITECTURE AND THE RELATIONSHIP TO THE HOUSE MATERIALS MAKES THIS AMENITY AN INTEGRAL PART OF THE SITE. THE WALL SUPPORTS A MAIN GATE AT IT'S HIGH POINT. THE SOUTH WALL SLOPES AND THEN REMAINS A CONSTANT HEIGHT.THE NORTH END SLOPES DOWN TO A CURB.

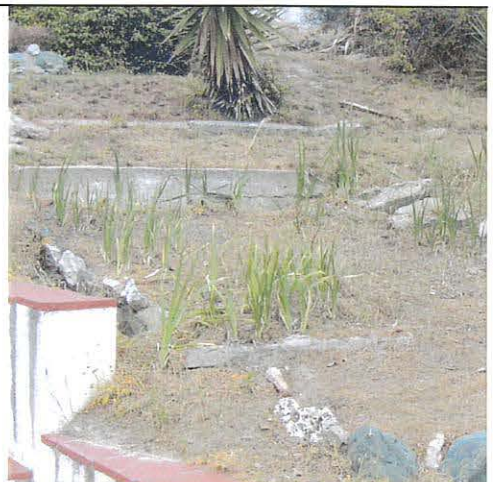
-DESCRIPTION-THE TERRACING ON THE SOUTH SIDE OF THE STAIRS IS IN DISREPAIR. THE DESIGN TECHNIQUE SERVES THE SAME PURPOSE AS TERRACE WALL "A", BUT THE CONSTRUCTION METHODS HAVE BEEN CHANGED. THERE ARE LESS STONES USED, IF AT ALL, AND THE CONCRETE FOOTINGS WERE POURED AGAINST A FORM VERSUS THE OTHER SIDE WHERE THE STONE AND CONCRETE WERE MORE ROUGHLY CONSTRUCTED.

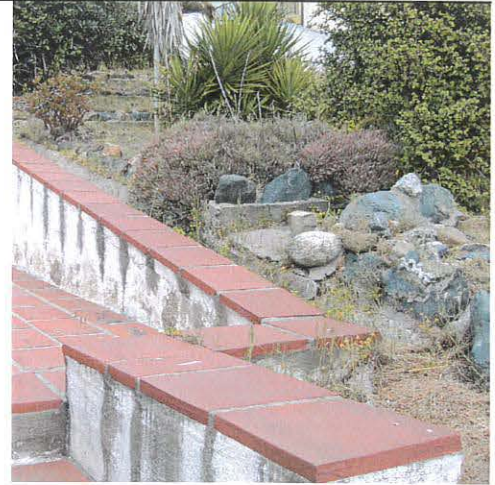
-DESCRIPTION-THE STAIRS CONNECT THE UPPER AND LOWER LEVELS OF THE GARDEN. THEY ARE A MAJOR ELEMENT OF THE GARDEN. FOUR WALLS FLANK THE STAIRS. THE ORIGINAL 12" SQUARE TILE HAVE BEEN REPLACED WITH 11.5" SQUARE HARD FIRED CLAY TILE.

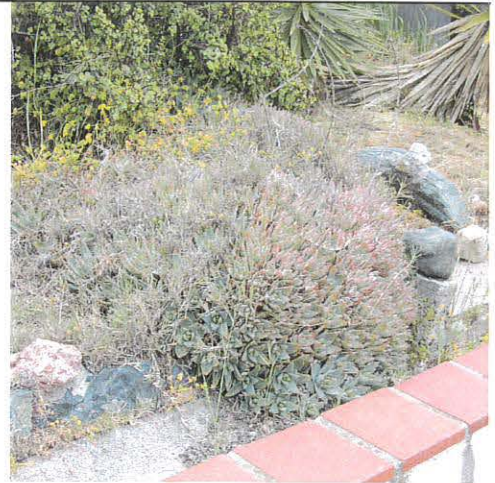
-DESCRIPTION-A CONCRETE CHANNEL OR SLUE IS LOCATED ON THE EAST SIDE OF THE STAIR. THIS DRAINAGE SYSTEM WAS INTENDED TO MOVE WATER FROM THE UPPER TERRACE TO A LOWER DEPOSITION AREA. THE SLUE IS CONSTRUCTED OF CONCRETE AND LINED WITH STONE SIMILAR TO THE TERRACE WALLS. THE CURRENT CONDITION HAS LEFT THE DRAINAGE SYSTEM MOSTLY INOPERABLE.

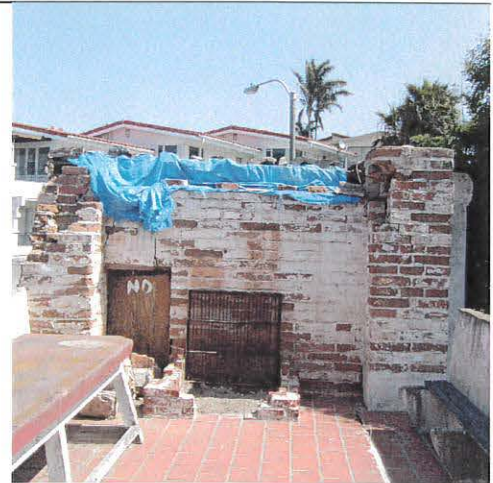
-DESCRIPTION-THIS WAS ONCE A FUNCTIONING KITCHEN WITH A WOOD SHED. THE KITCHEN WAS CONSTRUCTED OF ADOBE BRICK AND HAD A TOWER STRUCTURE. THE TOWER IS GONE AND THE STRUCTURE IS IN A DETERIORATING CONDITION.

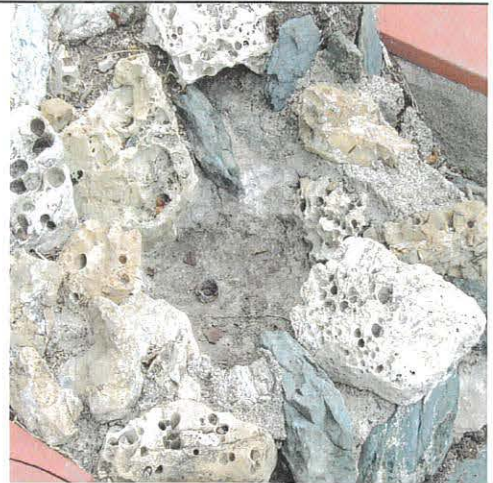
-DESCRIPTION-THE WATER IN THE TILED BASIN OF THE WALL FOUNTAIN WAS PIPED UNDER THE WALK AND INTO THIS BASIN WHERE IT COLLECTED AND THEN FLOWED DOWN THROUGH THE WATER CHANNEL. THE ROCK THAT LINE THE BASIN ARE INDIGENOUS AND WERE ONCE PART OF THE COASTLINE. THE PIPING FOR THE BASIN HAS OXIDIZED OVER TIME.

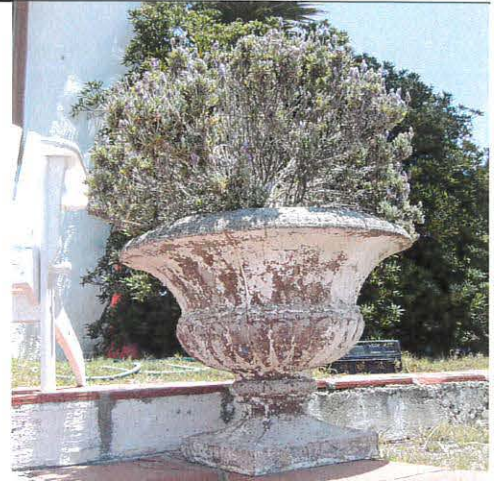
-DESCRIPTION-THERE ARE TWO URNS REMAINING ON THE SITE. ONE HAS SUFFERED A FRACTURE ALONG THE RIM. THE URNS WERE A POPULAR FEATURE OF SPANISH COLONIAL REVIVAL.

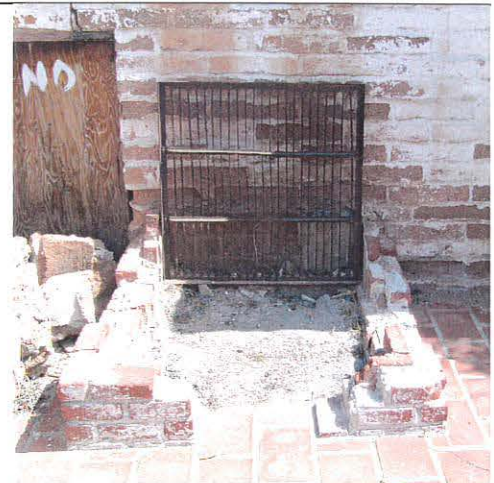
-DESCRIPTION-THE BARBECUE IS IN DISREPAIR. IT IS LOCATED OFF THE CURRENT STORAGE SHED (KITCHEN), IS CENTRALLY LOCATED AND PROVIDES A TERMINUS TO THE KITCHEN.

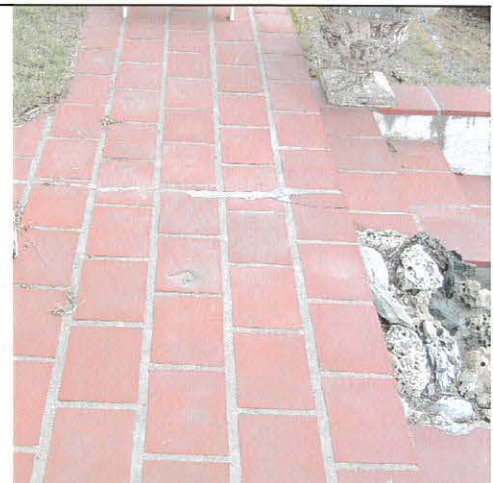
-DESCRIPTION-THE HARDFIRED TILE IS A REPLACEMENT FOR THE ORIGINAL 12" SQUARE TERRA COTTA TILE. THE ORIGINAL TERRA COTTA IS EVIDENT UNDER THE 11.5"x7" TILE AT THE FRONT DOOR AND SECONDARY DOOR OFF PASADENA COURT.

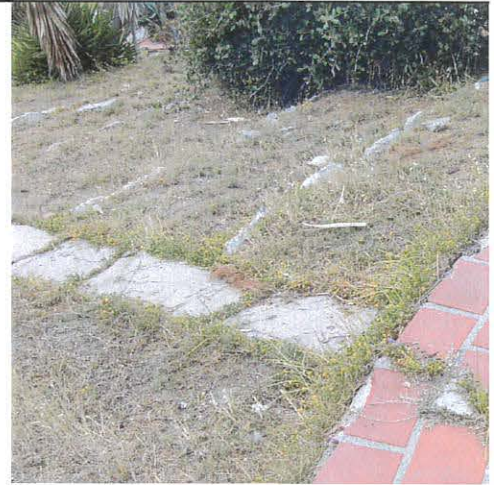
-DESCRIPTION-THE NARROW WALK MAY HAVE CONTINUED IN ITS CURRENT DIRECTION UNTIL IT MET WITH AN ADJOINING PATH.THE WALKWAY CAN STILL BE SEEN PERPENDICULAR TO THE STAIRS. BROKEN PORTIONS OF THE PATH HAVE BEEN DEPOSITED JUST SOUTH OF THE EXISTING PATH.
