Memorandum Planning

To: Planning Commission
From: James Pechous, City Planner
Subject: Review of thoughts and comments from the Planning Commission
Architectural Tour.
Copies: James Holloway, Community Development Director
Jeffrey Hook, Principal Planner

Architectural Review Tour

ITINERARY AND INTRODUCTION

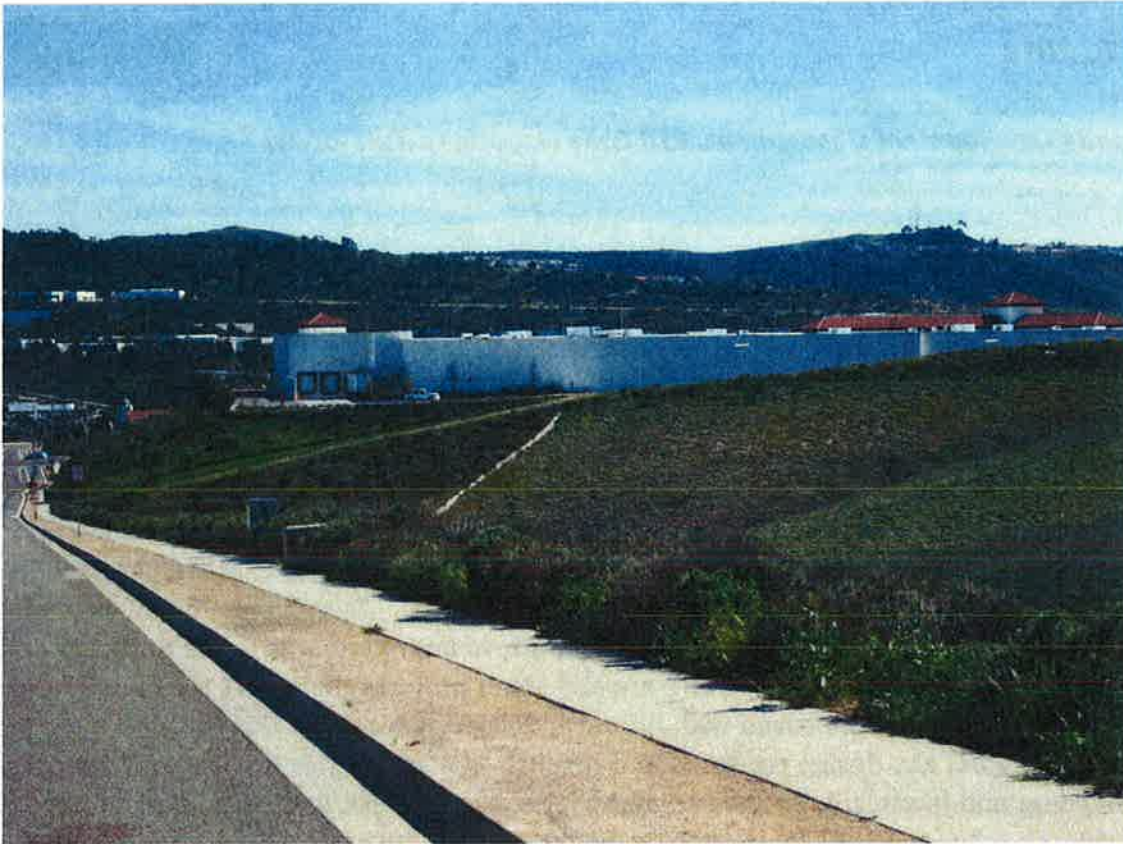
Stop 1:

- Building massing/articulation/detailing as viewed from North La Pata
- Landscape screening
- Slope bank landscaping along Avenida Vista Hermosa
- Retaining wall treatments

- Do not only focus on front entrance to a building. Make sure to evaluate all sides of the building and account for future entryways into the City
- Loading dock needs to be screened
- Look at tree selection, number and growth rates
- Crib walls are filling in well

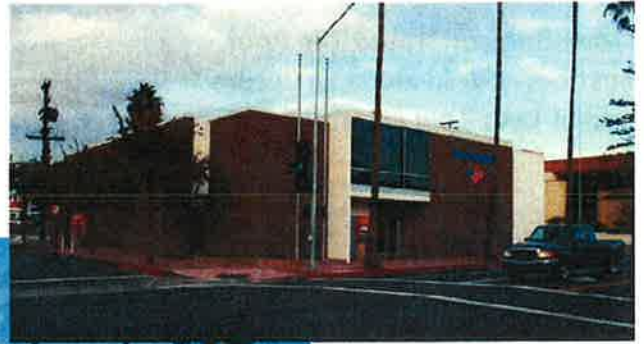
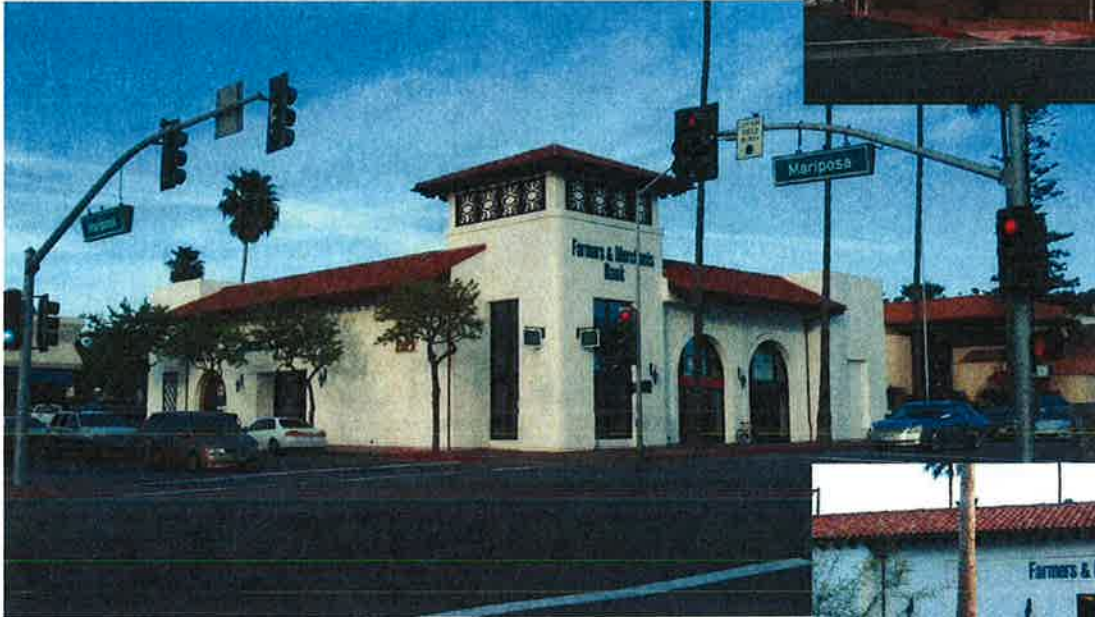
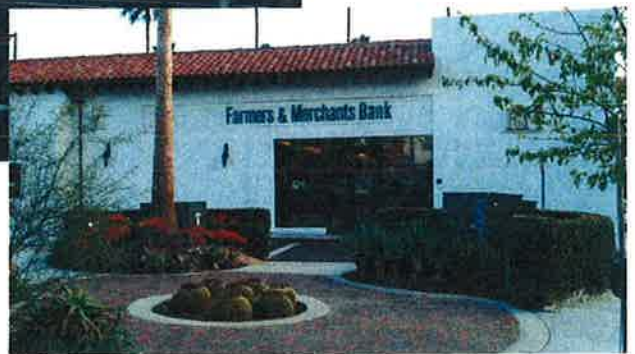
Stop 3:

- Preliminary direction given: Property not within A-Overlay requiring SCR architecture.
- Architect spent thousands developing a modern architectural style.

- Development Management Team recommends SCR architecture based upon the Downtown Vision and Strategic Plan, which recommends area be included within A-Overlay in the future.

- Important to have clear Policy direction on architectural style within specified geographic boundaries. Zoning Code never amended to reflect the Downtown Vision and Strategic Plan.
- Importance of QAP: Funky rafter tails.

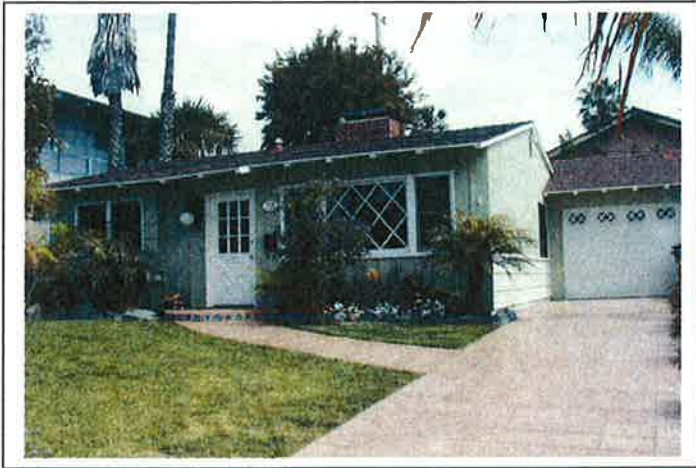
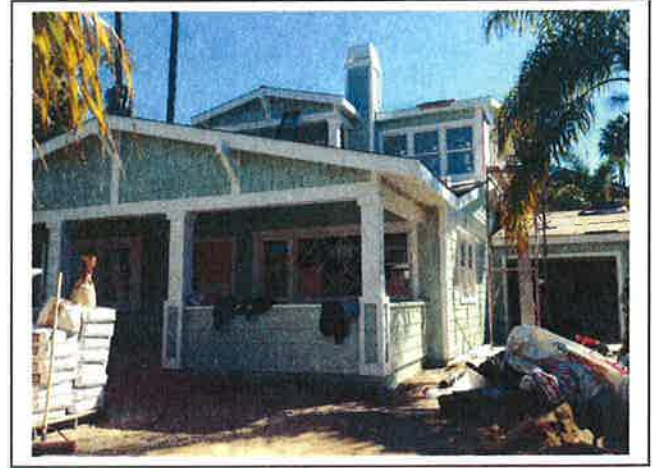
Stop 4:

- Remodel and 82% expansion of 1,150 sq ft non-conforming structure. The project includes: 1) 285 sq ft first story addition at rear of building, 2) new patio cover on front elevation, and 3) 665 sq ft second story addition.
- Residence has nonconforming side yard setbacks.
- First example of project allowed as a result of the Nonconforming Ordinance update (adopted in early 2012).
- Under new rules, small residences (less than 1,400 sq ft) can be expanded over 50% (up to 2,100 sq ft) and remain nonconforming with the approval of a Minor Architectural Permit.
- Under old rules, it was easier and less costly to demolish small dwellings and construct much larger homes that maximize a site.

- The new Nonconforming Ordinance is successfully incentivizing the preservation of small houses. This project shows it is possible to expand small residences greater than 50% and remain nonconforming, while maintaining the character of neighborhoods.

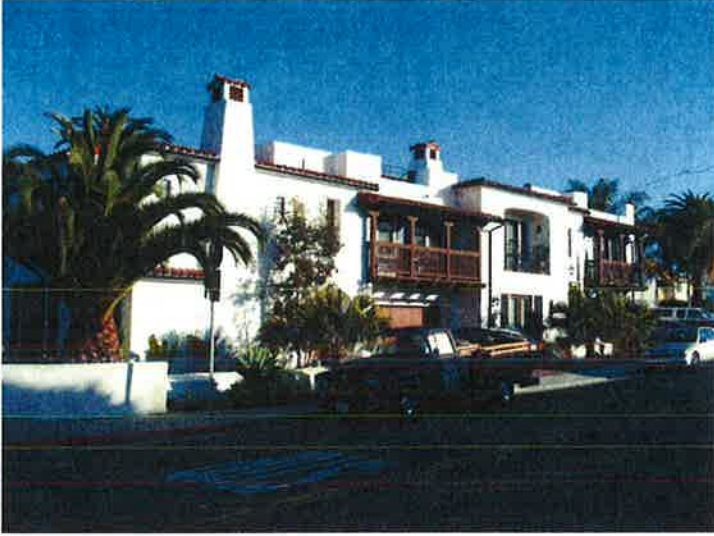
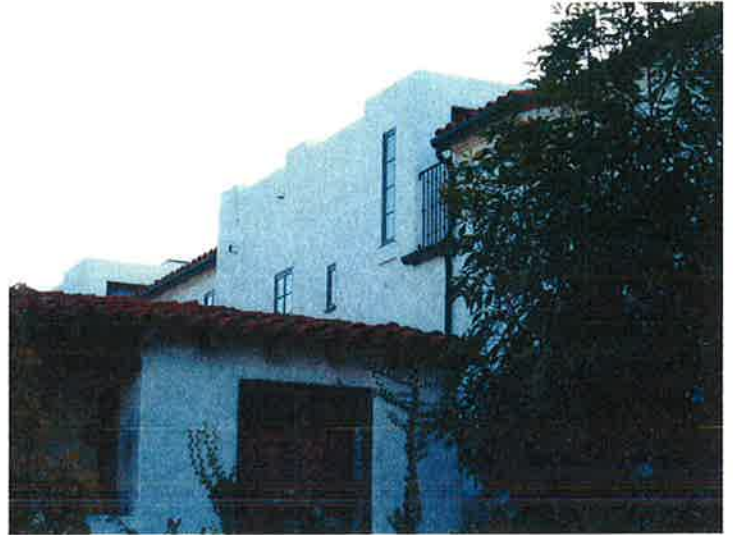
Stop 5:

- The scale and massing of the duplex adjacent to the historical house was a concern when reviewing the project. The second level deck along Buena Vista was setback to reduce the mass adjacent to the historic house. A segment of the building wall along the side property line shared with the historic house was set back an additional foot to reduce the massing to the historic house and its back yard.
- The architectural design was determined to be compatible with the historic house because it is a Spanish Colonial Revival Design and with the additional setbacks provided.
- The landscaping along Buena Vista for both properties has screened the view to the new duplex.

It is important to design a project with a five sided review approach. This will ensure a quality design on all sides and not just the elevations fronting the street.

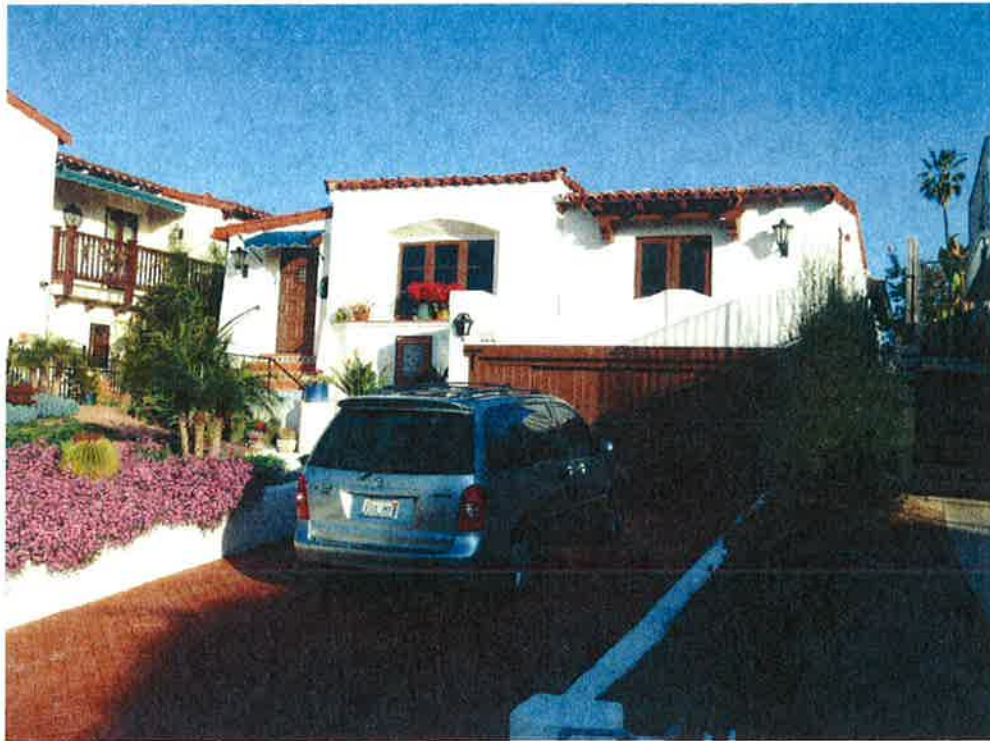
Stop 6:

- 2,157 addition to a Historic home
- Historic Preservation Program Agreement (HPPA) property

The applicant utilized the topography of the site and the available property at the back of the house to place a significant addition that is not visible from the street.

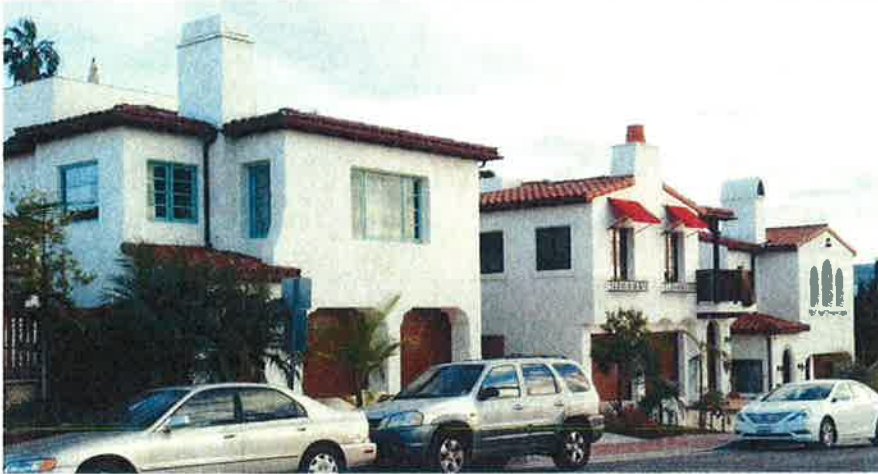
Stop 7:

- **Architectural style**
- **Design variation between three buildings**
- **Neighborhood compatibility**
- **Site layout**

- The duplexes were designed to be different and unique from one another.
- The contractor/applicant agreed to do various aesthetic and architectural details to ensure the project met the high architectural standards of the Architectural Overlay while working through the discretionary process.
- In the field the designs became more “cookie cutter” Spanish Colonial Revival architecture as the contractor did not follow the design of the plans.
- Staff continued to work to get the best product possible, even bringing the project back to DRSC due to the amount of changes in the field.

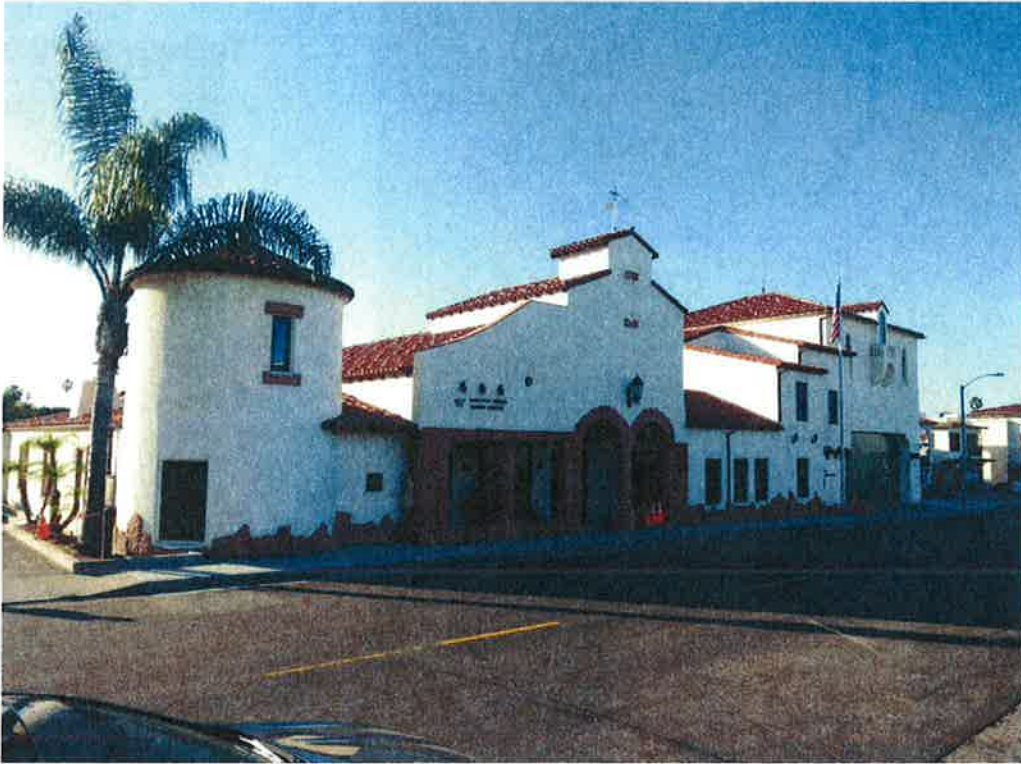
Stop 8:

- Changes in Architects, Planners and Contractors
- Approved elevations not matching working drawings
- OCFA requirements effect on architecture and site design
- Change orders and their cost

- Changes in personal during various phases of a project can have significant impacts on the final project design. It is important to get new personal up to speed quickly when these transitions occur.
- We need to do a better job in the project design phase and understanding the requirements of other agencies, in this case OCFA and developing realistic solutions. The apparatus bay design had to be brought back to DRSC several times for redesign.
- Need to gain a better understanding on how change is design impact cost.

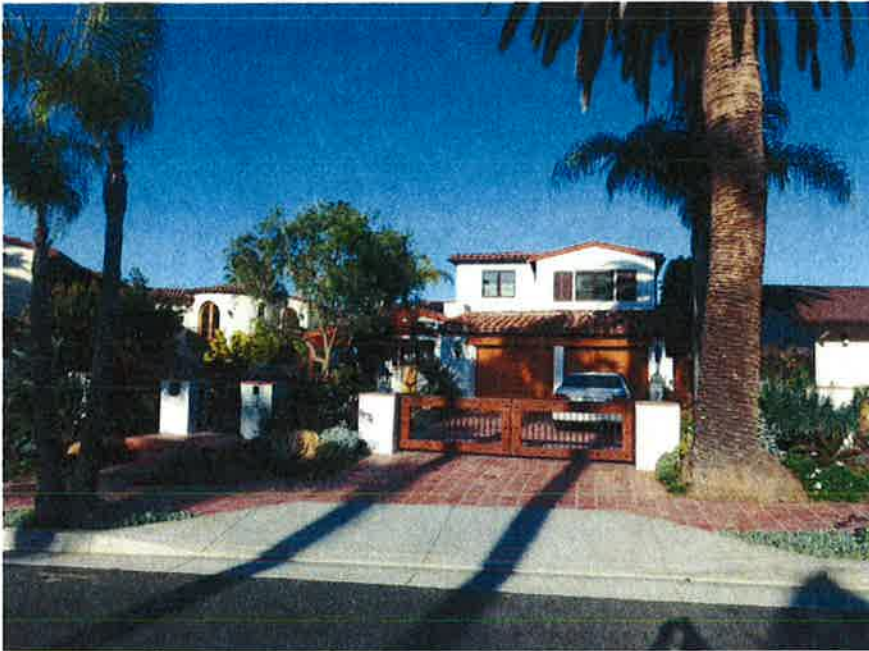
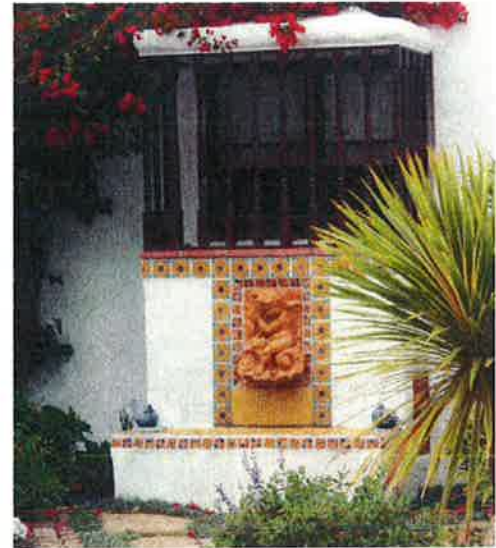
Stop 9:

- Remodel/addition to historic home
- Second-story addition
- Conformance with Secretary of the Interior's Standards

- The project was a large addition compared to the size of the original historic home, and there was concern about the second floor and if it would become the prominent feature when the historic structure is viewed from the street.

- There was extensive discussion regarding demolition of the rear portion of the historic structure.
 - While reviewed and approved during the discretionary process, there was concerns during the building process regarding the impact to the historical integrity of the structure.

- There had been several additions to the house through out the 50s, 60s, and 70s which damaged a lot of the historical integrity of the residence and had added significant square footage to the residence.

- The construction of the residence to the left of the project site, it changed the character and historic orientation of the residence.
- What remained of the historic and character defining features of the residence, there was an emphasis of preserving and refurbishing, including the fountain at the front of the residence (shown above), the re-use of the original roof tiles, and the refurbishing of the large side covered patio.

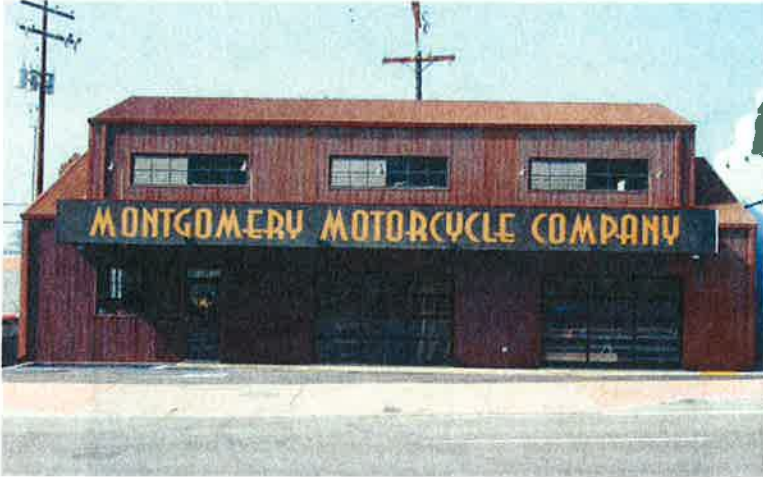
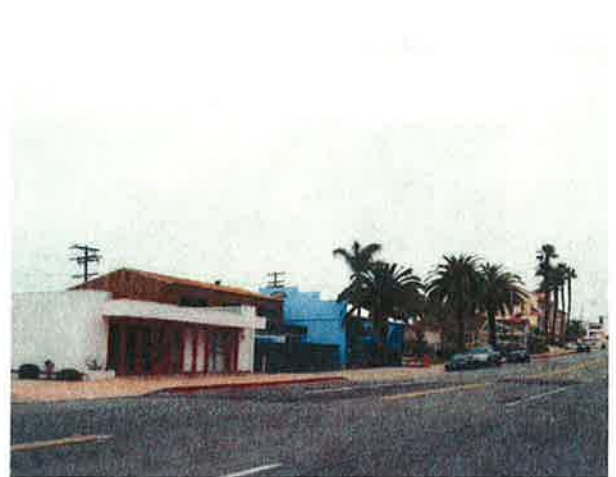
Stop 10:

- The sign was integrated into the design of the building and an after thought. The style of the sign, construction and location was compatible with the architectural style of the building which is required by the Design Guidelines.
- The Sign Exception Permit was justified because the commercial building is setback from the street and the view to the building when traveling north and south along El Camino Real is obstructed by the adjacent buildings and mature landscaping.

- Discretionary sign applications should be integrated into the building design to enhance the aesthetics of the project.

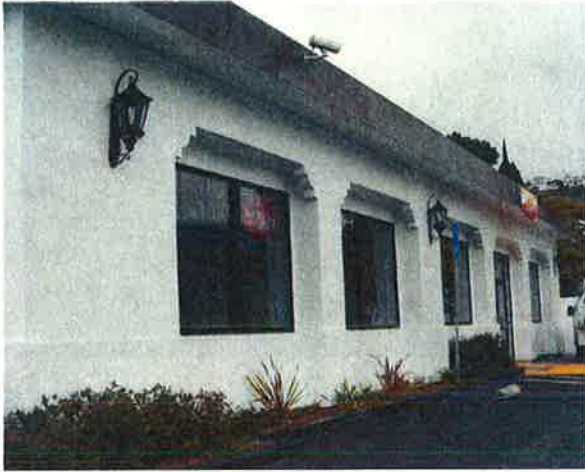
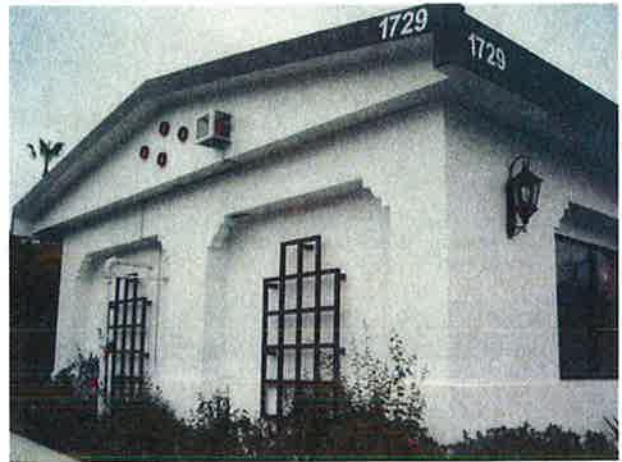
Stop 11:

- Service station remodel
- Standpipes
- Removal of the pole sign

- The City's policy regarding a change of use for service stations, in particularly the addition of a convenience store and removal of the repair portions of the site, was re-enforced when the project was taken all the way to City Council for review of the pole sign issue.
- The applicant/station owner stated that he could not operate his business without the pole sign. The City Council approved the project, with the removal of the pole sign.
- As a test, the applicant covered his pole sign for a month, and saw minimal change to his sales, and ultimately decided to move forward with the upgrades to the site and removal of the pole sign.
- The architectural improvements bring the site more in conformance with the City's adopted architectural style.
- This project is also an example for other service stations and the potential of changing uses and maintaining pole signs.

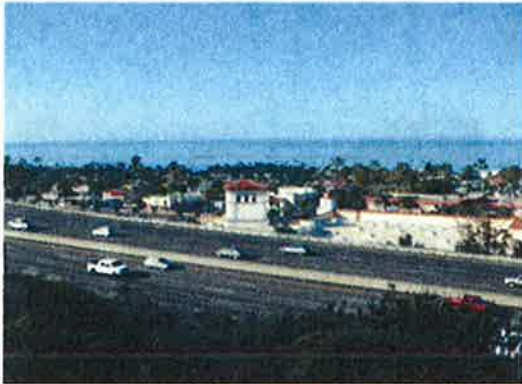
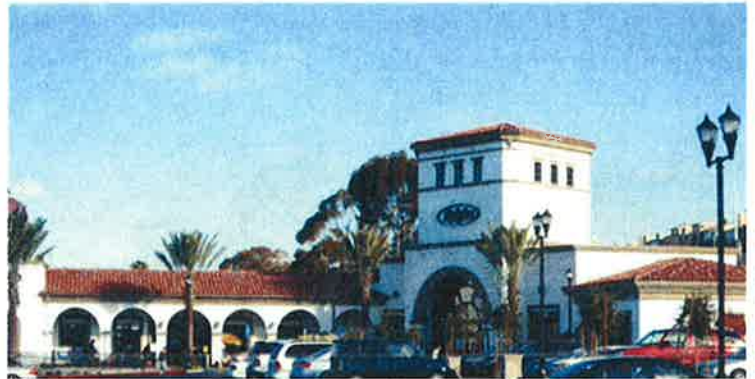
Stop 12:

- Tower scale/relationship to views
- Signage
- Circulation

- Site was finally approved with just a remodel and addition to the grocery store.
- Substantial exterior changes were made to bring the building more in line with Spanish Colonial Revival architecture, and to be an example of future development along the South El Camino Real corridor leading towards downtown.

- During construction there was debate concerning the height of the tower, and views from the freeway. While the tower was reviewed during the discretionary process and found to be consistent with the scale of the building and project site, there were concerns.

- In particular, there was concern that there was going to be signage on all sides as well as usable space for offices and other uses within the tower.

- Another issue, that is still being worked on today, is the circulation of the site.
- The applicant attempted to create the same one-way circulation for the site that they originally had. Though this has created some problems and back up onto South El Camino Real.

- Engineering included conditions of approval to allow for modifications to be made to the parking lot if determined necessary to resolve problems.
- Engineering is continuing to work with Ralphs to modify the stop light and onsite circulation to address community concerns.

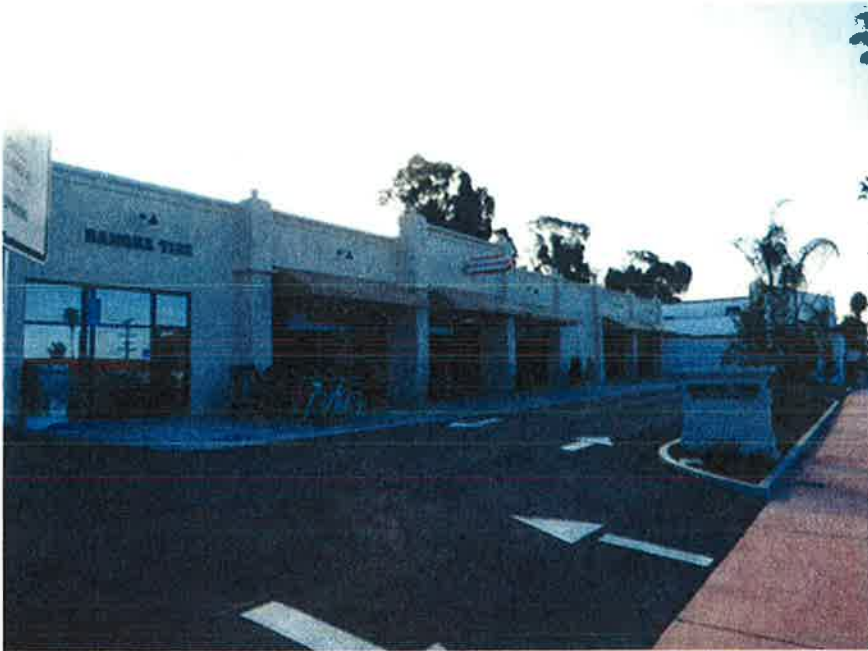
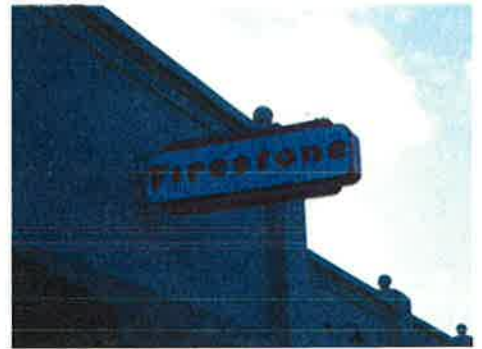
Stop 13:

- No defined auto-related commercial remodel
- Deco Architectural style and materials
- Compatibility with adjacent historic buildings

- Process lead to a fresh look on how we look at auto oriented uses on ECR. ECR distinguishes history distinguishes itself from the Downtown core because it has always been automobile oriented. The development of future design guidelines should consider this.
- For some remodels alternative but compatible architectural styles to SCR can be successful

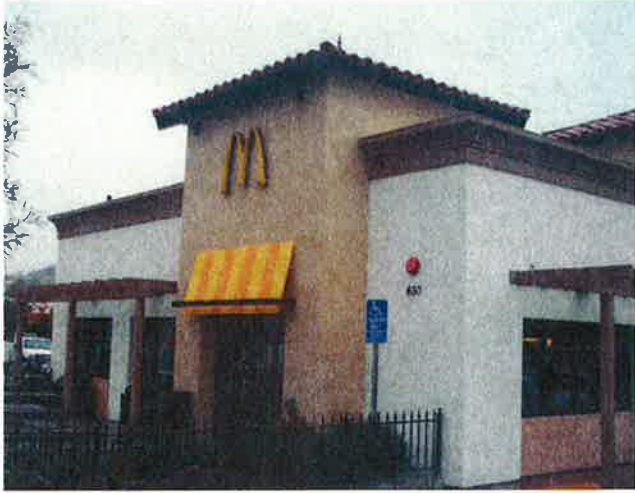
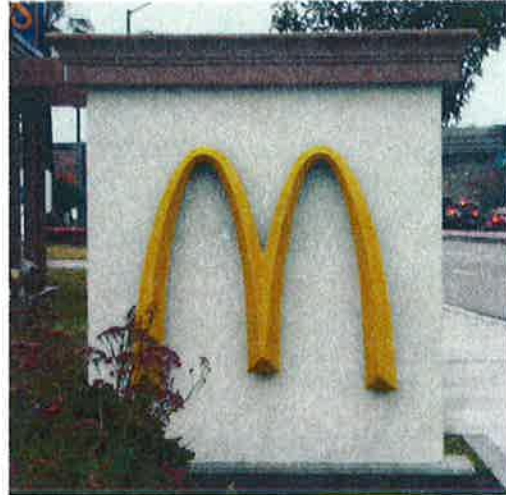
Stop 14:

- Corporate "branding" vs. City standards
- Architectural details

- Almost a year of work was put in by staff prior to a formal submittal to get the design of the building consistent with the Design Guidelines.
- Throughout the process, McDonalds was difficult to compromise with as branding is a major component of McDonalds, and they wanted to use their standard design and features.

- Through several meetings, and ultimately compromise on both sides, the site architecture and circulation was greatly improved.
- There are unique details on this project that "had" to be included, most importantly the yellow and orange awnings above the doors.

- Additionally, the only internally illuminated signs are the "Golden Arches" and staff and DRSC was able to work with corporate McDonalds to get the metal pin mounted "McDonalds" name halo lit for the primary signage, and reduced the modern looking drive thru features that are typical on other McDonalds.
