Design Review Subcommittee (DRSC)

Meeting Date: July 29, 2015

SUBJECT: **MCUP 15-111 / MCHP 15-112, Tamarindo Restaurant**, a request to consider the remodel of a one-story commercial building and beer and wine for two future restaurant uses at 108-110 South El Camino Real.

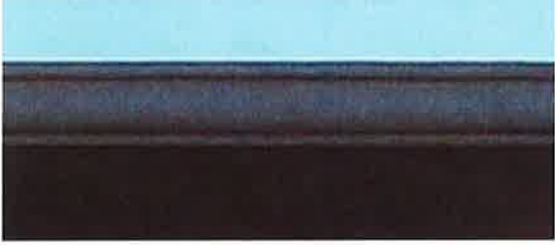
<p>2. A cornice detail should be added to the front and rear parapets. Cornice detail should be simple in design.</p>

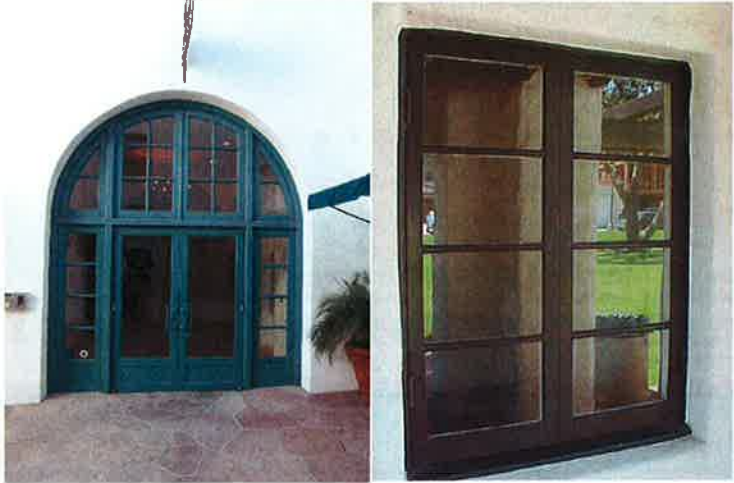
<p>3. Wood doors/windows should be provided along the front elevation and they should have lites. Steel door and aluminum windows at the rear are acceptable provided their finish and detailing is consistent with a wood doors/window. They should have traditional profiles, recessed, and the aluminum windows should have lites.</p>

- 4) remove aluminum storefront and replace with wood doors and windows;
- 5) install potted plants to serve as barrier between outdoor dining area and sidewalk;

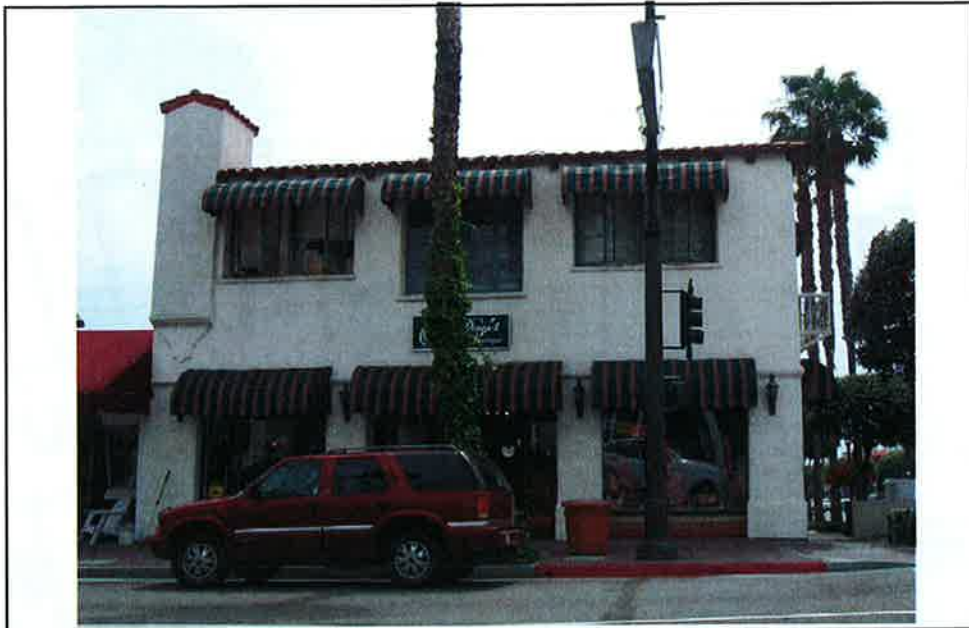
P3a. Description:
The property contains a two-story commercial building with a rectangular plan and wood-frame construction. Designed in the Spanish Colonial Revival style, it has a hip roof with clay tiles and exposed rafter tails. The exterior walls are clad with smooth stucco. The primary (east) facade is three bays wide and symmetrically arranged, with three regularly-spaced rectangular openings in each story. A stucco-clad turret with a clay tile-clad gable roof extends from the southernmost corner of the facade. Alterations include non-original doors, though the door openings appear original. The fenestration consists of original wood divided-light double-casement windows on the front and side elevations of the second level, and original storefront openings on the front and side elevations of the first level. Non-original canvas awnings shelter the openings on the street facade. The building is in good condition. Its integrity is good after a recent renovation to repair fire damage.

- P5b. Description of Photo: East elevation, west view. May 2006.
- P6. Date Constructed/Sources: Historic Both Prehistoric
1926 (E) Tax Assessor
- P7. Owner and Address: Pier Group Llc
6 Del Valle, Orinda Ca 94563- 2009
- P8. Recorded by: Historic Resources Group, 1728 Whitley Avenue, Hollywood, CA 90028
- P9. Date Recorded: 9/18/2006
- P10. Survey Type: City of San Clemente Historic Resources Survey Update

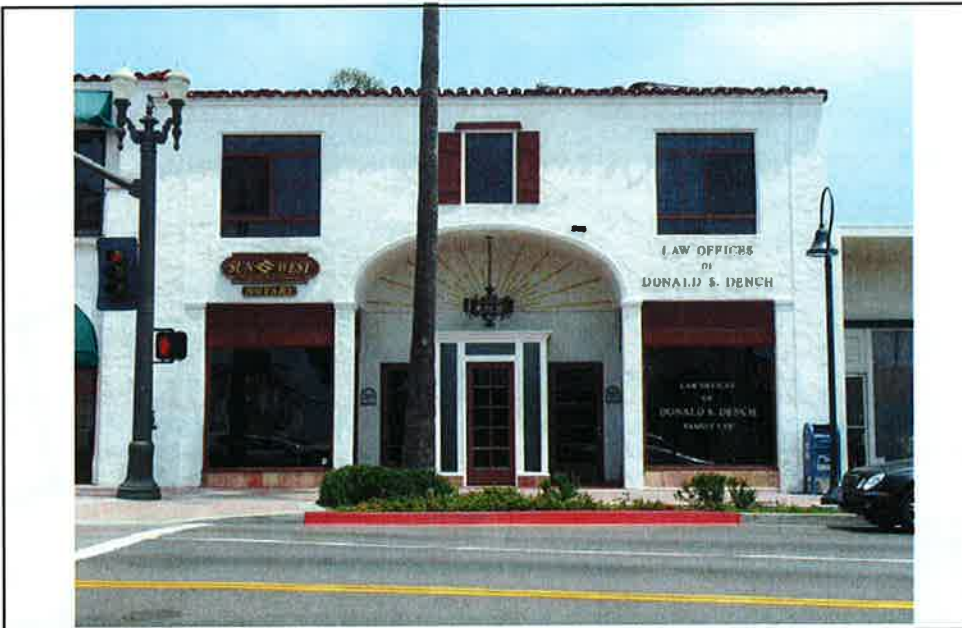
The property contains a two-story commercial building with a rectangular plan and wood-frame construction. Designed in the Spanish Colonial Revival style, it has a low-pitch hip roof with clay tiles. The exterior walls are clad with smooth stucco. The primary (west) facade is three bays wide and symmetrically arranged. The ground level is characterized by a large recessed arched opening that contains the building's main entrance. The entrance is composed of a non-original projecting entry vestibule flanked by two non-original divided-light wood doors. The outer bays each contain a large fixed picture window. The upper level features a small centered window and two larger outer windows. The fenestration consists of non-original vinyl windows throughout the building. The building is in good condition. Its integrity is fair.

West elevation, east view. May 2006.

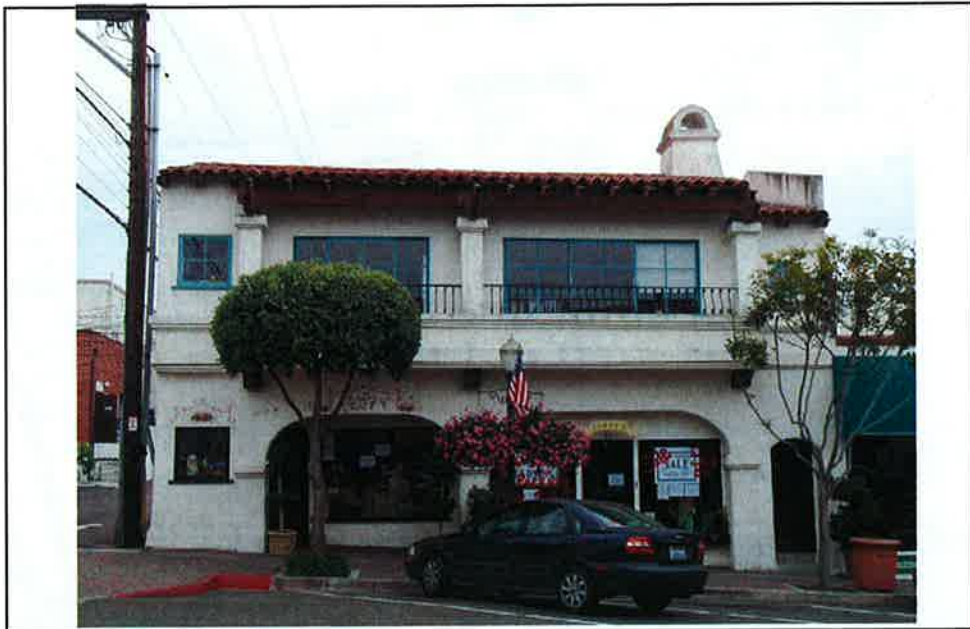
The property contains a one- and two-story commercial building with a rectangular plan and wood-frame construction. Designed in the Spanish Colonial Revival style, it has a low-pitched gable-side roof over the two-story portion with clay tiles and exposed structural elements, including exposed rafter tails and projecting roof beams; the one-story portion has a flat roof. The exterior walls are clad with smooth stucco. The fenestration consists of both original and non-original wood and steel windows throughout the building. The street level facade is defined by two elongated rounded arched storefront openings, flanked by a rectangular window on the left and an arched opening to a stairwell. The second floor exhibits a slightly projecting, partial width balcony, covered by an extension of the side-gabled roof with stucco post supports and non-original metal balustrade. A stucco chimney with an arched cap exists at an end wall. The building is in good condition. Its integrity is good.

North elevation, south view. May 2006.
