Subject: *SAN CLEMENTE PIER PRESENTATION FROM COASTAL ADVISORY COMMITTEE MEETING*

San Clemente Pier

March 10, 2016

San Clemente Pier Presentation Outline

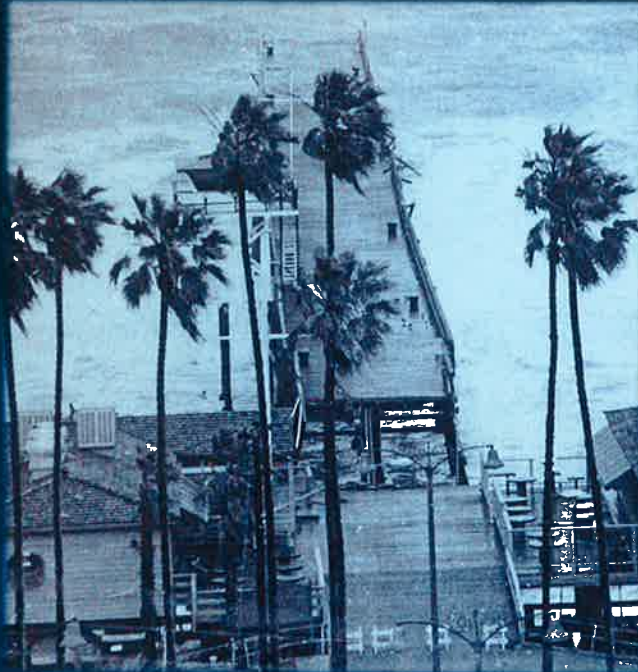
San Clemente Pier Storm Damage

1983

- 36% of the length of the pier was destroyed
- 48% of the total number of piles went missing

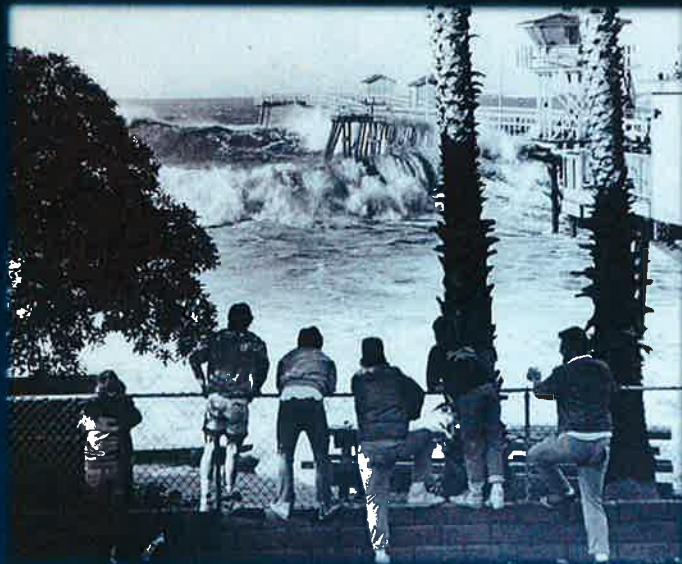
San Clemente Pier Storm Damage 1988

- Severe storm waves coincident with high tides caused severe beach erosion that undermined & endangered several San Clemente facilities along the beach.
- These facilities included Marine Safety, restrooms, concession buildings, the entrance to the pier, picnic shelter areas, access roads, the trash disposal area, and the utilities.
- Wave-driven debris acted as a battering ram destroying some pier piles.

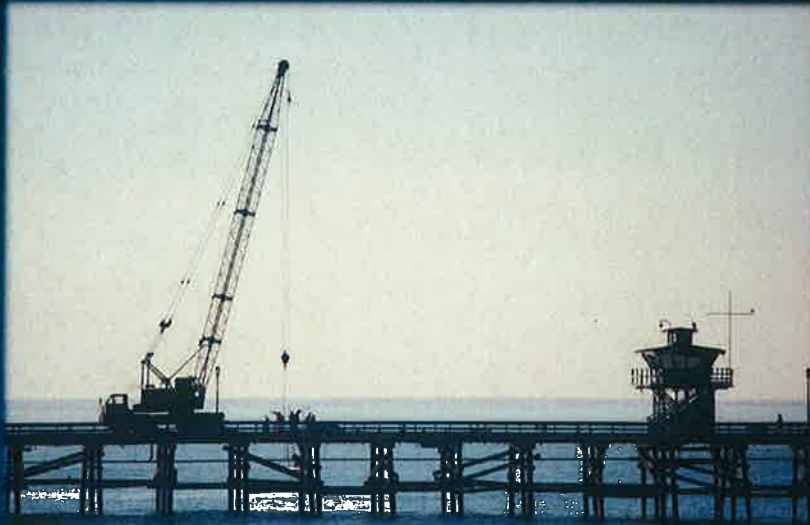
Pile driving equipment moving on long beams/track to prevent excessive point loading

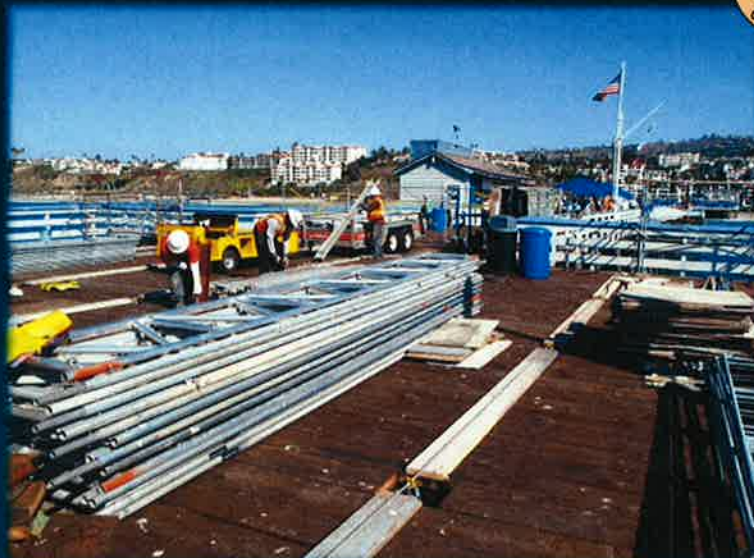
Scaffolding for under the Pier

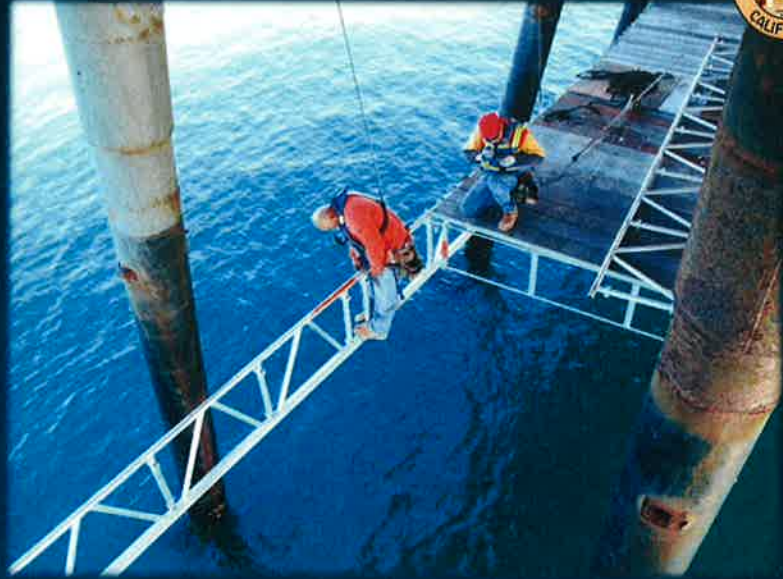
Scaffolding being assembled under the Pier to repair steel piles

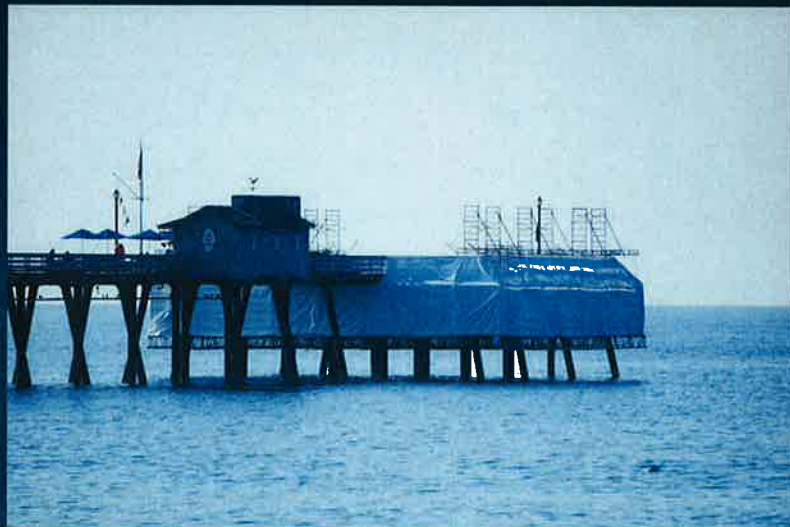
Enclosure for steel Piles' repairs under the Pier to prevent debris falling in Ocean

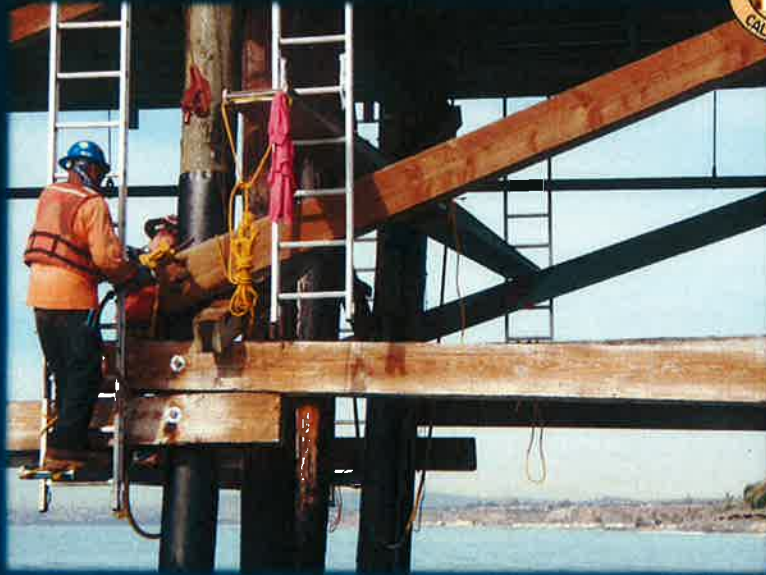
HDPE jackets are placed around wood piles & new bracing being installed

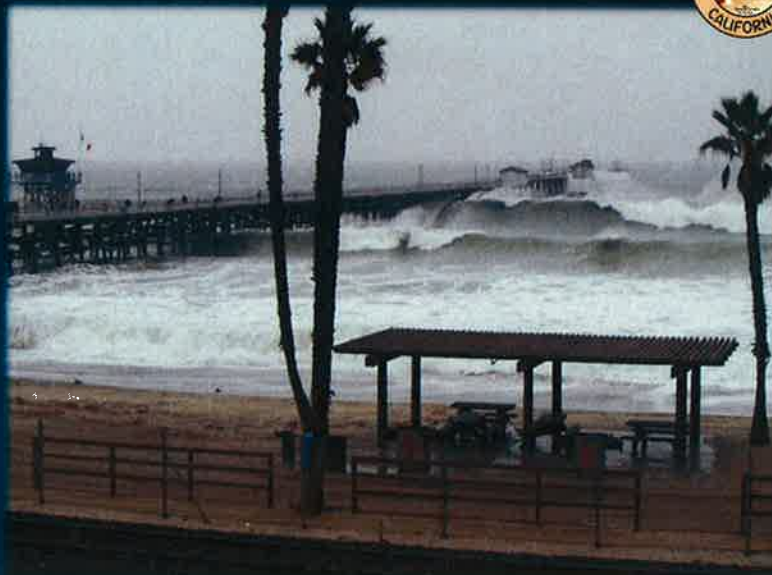
January 20, 2010 destroyed contractor's scaffolding and enclosure (approximately worth \$300k)
