## Design Review Subcommittee (DRSC)

**SUBJECT:** **Historic Property Preservation Agreement (HPPA) 18-435, Ciotola HPPA**, a request for a Mills Act agreement between the City and the owners of a historic private residence at 1411 Calle Mirador.

# PHOTOGRAPHS OF PROPOSED RESTORATION IMPROVEMENT TIMELINE

HPPA 18-435, CIOTOLA RESIDENCE HPPA, 1411 CALLE MIRADOR

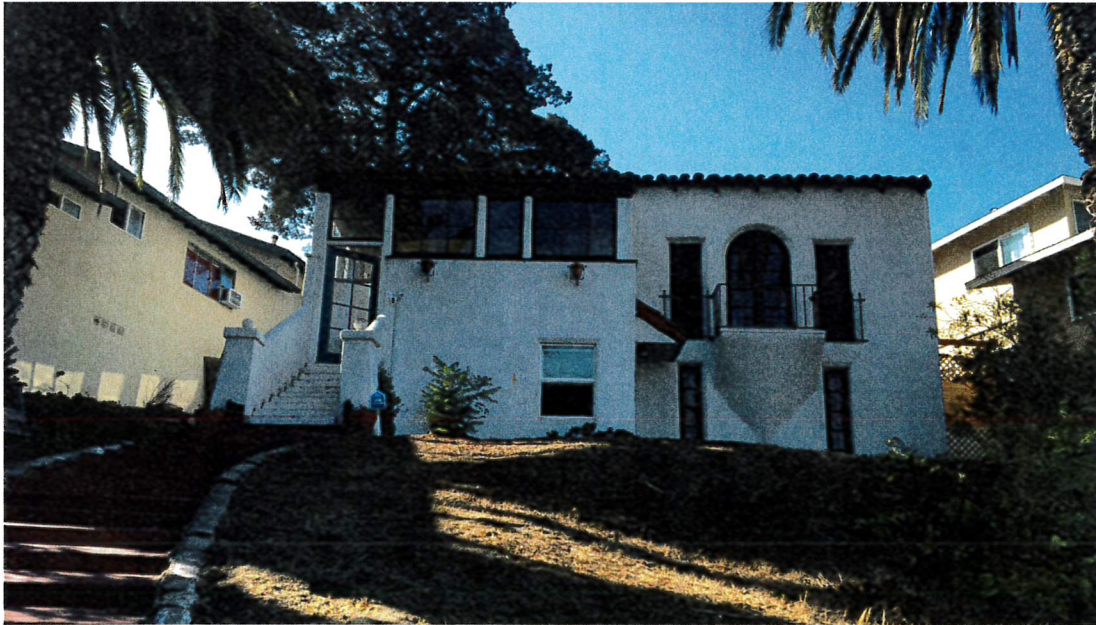
**Figure 1 – Existing Site Conditions**

The subject property was developed in 1928 and includes a 1,520 square-foot residence on a 6,200 square-foot lot. The site is in the Residential Medium Zone and Coastal Zone Overlay District (RM-CZ). The architect and builder are unknown. Please reference Attachment 1 for a vicinity map.

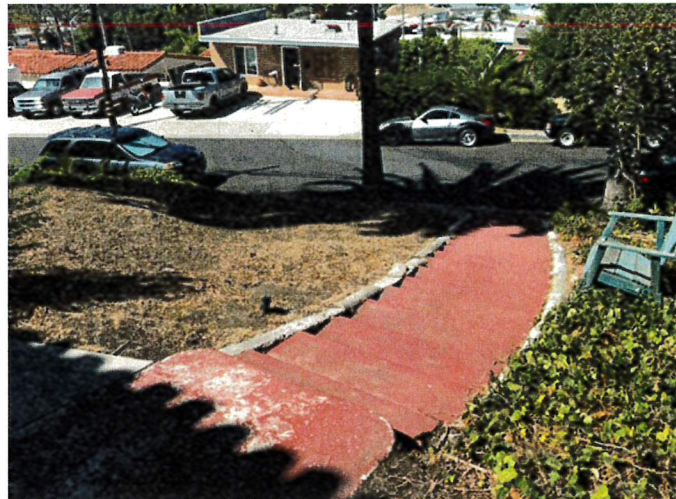
**Figure 2 – Unique Work List Item**

Additionally, the front concrete walkway that leads to the front entry is in need of repair, as seen in Figure 2. A 1938 historic aerial image shows that the walkway still obtains its same proportion. Staff and GPA presume the existing walkway is original and worthy of including this element on the work list due to its historic characteristics such as curvature, red concrete, and function, and its visibility from the street.

7.	Repair the front original concrete walkway in kind using concrete mix to match historic concrete to the greatest extent feasible.	2023
8.	Prep, patch, repair and repaint exterior stucco and wood trim in kind.	2024

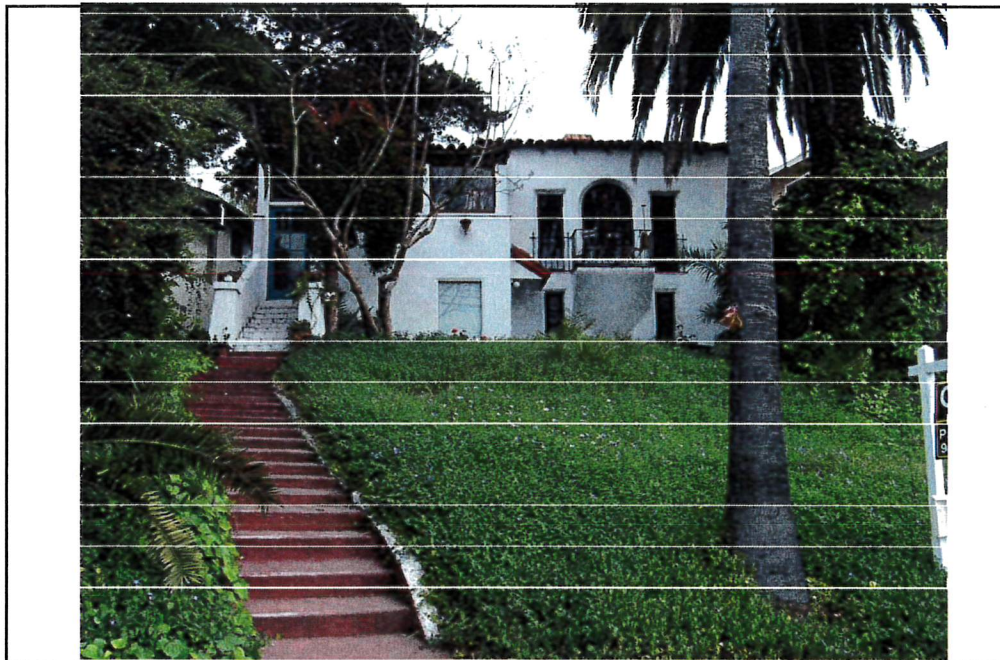
P5b. Description of Photo:

North elevation, south view. May 2006.

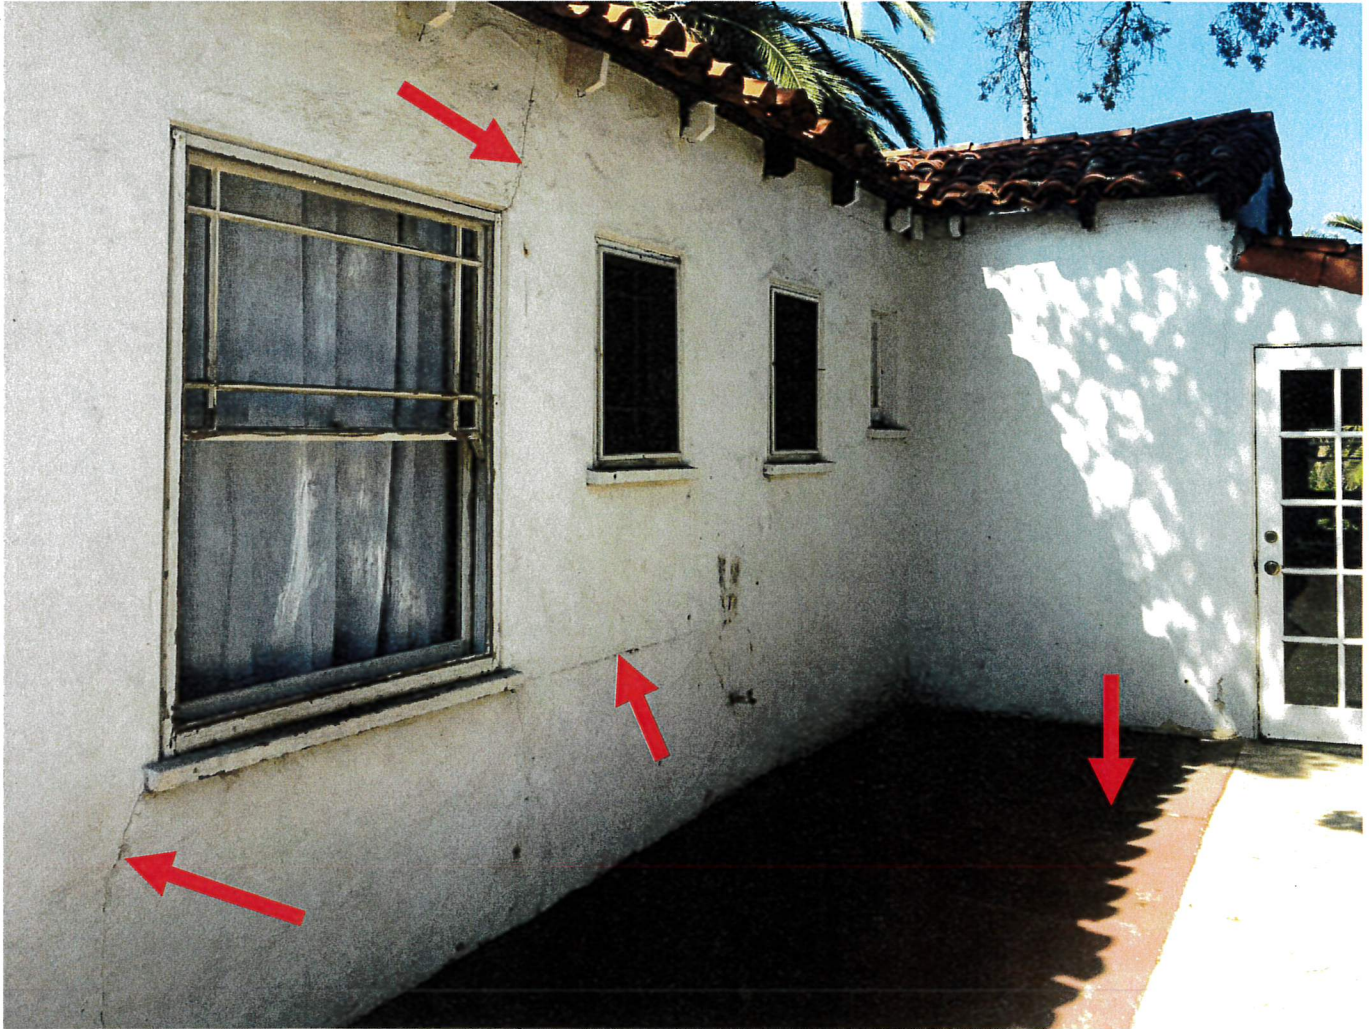
# Improvements 1

Cracks on exterior walls were noticed that may be due to the destabilized foundation. The highest priority work list item is to repair destabilized foundation after obtaining an assessment report and implementation plan from a qualified structural engineer. The report would ensure that repairs be executed in a way that mitigates impacts to the historic structure.

**Foundation-** there is a crack in the fondation on the left side of the structure. At this time I do not have a estimate for repair but it will need to be addressed in the future because there is separation due to lack of rebar.

Hire a structural engineer to assess building foundation/structure and prepare an implementation plan for recommended work (including repair of crack in foundation on the east side of the structure).

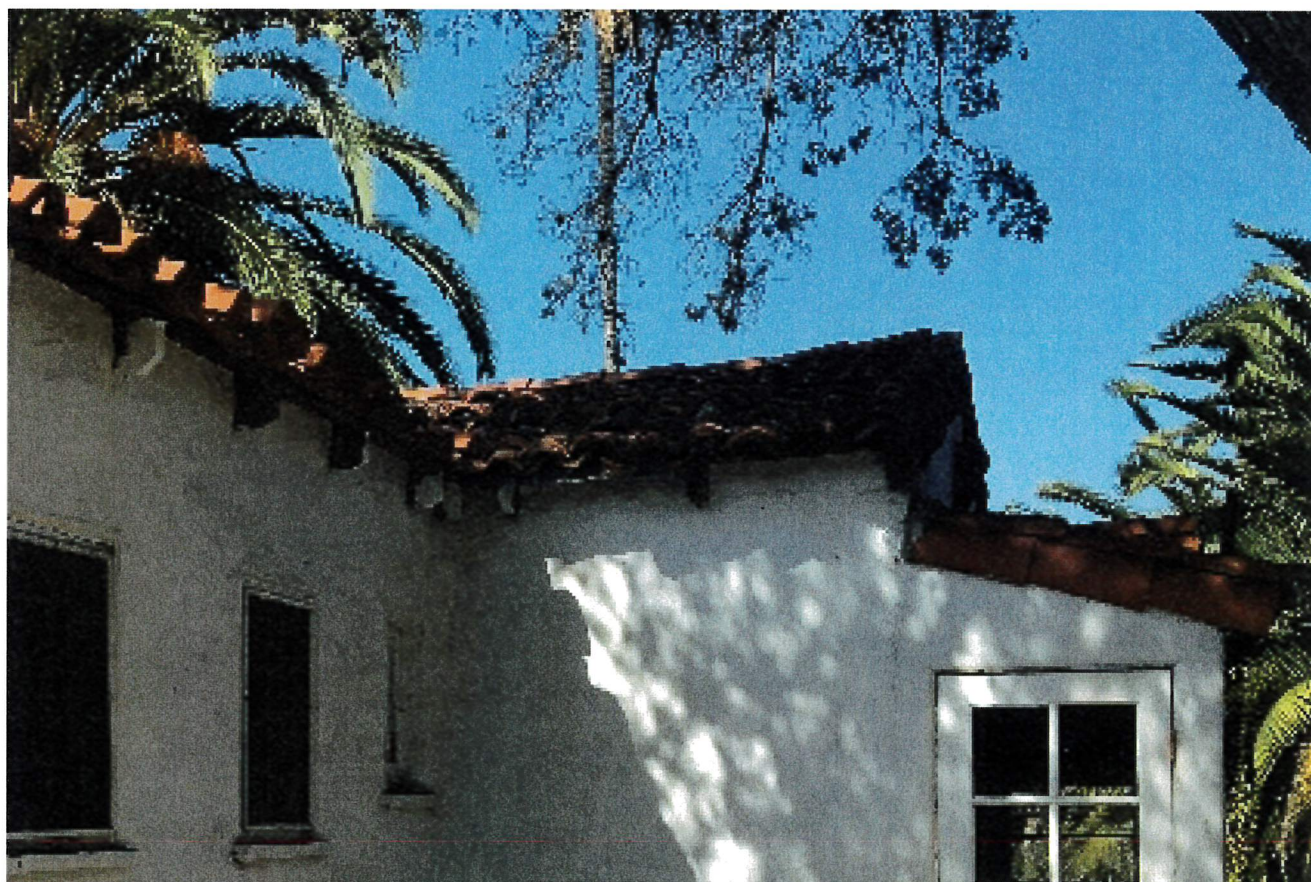
# Improvement 3

**Roof-** the tile roof of the structure is overall in good condition per our roof contractor but is lacking maintenance. There are areas where light can be seen from the attic area. Tiles are damaged in a few areas.

Repair damaged roof clay tiles, or replace as needed with tiles that are compatible with the historic character of the building.

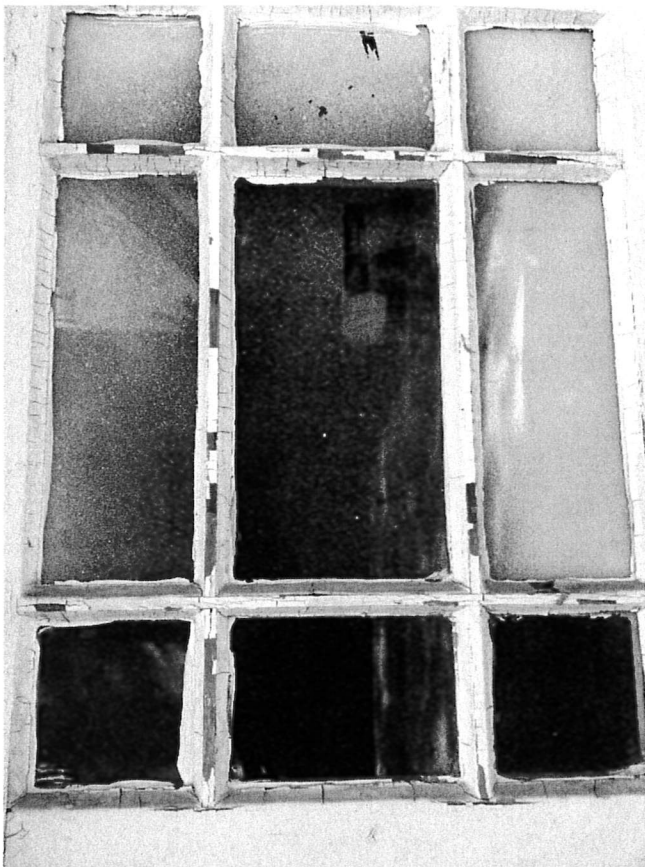
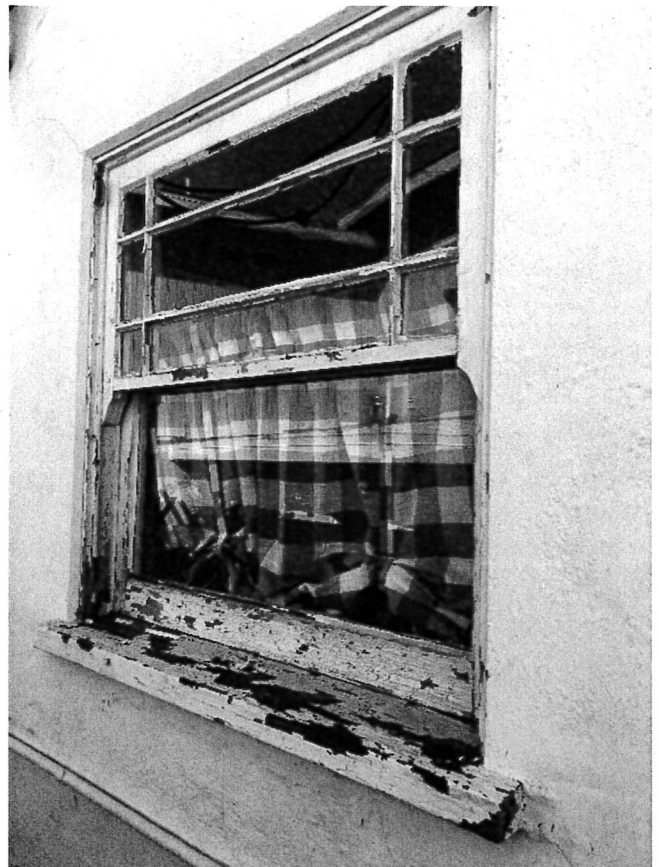
# Improvement 4

**Windows-** Every window in the home needs to be repaired or replaced with wood double hung windows. We have contacted Spectra Company to get information about refinishing the windows. After speaking to Jonathan he advised us that the cost for services is \$80 per hour labor, plus materials plus 10%. Each window would take about 1 ½ to 2 days. There are 29 windows that need repair. \$1408 per window not including material cost. \$40,832 at a minimum, not including the materials cost.

Repair window frames and sash by patching and splicing where feasible. Where windows are too deteriorated to repair, replace in kind using the original windows as a model to reproduce the feature.

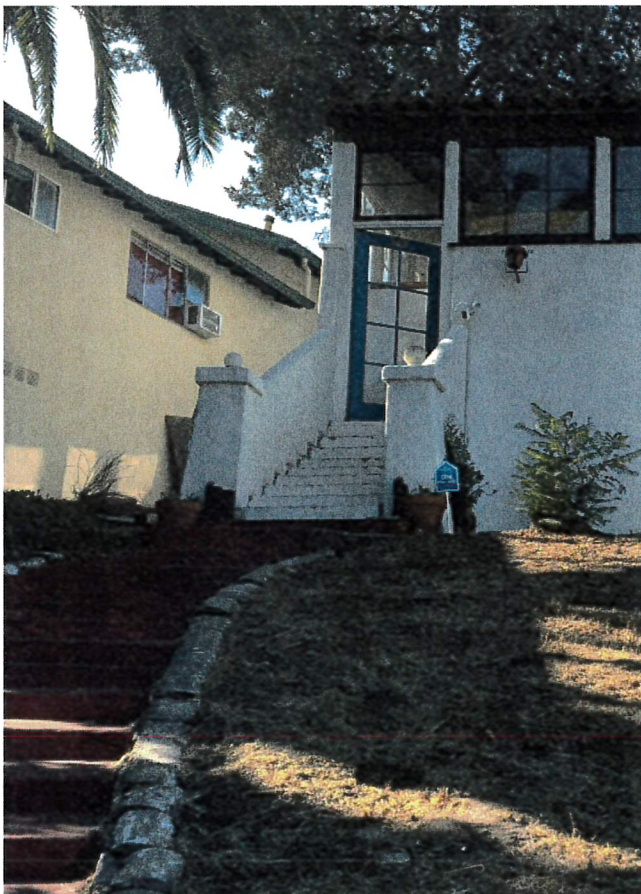
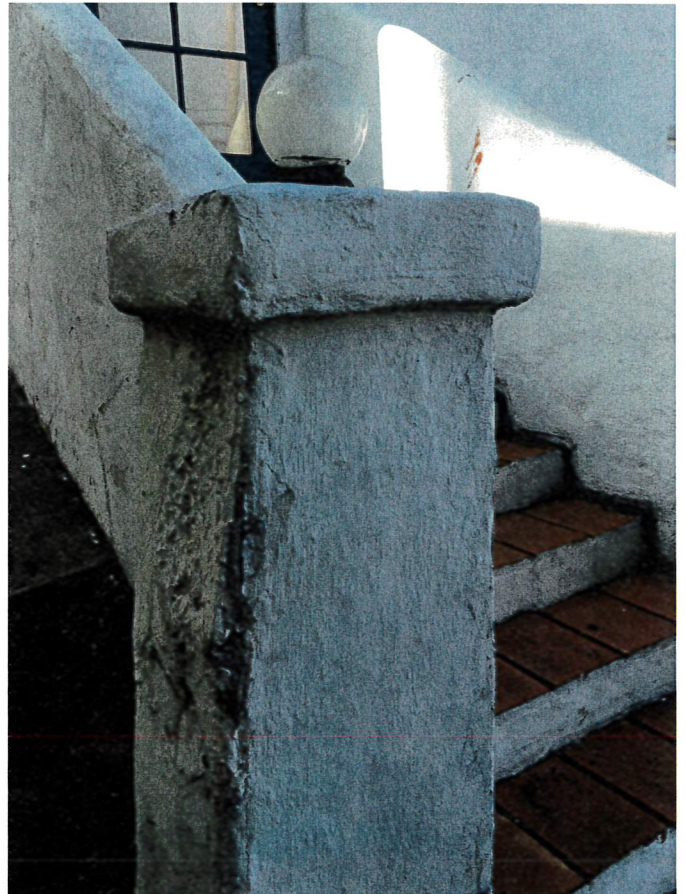
# Improvement 6

**Entry Stairs-** need to be structurally repaired and tile replaced due to rot of supports and mortar has allowed water to get under the structural supports. - cost estimate \$5000-\$7000

Engage the services of an architectural historian or architect/designer to investigate materials of deteriorated entry stairs and repair or replace as recommended. Existing structural supports are hollow and appear non-original or significantly altered.

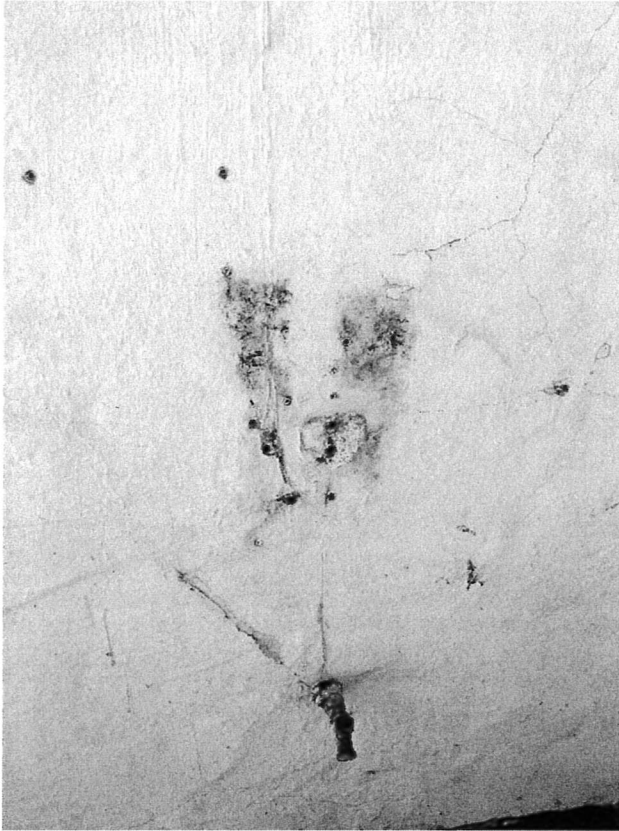
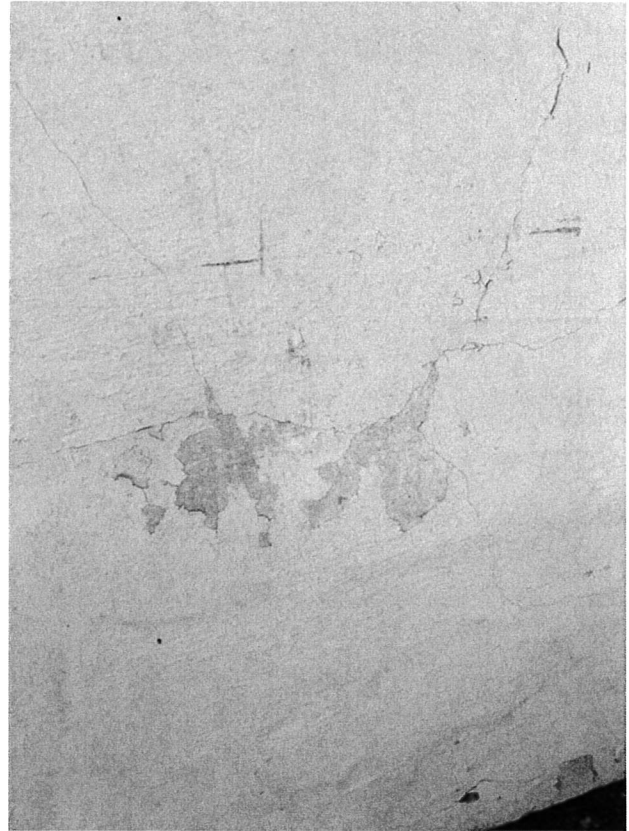
# Improvement 8

**Exterior Paint-** Exterior of the structure needs to be repainted with repairs to stucco and roof tails at a cost of \$10,000

Prep, patch, repair and repaint exterior stucco and wood trim in kind.

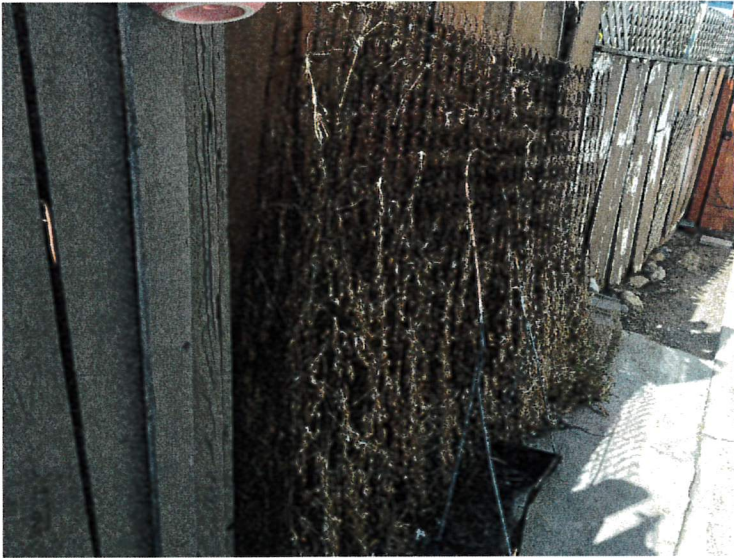
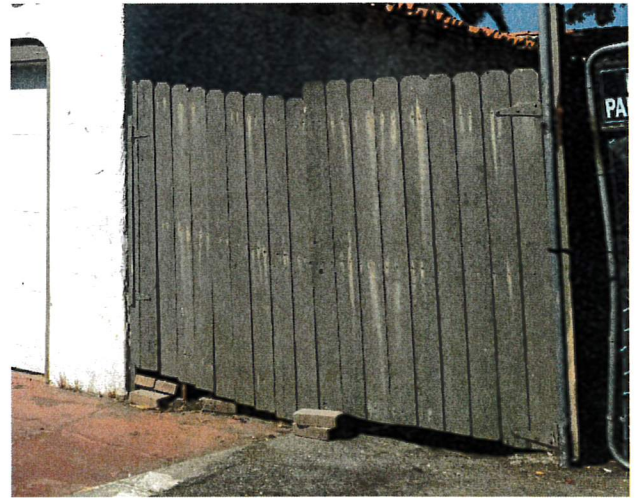
# Improvement 13

**Fence-** repairs around structure to include replacing posts \$3000

Remove damaged and inconsistent wood fencing and gates.  
Replace with compatible option.
