Design Review Subcommittee (DRSC)

SUBJECT: **Historic Property Preservation Agreement (HPPA) 19-190, Cocomares Residence**, a request for a Mills Act agreement between the City and the owners of a historic private residence at 102 West Avenida Cadiz.

Annotated Photographs of Proposed Restoration Improvement Timeline

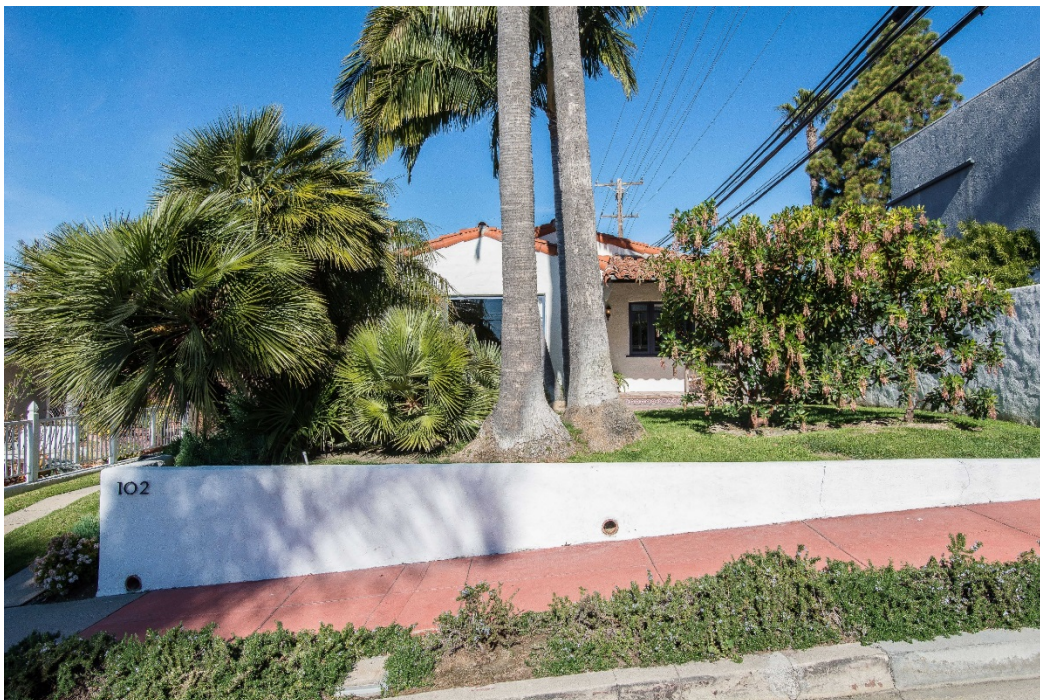
Figure 1 – Existing Site Conditions

The subject property was developed in 1935 and includes a 1,198 square-foot single-family residence and a detached 400 square-foot two-car garage on a 4,800 square-foot lot. The architect was Leo Smith, one of many identified architects in the 2006 Historic Resources Survey Update. Leo Smith designed multiple residential buildings in San Clemente, including the Casa De Marca Apartments (1930). The subject site is in the Residential Low (RL) Zone. Please reference Attachment 1 for a vicinity map.

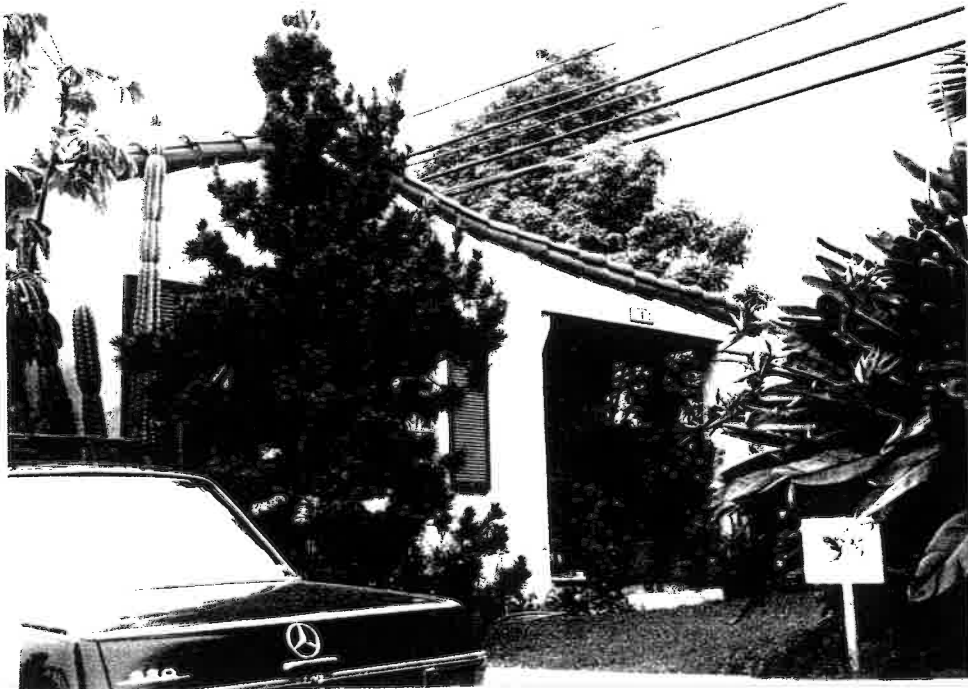
This one story residence displays the characteristics of the Spanish Colonial Revival style. It is sheathed with white stucco and capped by a front gable roof of red tile. The right (east) rake of the roof extends further than the left rake to embrace an entry porch recessed into the southeast corner of the building. A pier with a capital and a bracket attached to the facade support the flat-headed opening to the porch. Centered below the peak of the gable, a tripartite casement window occupies most of the rest of the facade. It and other windows on the side elevations are flanked by wood shutters. The house appears to be substantially unaltered, although building permits indicate that a window and door have been replaced and a bathroom added. Set back from the street by a low retaining wall, the well maintained house is enhanced by its landscaping, which includes a palm, bird of paradise and cactus plants.

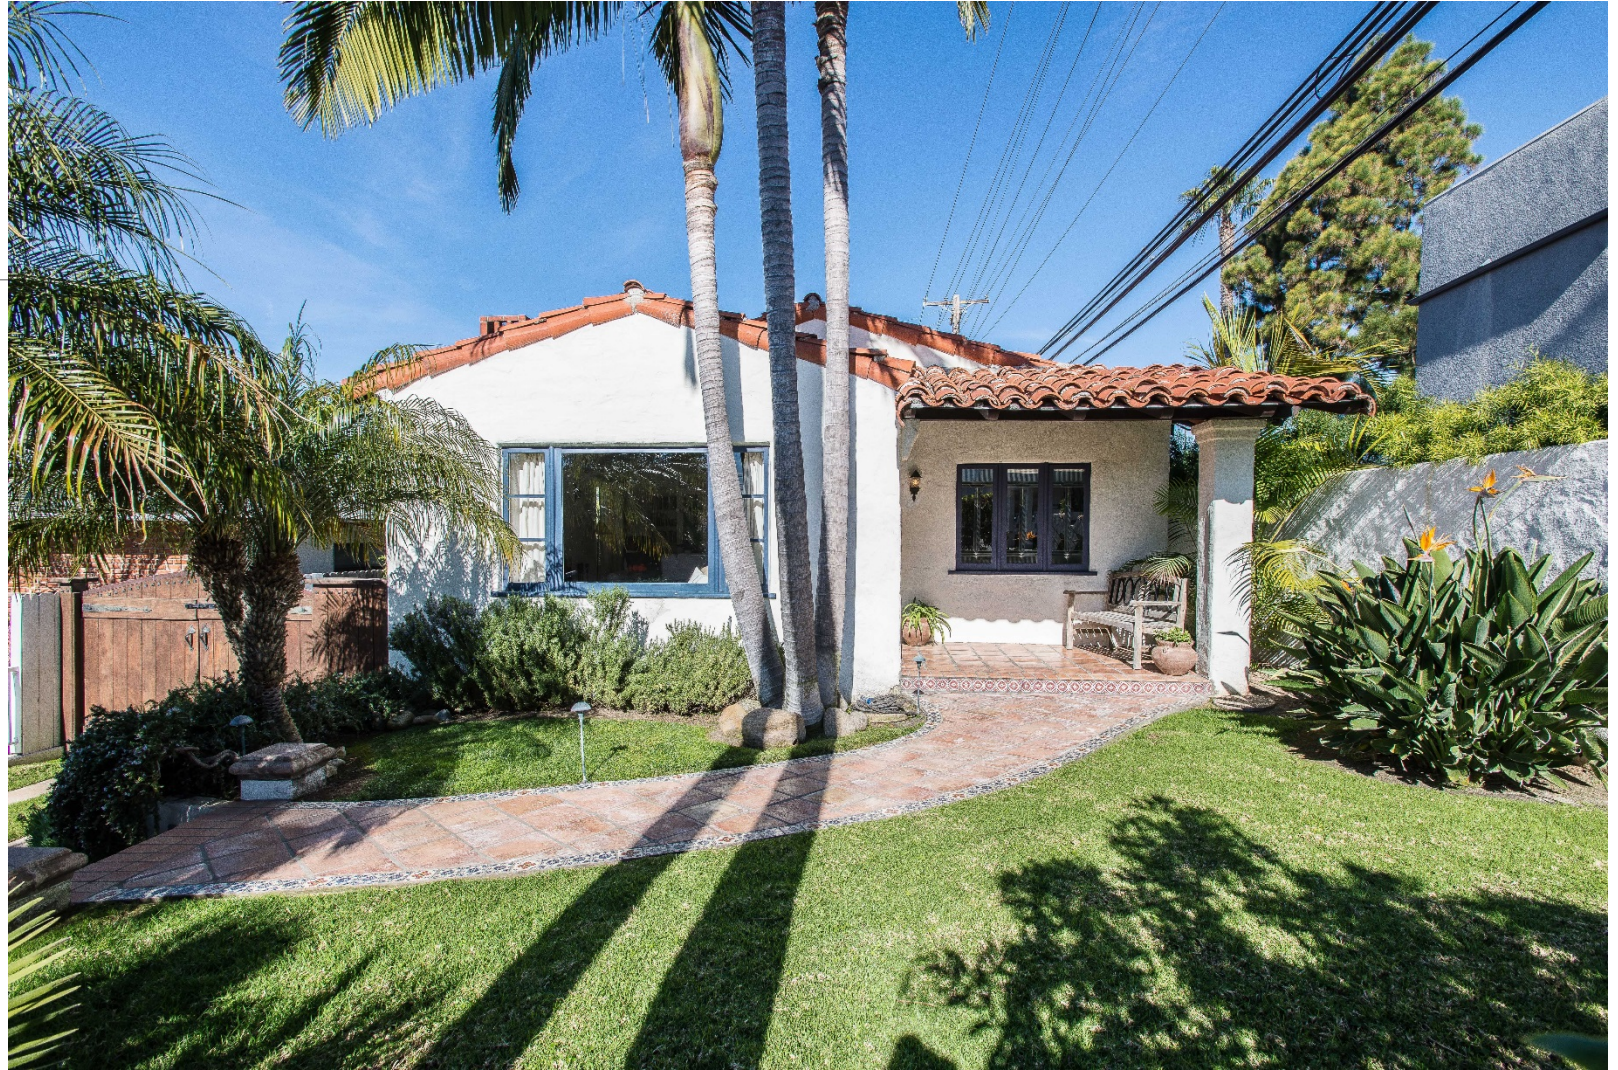
* This photograph does not specifically demonstrate the work list item to address.

Building Feature	Proposed Work/Task
1.	Foundation	Seismic retrofit; foundation bolting. Engage a qualified structural engineer experienced in working with historic properties to properly execute the seismic work and avoid causing damage to historic fabric or visually impacting the historic building.

1. Engage a qualified structural engineer experienced in working with historic properties to properly execute seismic retrofitting and foundation bolting.

Proposed Completion: 2022

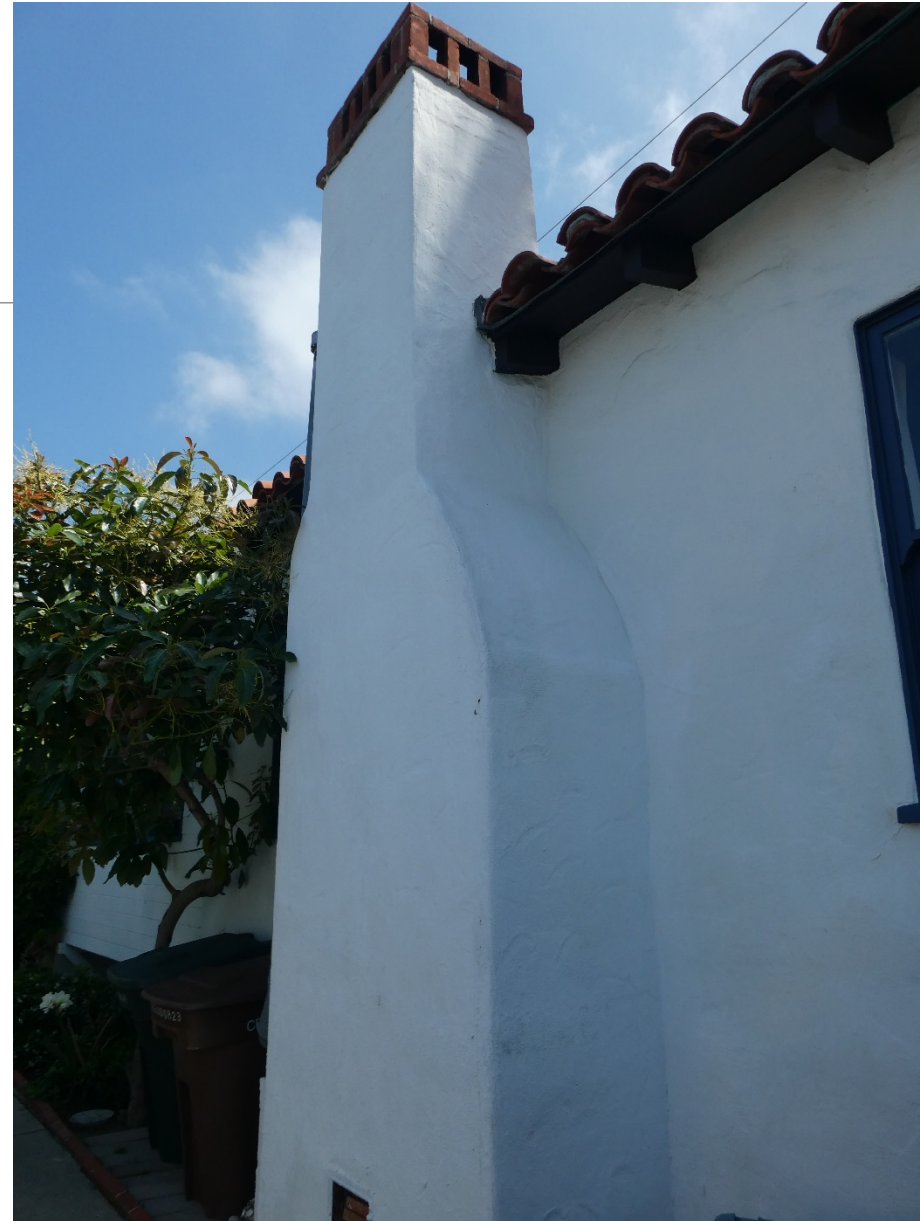
2.	Chimney	Engage the services of a structural engineer to inspect and make recommendations for work to preserve the chimney. The decorative brick chimney crown should be reinforced to ensure the structural stability and a chimney cap should be installed to prevent water and pests from infiltration. Work should be completed without damage to historic fabric to the greatest extent feasible.

2. Engage the services of a structural engineer to inspect and make recommendations for work to preserve the chimney.

Proposed Completion: 2023

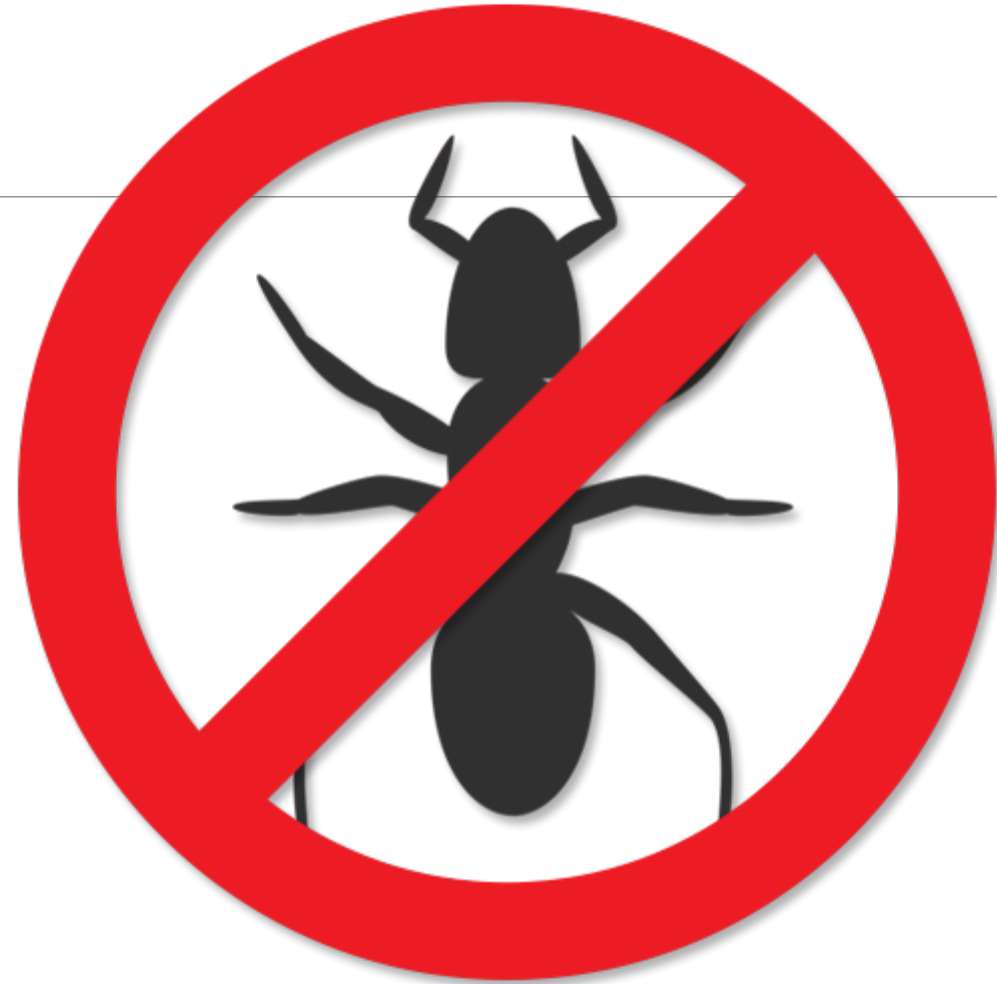
3.	Structural/Wood Elements	Fumigation: treat property for termites, thereby preventing immediate and long-term damage to the historic fabric. Property owner should inspect annually for termite damage, as well as weather or other damage and make related repairs in kind as needed.

3. Treat property for termites, thereby preventing immediate and long-term damage to the historic fabric.

Proposed Completion: 2024

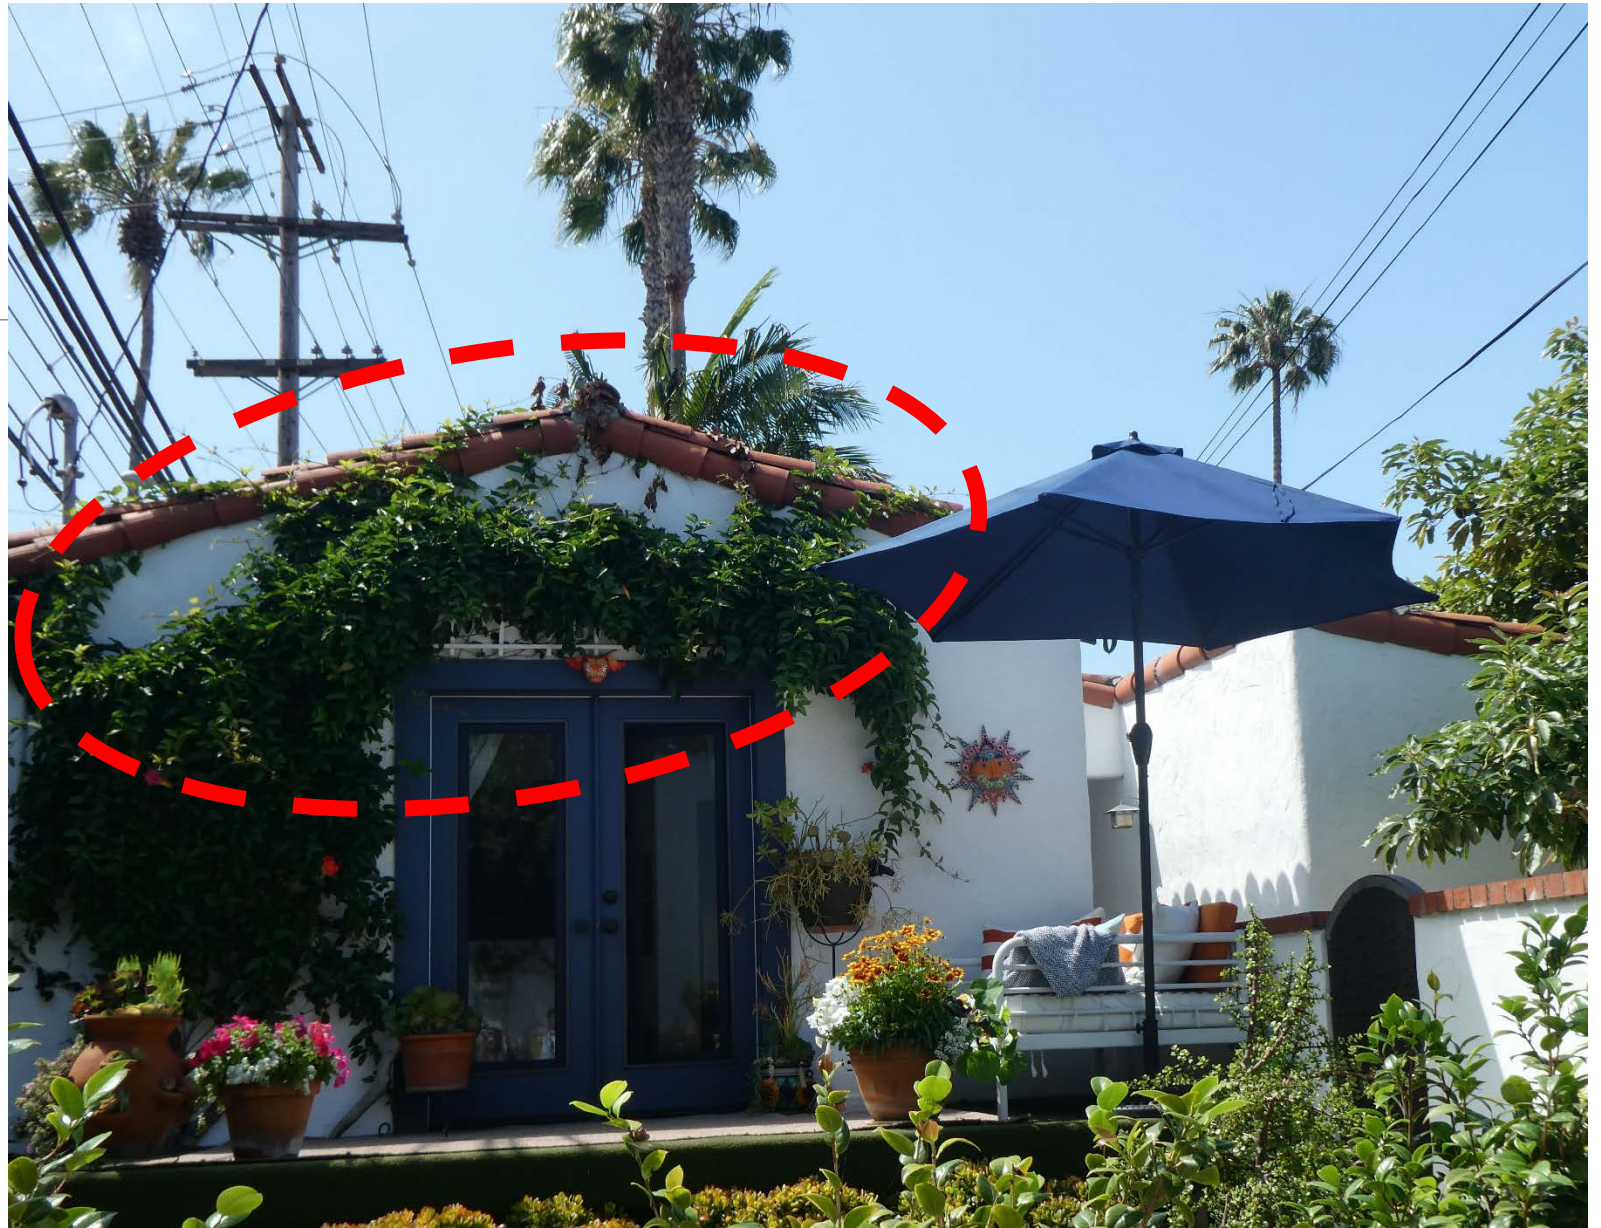
4.	Exterior	Vines are growing up exterior surface and roof of house. Vines can cause damage to exterior surface materials, deteriorate wood features, cause water to penetrate structure and promote pest infestation. Carefully remove vines and repair any damaged materials in kind.

4. Carefully remove vines and repair any damaged materials in kind.

Proposed Completion: 2024

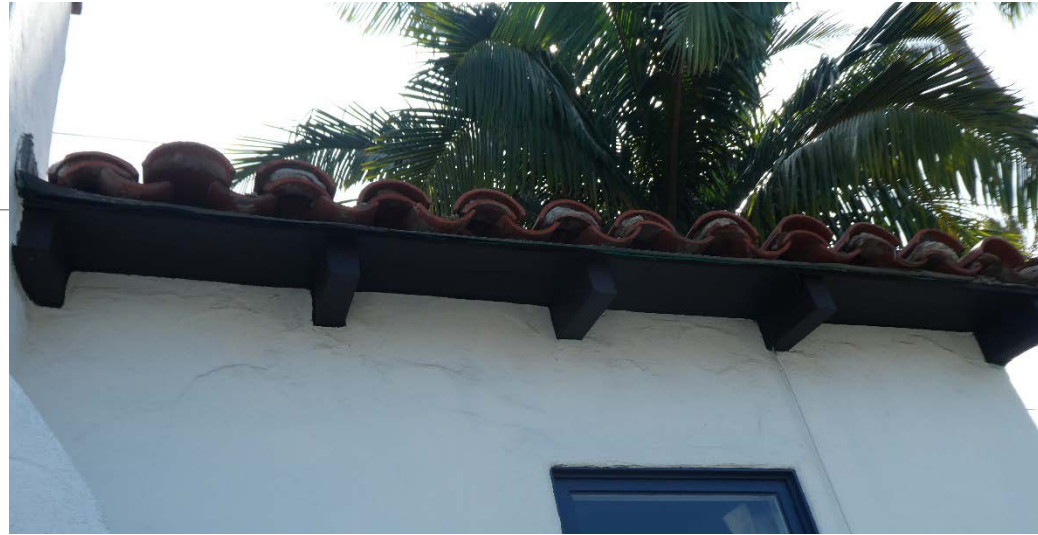
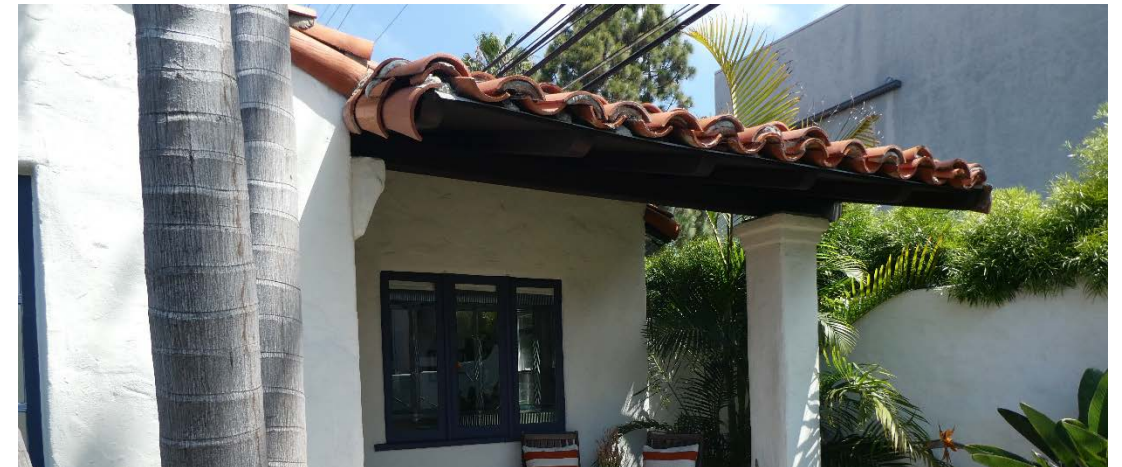
5.	Roof Perimeter: Gutters and Downspouts	Where missing, install appropriate gutters around roof perimeter with downspouts strategically installed to ensure that water is properly diverted away from the building.

5. Where missing, install appropriate gutters around roof perimeter.

Proposed Completion: 2025

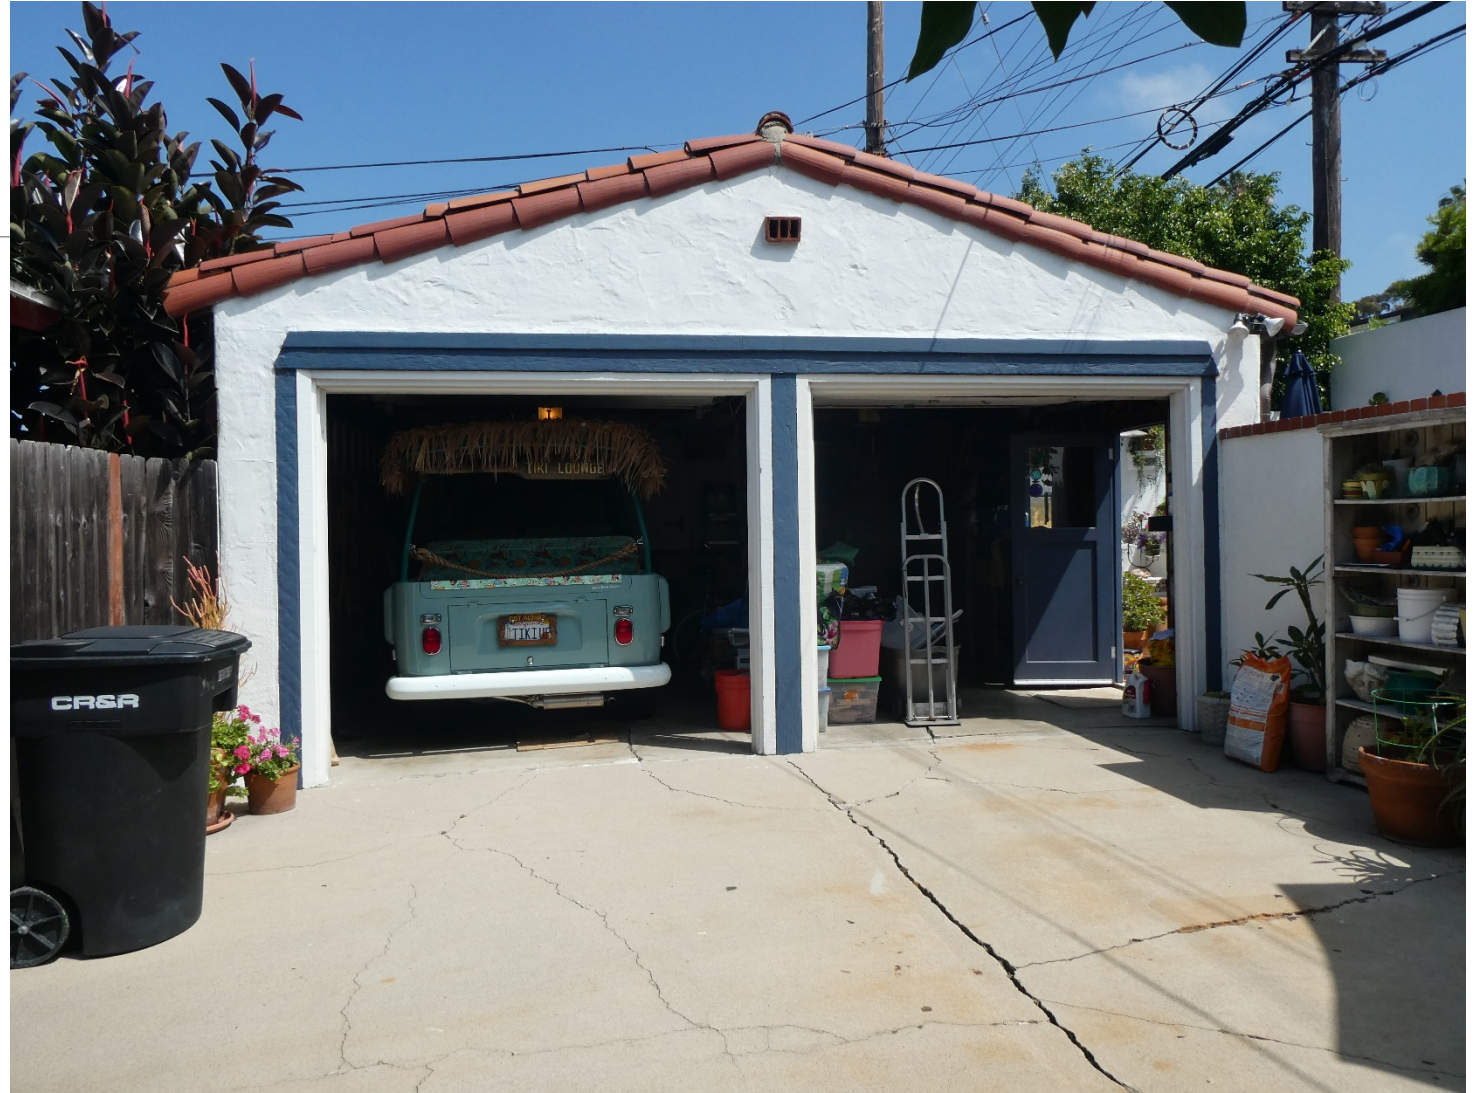
6.	Garage Slab/Foundation	Substantial cracks were observed in concrete slab floor of garage. Engage the services of a structural engineer with experience in historic preservation to inspect garage slab and repair concrete slab/foundation of garage as recommended.

6. Engage the services of a structural engineer with experience in historic preservation to inspect garage slab and repair concrete slab/foundation of garage as recommended.

Proposed Completion: 2028

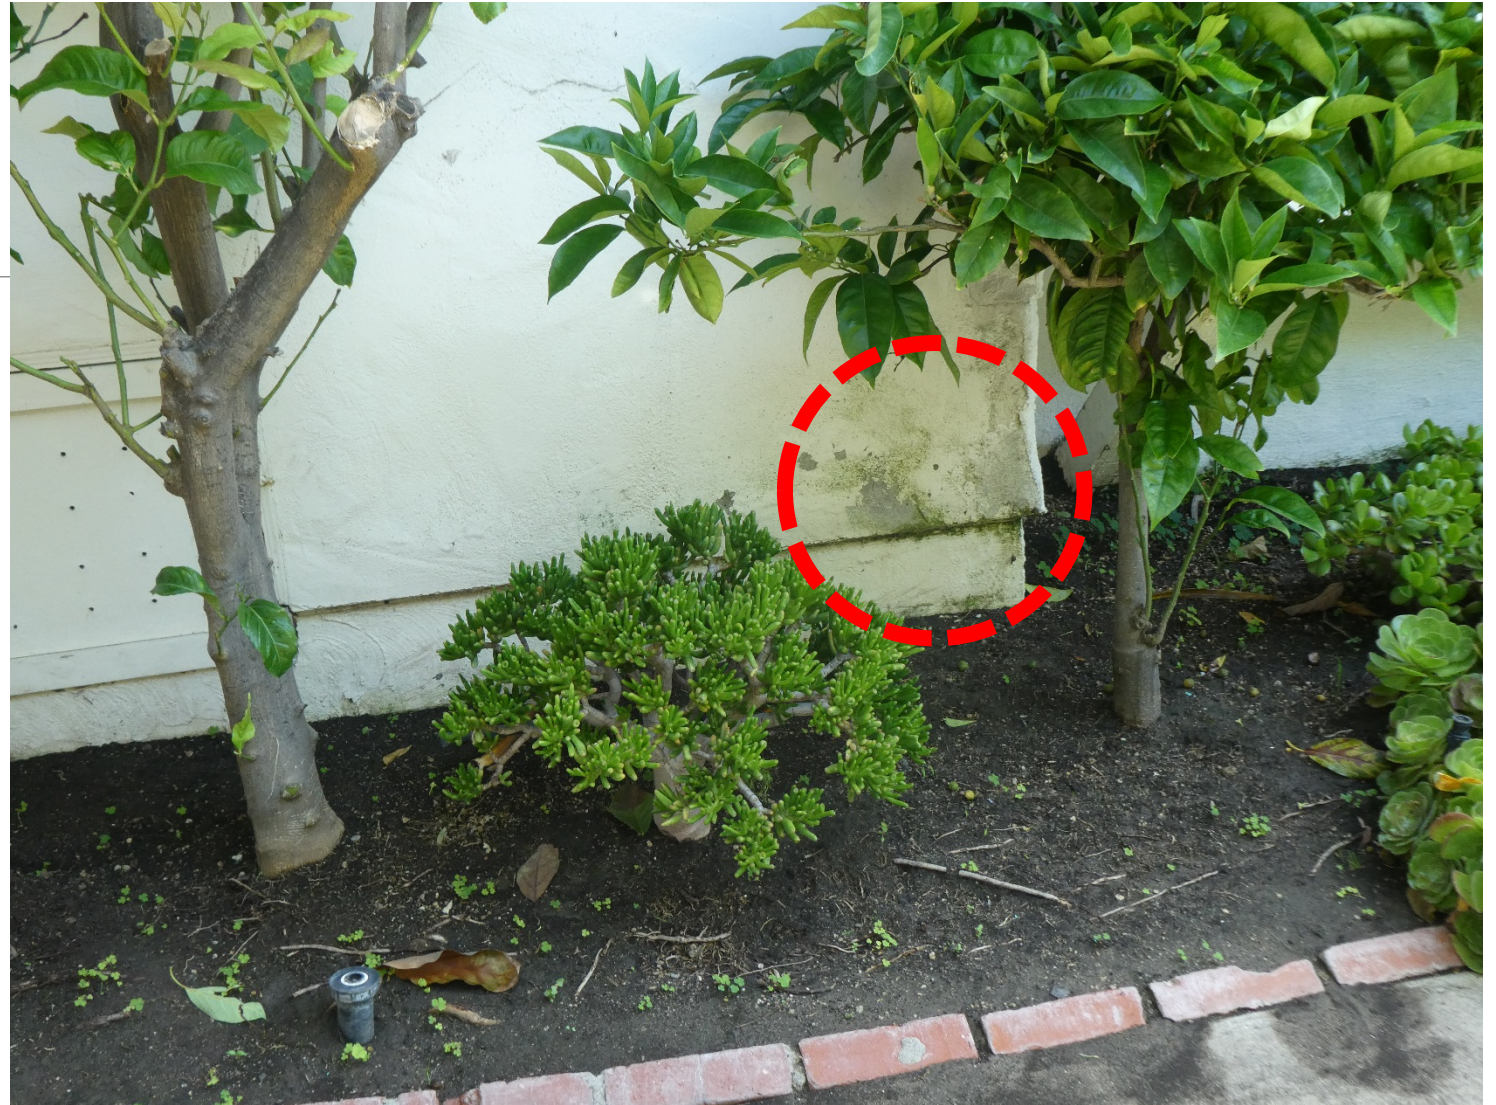
7.	Landscaping and Irrigation	Algae growth and water damaged stucco at base of building is visible around building perimeter. Relocate irrigation systems away from the base of the house to prevent deterioration of exterior stucco from constant watering and potential damage to foundation. Sprinklers should be directed away from the building.

7. Relocate irrigation systems away from the base of the house to prevent deterioration of exterior stucco from constant watering and potential damage to foundation.

Proposed Completion: 2029

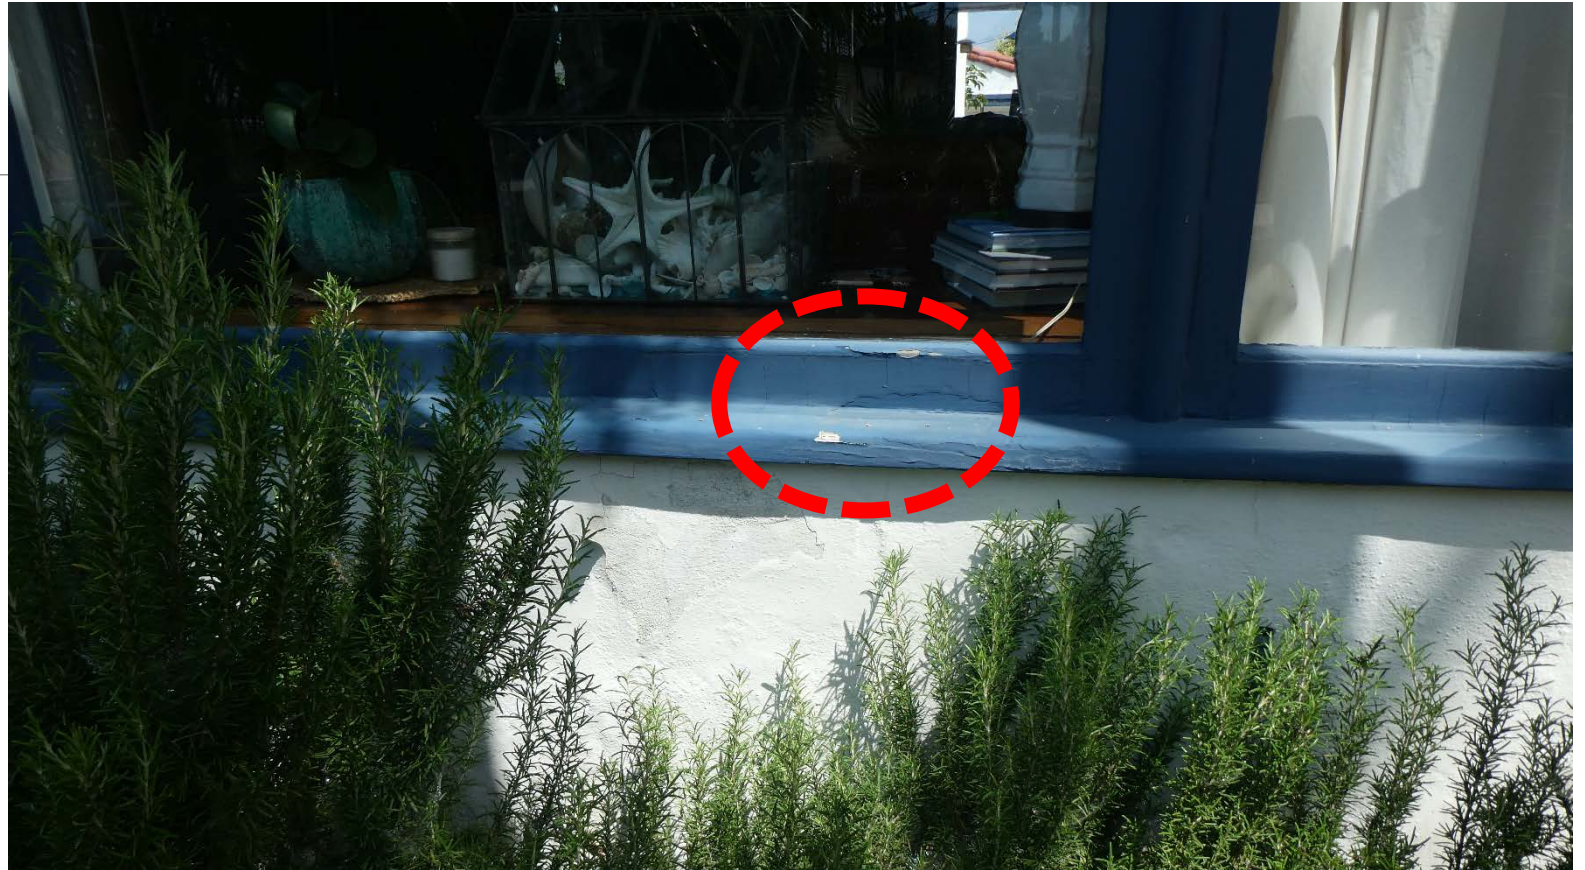
8.	Windows	Paint is peeling on some wood windows and frames, particularly on the south (front) elevation from constant sun exposure. Gently scrape paint, sand, and make any necessary repairs. Carefully repaint, ensuring paint and putty do not bleed onto glazing.

8. Scrape paint, sand, and make any necessary repairs to windows.

Proposed Completion: 2030

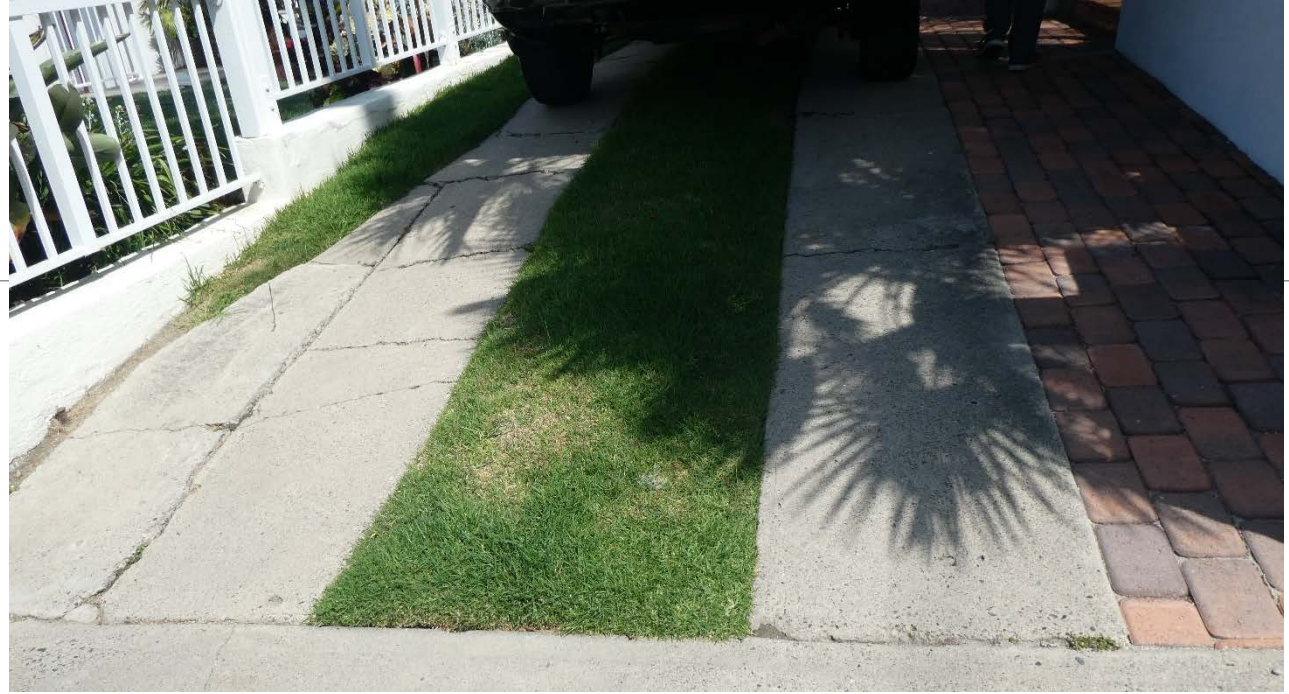
9.	Driveway	Concrete driveway is severely cracked. Repave driveway or patch repair concrete using mixture to match historic concrete to the greatest extent feasible.

9. Repave driveway or patch repair concrete using mixture to match historic concrete to the greatest extent feasible.

Proposed Completion: 2031

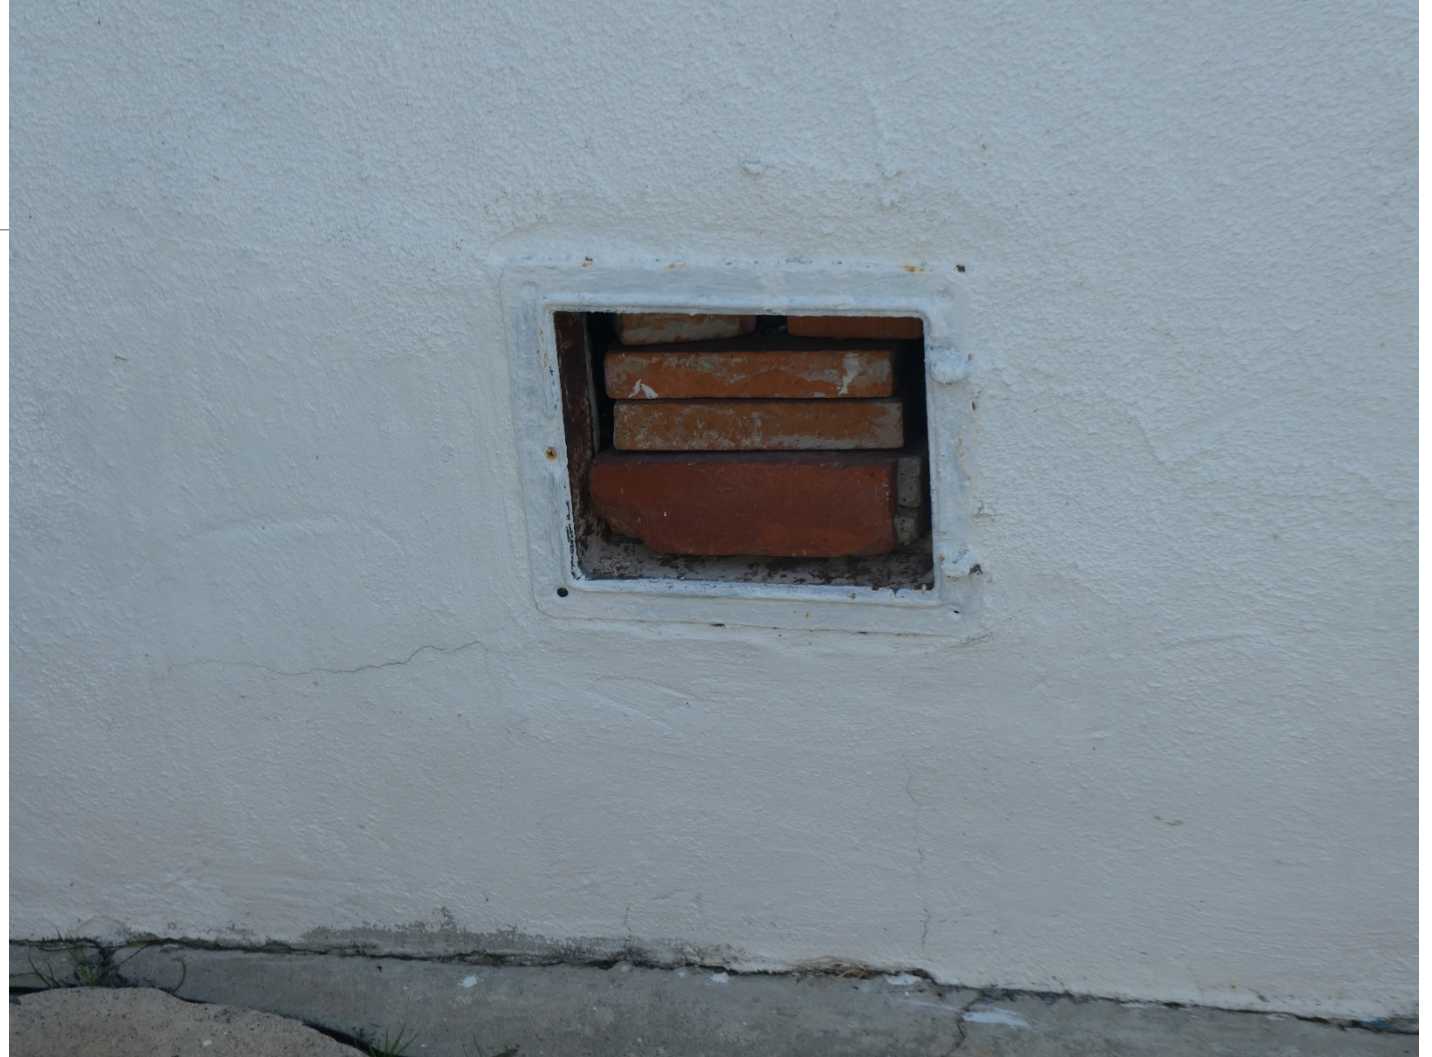
10.	Chimney	The chimney cleanout door is missing and the opening has been temporarily blocked by stuffing in pieces of brick/tiles. Replace missing cleanout door with historically appropriate cast iron door.

10. Replace missing cleanout door with historically appropriate cast iron door.

Proposed Completion: 2031

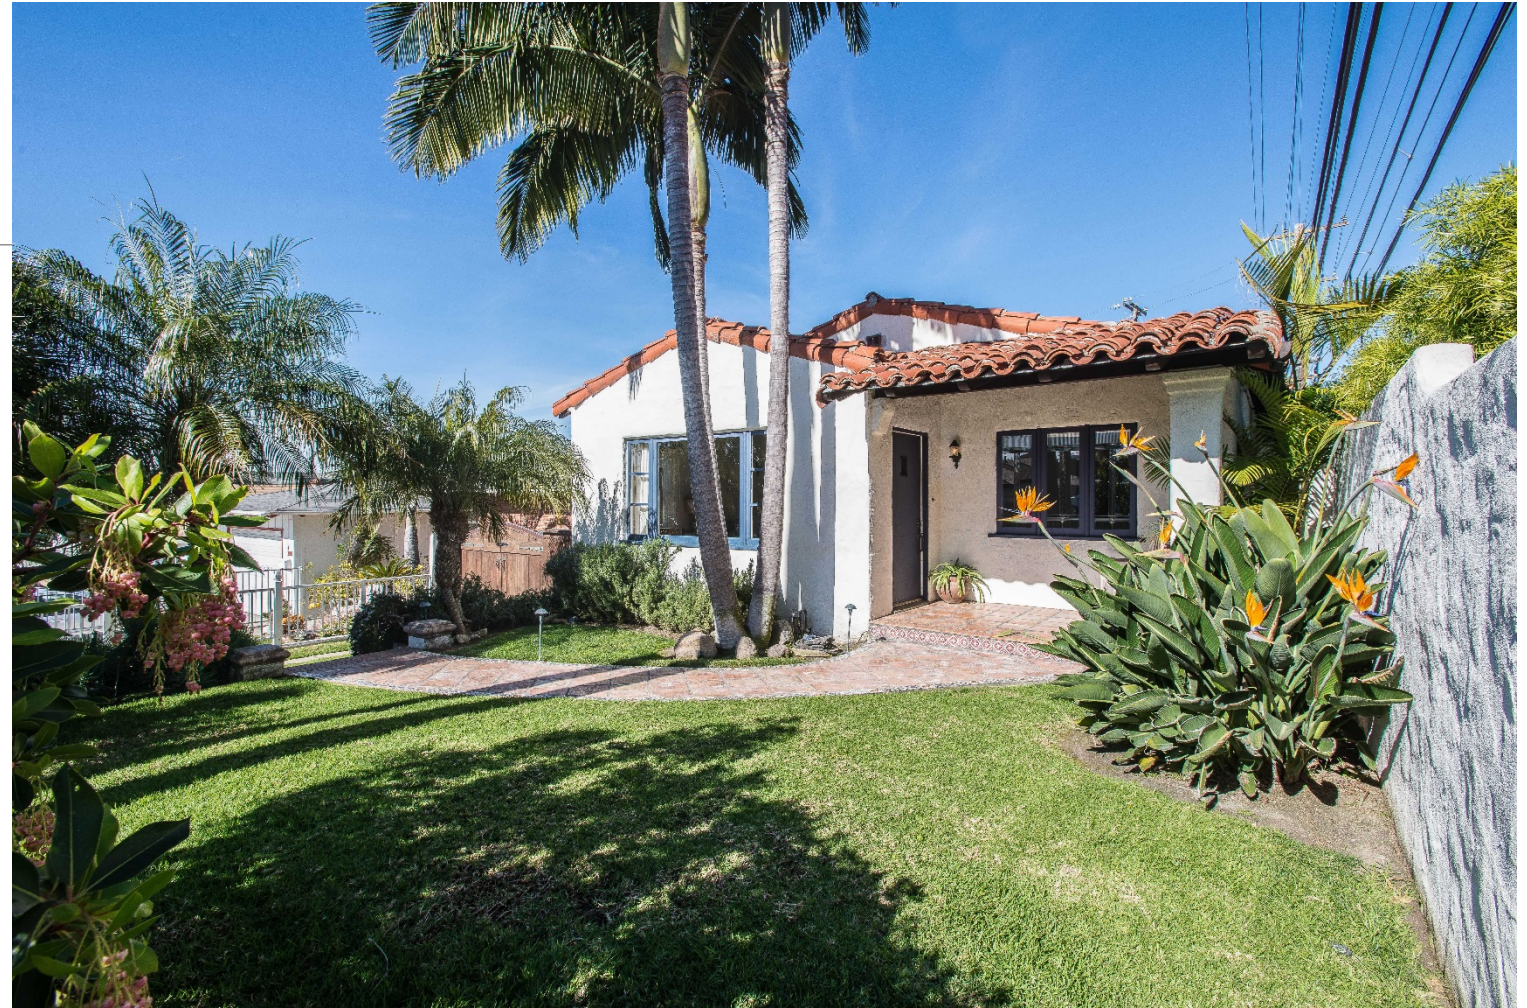
* This photograph does not specifically demonstrate the work list item to address.

11. Maintenance:
Inspect annually for
damage and
deterioration such
as hairline cracks
and make related
repairs in kind as
needed.

Proposed Completion: Ongoing
