City of San Clemente Master Plan for Beach Restrooms

Maintenance and Upgrade Strategy

July 13, 2010

Authored by: Beaches, Parks and Recreation Department, Appendix by Community Development, Engineering

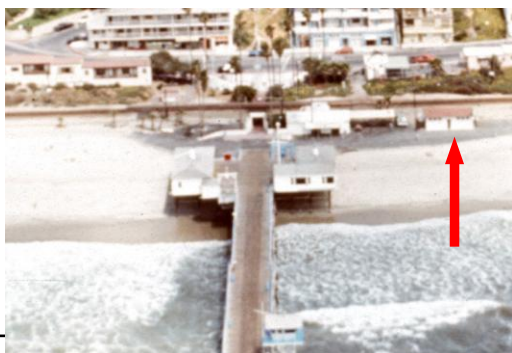
Base of Pier restroom as noted previously is not reflective of the Spanish Colonial Revival Architecture as noted in the Architectural Overlay Zone. In addition, there may have been previous planning work done to identify a wood siding, “Nautical Style” for areas west of the railroad tracks. The restroom meets neither. Nor is the use of wood siding consistent west of the railroad tracks, as the underpass is a white stucco wall with red tile cap, and will be further reinforced with Spanish styling with the addition of the Pier Bowl lighting upgrades. Research of old photos show that in 1972, the restroom building was a light color with what appears to be a tile roof. In 1979, the trash enclosure addition was added with what appears to be a wood shake roof.

Given that the restroom building is of masonry construction and is civic in nature, it could be retrofitted in a Spanish Colonial Revival style. The existing masonry walls could be covered with smooth stucco, the low pitch roof could be replaced with red tile, the use of colorful tiles to note the location (Pier Bowl), and signage could meet the Spanish design guidelines for the Pier Bowl District.

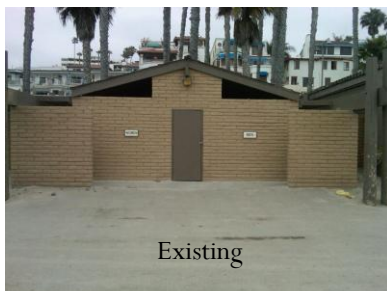
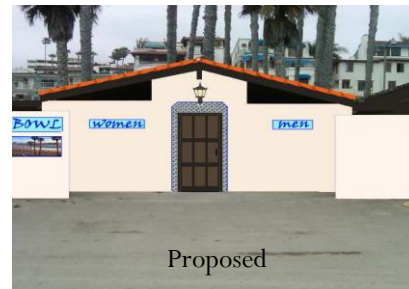
Summary of Phase One recommendations (Pier Bowl Restroom)

- Review and recommendations by Architect and Structural Engineer.
- Stucco masonry block with smooth stucco, replace existing rotted wood overhead and roof members as needed.
- Remodel interior for Handicap accessibility: new handicap stall location, adjust fixtures for proper heights and clearances, replace stall doors.
- Add tile signage and detail similar to tile type and font as used on the Beach Trail.
- Add new decorative iron gates at wing walls if needed.
- Repair and replace doors, seats, missing slats on overheads, and paint other restrooms – no structural work at this time, maintenance of existing only.
