ARBORIST TREE ASSESSMENT REPORT

**MEMORIAL CARE
SENIOR RESIDENTIAL DEVELOPMENT PROJECT
SAN CLEMENTE, CALIFORNIA**

LSA Project No. MEA2203

August 2022

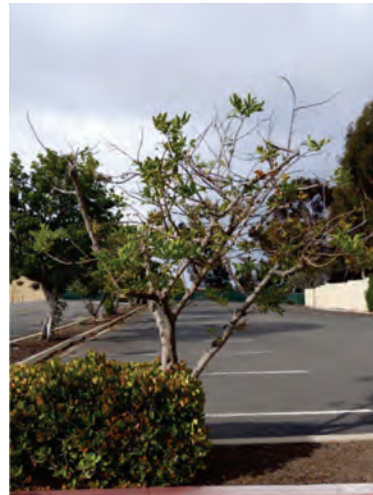
Tree 15 – Eight-foot-tall carrotwood tree in poor condition.

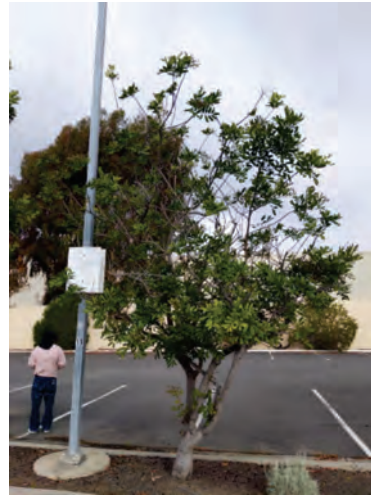
Tree 19 – Fifteen-foot-tall carrotwood tree in poor condition.

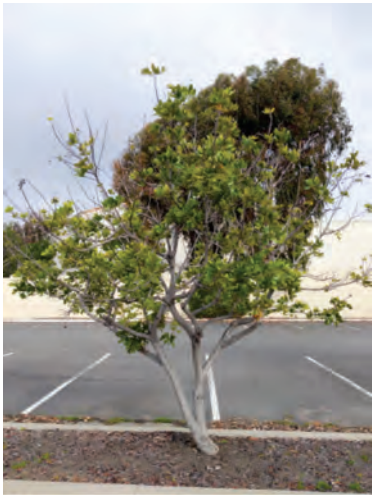
Tree 21 – Eight-foot-tall carrotwood tree in poor condition.

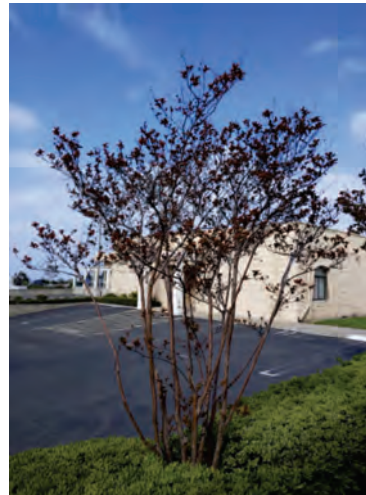
Tree 57 – Six-foot-tall crape myrtle tree in poor condition.

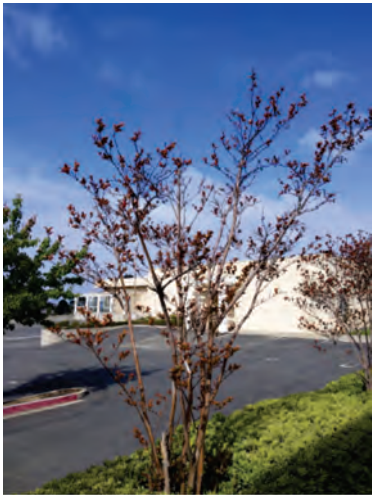
Tree 59 – Six-foot-tall crape myrtle tree in poor condition.

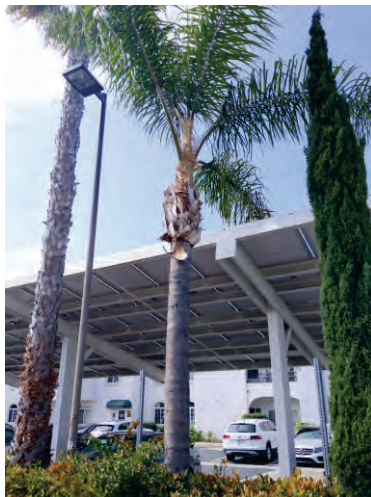
Tree 91 – Twenty-five-foot-tall Italian cypress in good condition.

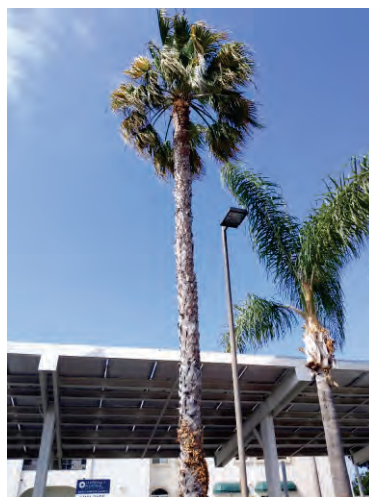
Tree 92 – Twenty-foot-tall queen palm in good condition.

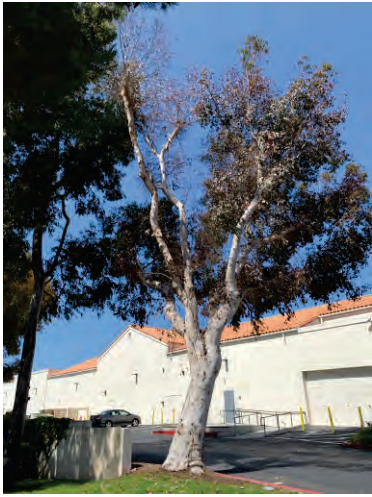
Tree 148 – Sixty-five-foot-tall spotted gum tree in very poor condition with most of the tree necrotic. Recommend removal.

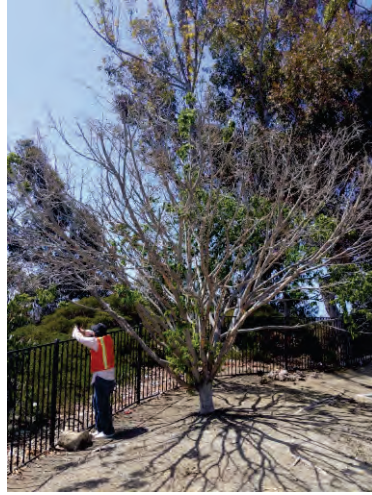
Tree 157 – Fifteen-foot-tall weeping fig tree in poor condition, significant canopy die back, bark decay.

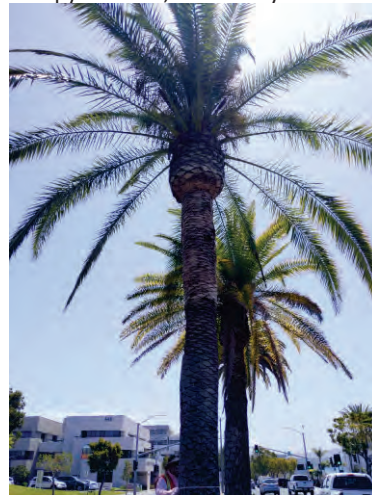
Tree 161 – Twenty-eight-foot-tall Canary Island date palm in fair condition. Cal-IPC invasive species list.

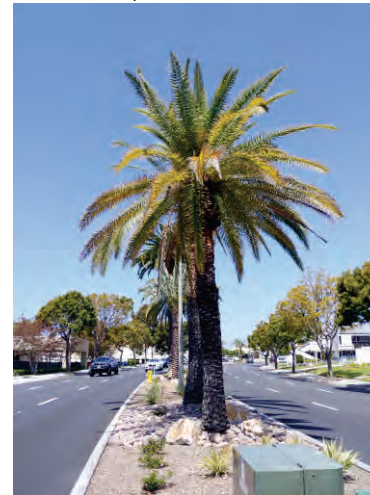
Tree 162 – Twenty-foot-tall Canary Island date palm in fair condition. Cal-IPC invasive species list.

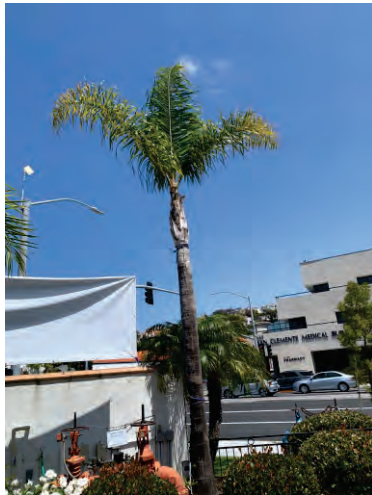
Tree 168 – Thirty-five-foot-tall queen palm in good condition.
