VISTA DE LAS OLAS

402 PASADENA COURT, SAN CLEMENTE

HISTORIC PRESERVATION REPORT

November 2002

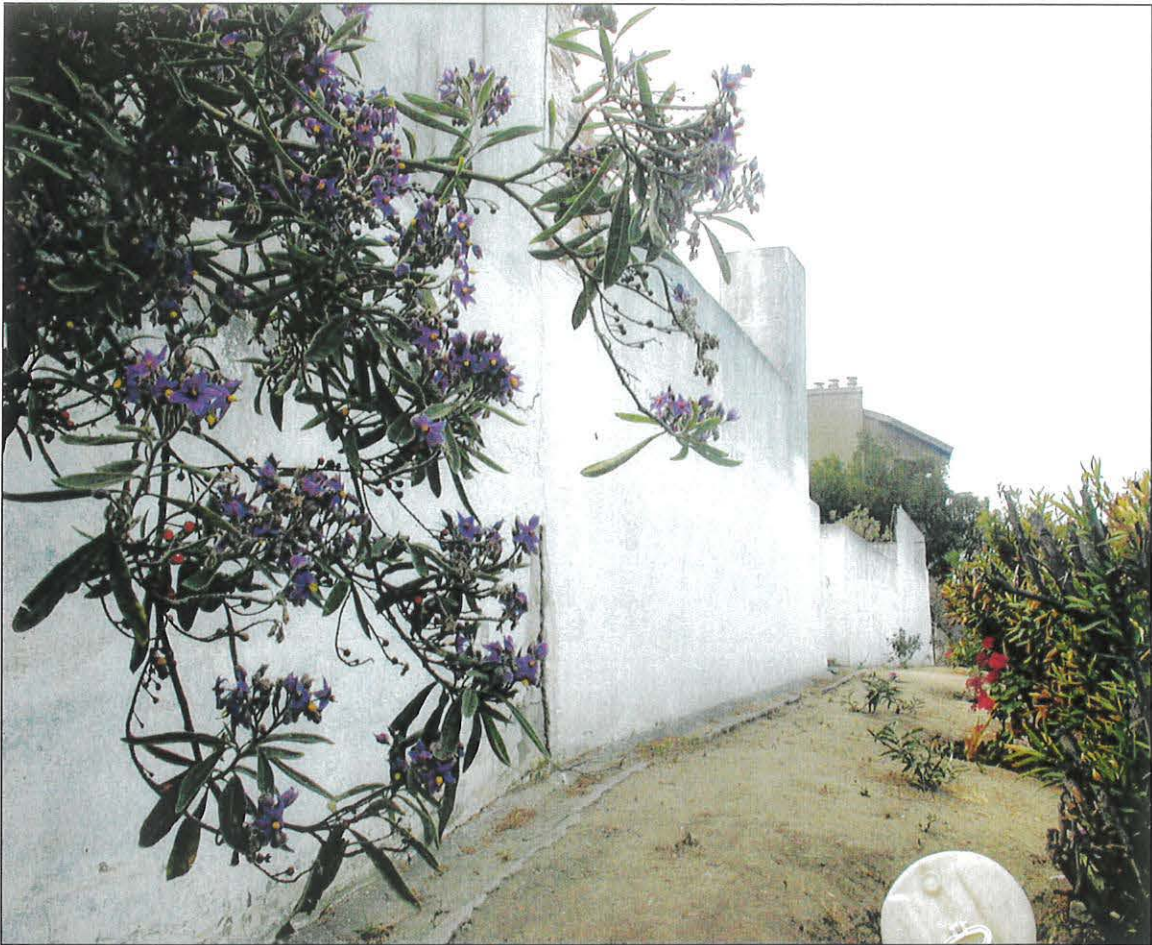
Photograph 11: Subject property, west retaining wall, view south, 2002 (CA)

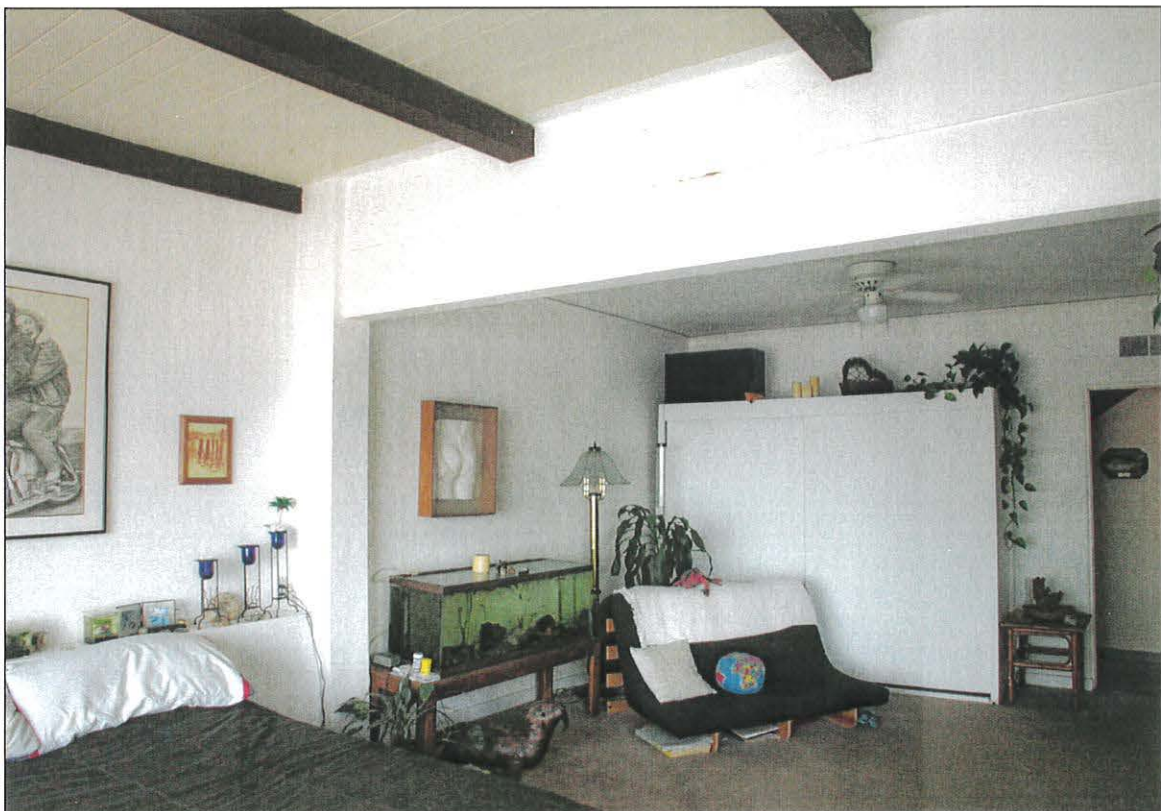
Photograph 22: Existing residence, second floor apartment, infilled porch (foreground), view northeast, 2002 (CA)

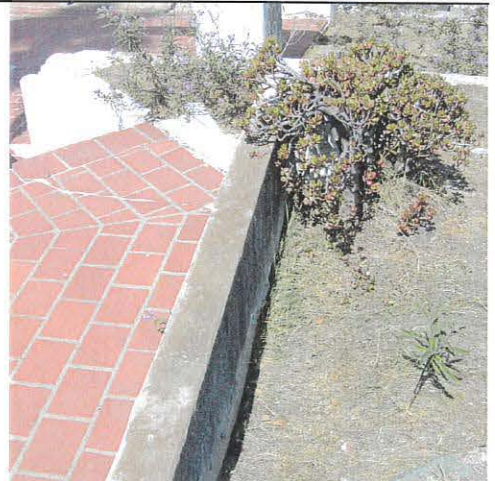
- 0 -CONSTRUCTION DATE HISTORIC c.1930
- MATERIAL CONCRETE AND WOOD
- CURRENT CONDITION POOR

-DESCRIPTION-THE SEATWALL WAS AN INTEGRAL ELEMENT IN THE DESIGN OF THE LOWER TERRACE PATIO. THE SEAT WALL PROVIDED A LOCATION FOR ENTERTAINING AND VIEWING THE OCEAN. THE HEIGHT AND LOCATION HELP ENCLOSE THE TERRACE SPACES AND FOCUS INTERNAL LINEAR VIEWS TOWARDS THE KITCHEN AND BARBECUE.

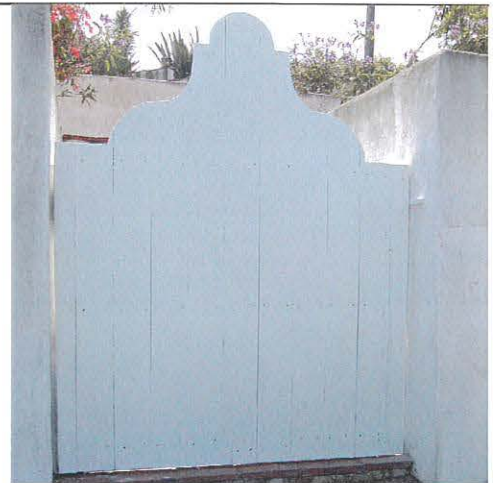
- 1 -CONSTRUCTION DATE NOT DOCUMENTED
- 1 -MATERIAL PAINTED WOOD
- CURRENT CONDITION GOOD

-DESCRIPTION-THE GATE IS LOCATED AT THE BASE OF THE STAIR AT THE LOWER TERRACE. IT SEPARATES THE PRIVATE GARDEN FROM THE MOTEL PARKING LOT.

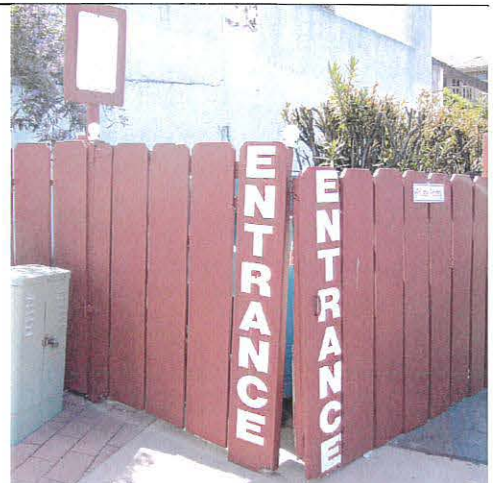
1 WOOD FENCE & GATE

- 1 -CONSTRUCTION DATE NOT HISTORIC
- 2 -MATERIAL PAINTED WOOD
- CURRENT CONDITION FAIR

-DESCRIPTION-THE FENCE IS USED TO HIDE THE DUMPSTERS LOCATED ON THE BEACH COMBER PROPERTY.

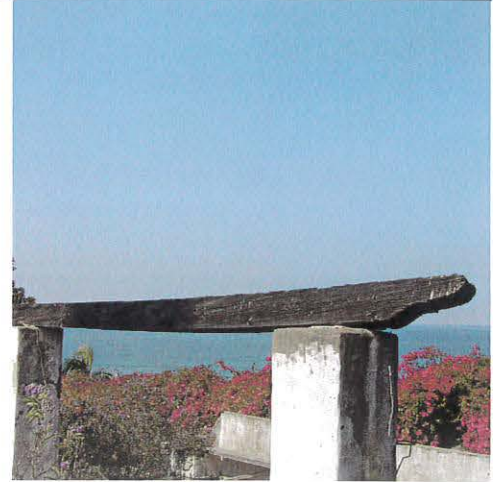
- 3 -CONSTRUCTION DATE HISTORIC c.1930
-MATERIAL CONCRETE AND WOOD
-CURRENT CONDITION POOR

-DESCRIPTION-THIS MASSIVE OVERHEAD STRUCTURE DOMINATES THE LOWER PATIO AND CREATES A SPACE PROTECTED FROM THE SUN. THE LARGE SUPPORTS AND BEAMS INDICATE THE IMPORTANCE OF THIS SPACE AND HELP SCALE THE OVERALL SITE. THEY RUN PARALLEL TO THE OCEAN AND ARE SITUATED ON A CENTRAL AXIS WITH THE FIREPLACE AND KITCHEN AREA. THE BEAMS HAVE A FLARED END AND ONCE SUPPORTED A LATTICE WORK FOR VINES.

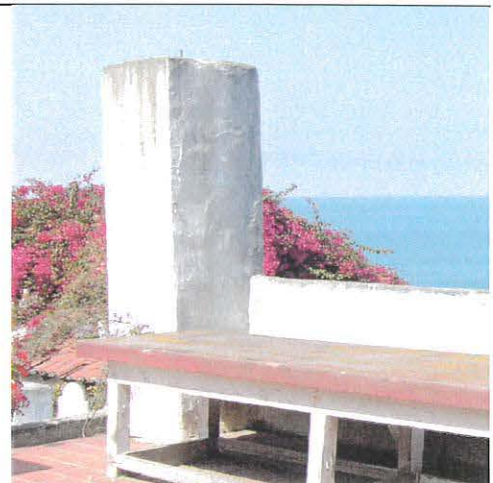
- 5 -CONSTRUCTION DATE HISTORIC c.1930
-MATERIAL CONCRETE W/ WHITE PAINT
-CURRENT CONDITION FAIR

-DESCRIPTION-THESE COLUMNS ARE 2.5' WIDE ON EACH SIDE AND STAND JUST OVER 8' TALL. THEY SUPPORTED MASSIVE WOOD BEAMS AS WELL AS LATTICE WORK AND VINES. THERE WERE ORIGINALLY EIGHT COLUMNS WITH TWO OF THEM BEING BUILT INTO THE CURRENT STORAGE SHED. TWO COLUMNS TO THE SOUTH-WEST MAY HAVE BEEN REMOVED BETWEEN THE EXISTING SEAT WALL. THE COLUMNS ARE THE MAIN ELEMENTS OF THE PERGOLA.

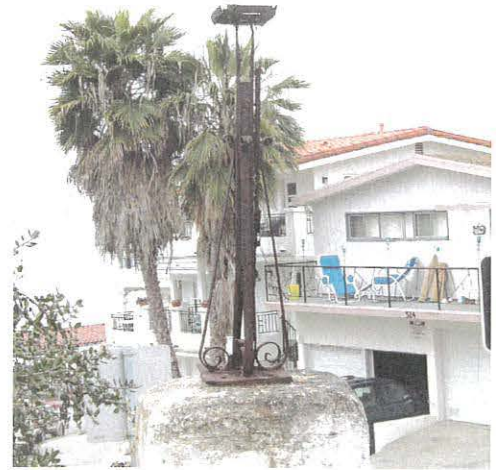
-CURRENT CONDITION FAIR

-DESCRIPTION-THE CORNER OF CAZADOR LANE AND AVENIDA VICTORIA IS ENHANCED BY A LONE PILASTER THAT DOMINATES THE STREET CORNER. THE PILASTER IS IN RELATIVELY GOOD CONDITION.

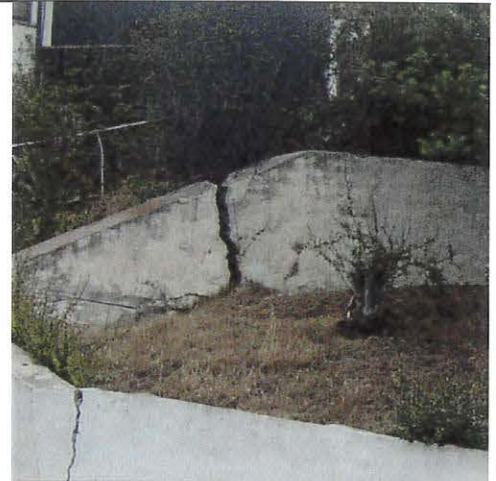
1 FREE STANDING WALL-8"

-CURRENT CONDITION POOR

-DESCRIPTION-THESE WALLS PROVIDE SPACIAL DIVISIONS IN THE LAYOUT OF THE GARDEN. THEY ARE CONNECTED TO THE RETAINING WALLS BORDERING AVENIDA VICTORIA.

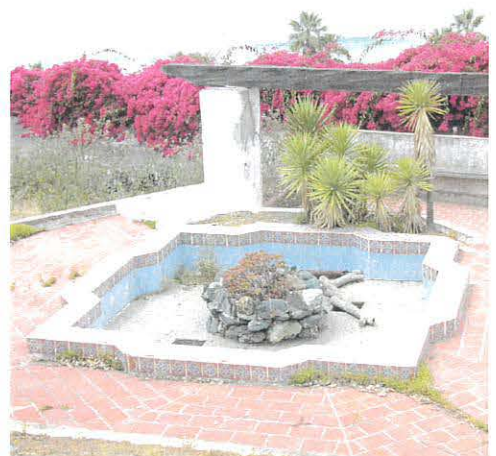
6 MOORISH FOUNTAIN

- CONSTRUCTION DATE HISTORIC c.1930
- MATERIAL TILE, STONE, CONCRETE
- CURRENT CONDITION GOOD

-DESCRIPTION-THE FOUNTAIN HAS SEVERAL CRACKS AND THE ORIGINAL CENTERPIECE HAS BEEN DISMANTLED AND IS LYING NEXT TO THE FOUNTAIN. THE QUATREFOIL SHAPED FOUNTAIN IS TYPICAL SPANISH COLONIAL REVIVAL. THE TILE IS SIMILAR TO THAT PRODUCED BY MALIBU POTTERIES. THE NON TRADITIONAL CENTERPIECE USED ROCK MATCHING THE WATER CASCADE, PLANTINGS AND FAUX WOOD FOUNTAIN SCULPTURE.

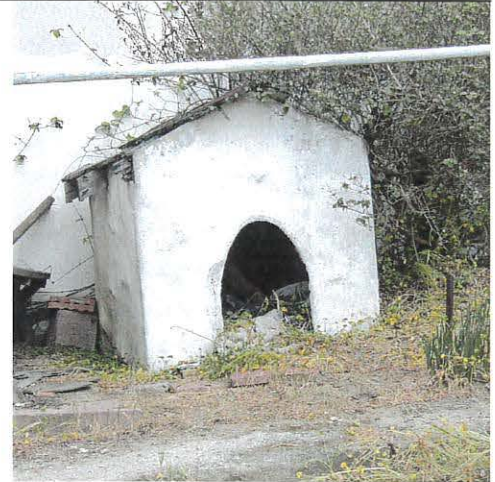
-CURRENT CONDITION POOR

-DESCRIPTION-THE DOGHOUSE IS AN EXAMPLE OF THE IMPORTANCE GIVEN TO EVERY DETAIL. THE STRUCTURE IS IN THE SPANISH COLONIAL AESTHETIC IN ORDER TO MAKE IT FEEL LIKE A PART OF THE OVERALL ESTATE GROUNDS.

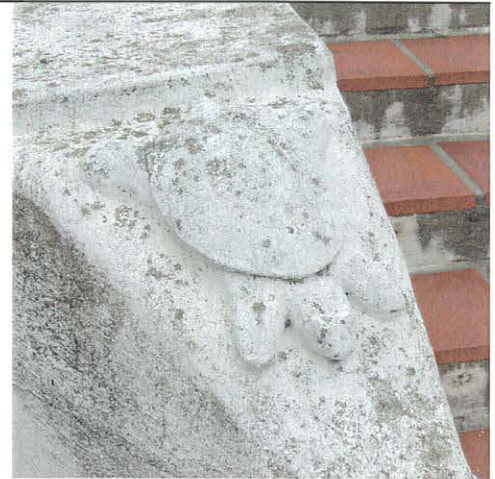
1 DECORATIVE CONCRETE TURTLE

-CURRENT CONDITION GOOD

-DESCRIPTION-THE TURTLE IS LOCATED ON THE WALL/STAIR LEADING FROM THE PERGOLA TERRACE TO THE MOORISH FOUNTAIN TERRACE. THE DETAIL MAY HAVE FADED AND THE CONCRETE IS SHOWING SIGNS OF AGE, BUT THE FORM IS STILL VERY STRONG.

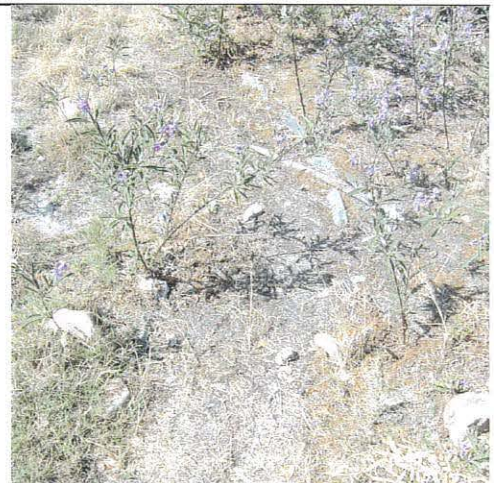
6 STONE LINED PATH

- CONSTRUCTION DATE NOT DOCUMENTED c1930
- MATERIAL D.G./RANDOM STONES
- CURRENT CONDITION POOR, SCATTERED

-DESCRIPTION-THE PATH WAS INFORMAL AND MAY HAVE BEEN DESIGNED TO BYPASS THE DUAL STAIR PROVIDING A SECOND ACCESS UP TO THE HOUSE.

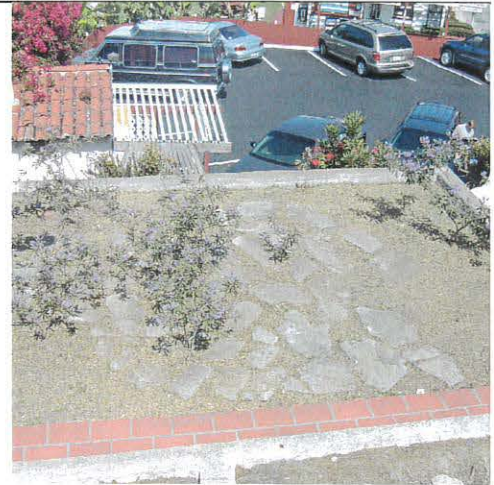
-CURRENT CONDITION POOR

-DESCRIPTION-A PORTION OF THE LOWEST TERRACE IS PARTIALLY PAVED WITH RANDOMLY PLACED FIELDSTONE.

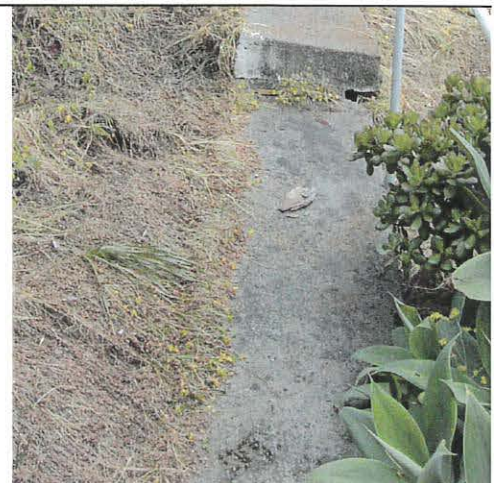
9 NARROW WALK-CONCRETE

-CURRENT CONDITION POOR

-DESCRIPTION-THE CURRENT 3RD FLOOR APARTMENT HAS A REAR ENTRY. THE NARROW WALK IS THE MAIN ACCESS TO THE APARTMENT PATIO ENTRANCE.

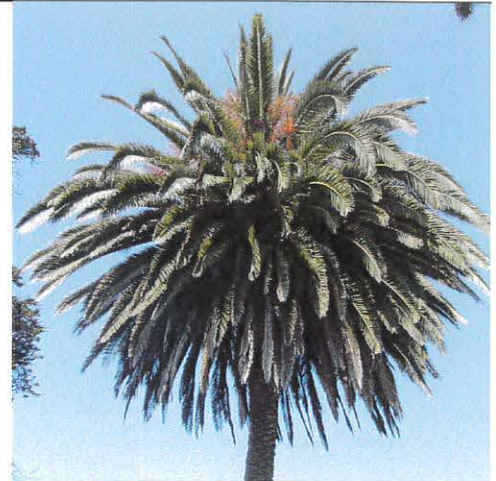
P PHOENIX CANARIENSIS

- C**
- COMMON NAME CANARY ISLAND DATE PALM
 - PLANTING DATE HISTORIC c.1930
 - CURRENT CONDITION GOOD
 - DESCRIPTION-THE TREE IS A SPECIMEN TREE.

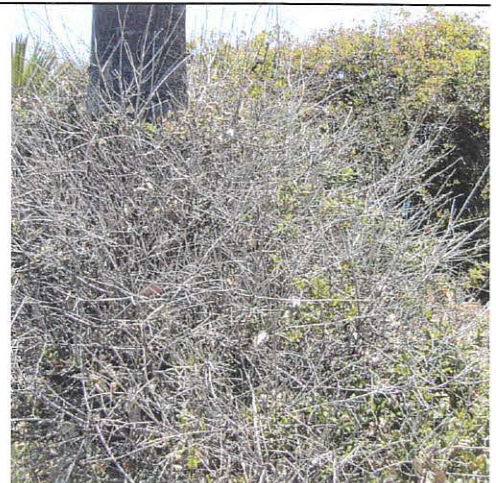
Q QUERCUS AGRIFOLIA

- A**
- COMMON NAME COAST LIVE OAK
 - PLANTING DATE NOT DOCUMENTED
 - CURRENT CONDITION POOR
 - DESCRIPTION-THIS PLANT IS OF THE SHRUB MASS AT THE BASE OF THE WASHINGTONIA ROBUSTA.

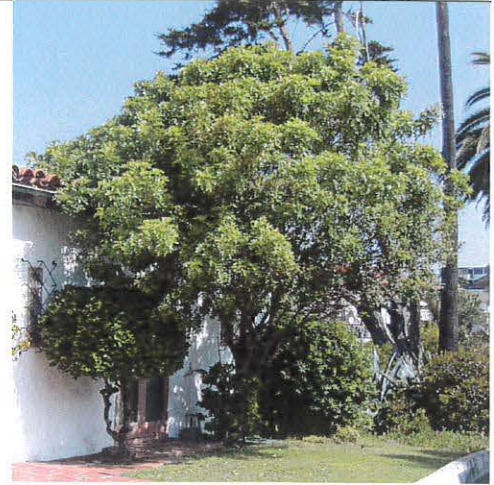
S SCHINUS TEREBINTHIFOLIUS

- T** -COMMON NAME BRAZILIAN PEPPER
-PLANTING DATE NOT DOCUMENTED
-CURRENT CONDITION GOOD
-DESCRIPTION-THE TREE SHADES THE NORTH SIDE OF THE HOUSE.

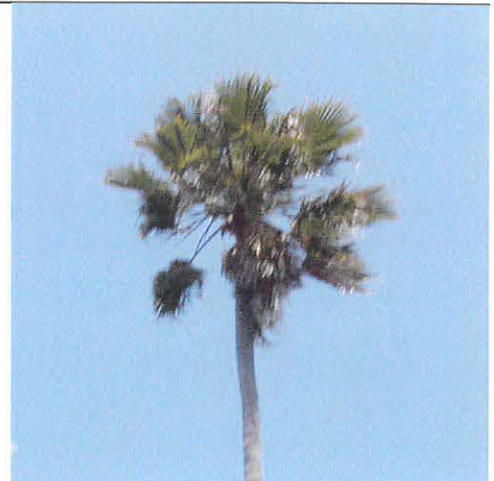
W WASHINGTONIA ROBUSTA

- R** -COMMON NAME MEXICAN FAN PALM
-PLANTING DATE HISTORIC c.1930
-CURRENT CONDITION GOOD
-DESCRIPTION-A LINEAR SERIES OF THESE PALMS OCCURS ALONG CAZADOR LANE. THERE ARE SEVERAL GROUPINGS OF SMALL WASHINGTONIA ROBUSTAS. THEY ARE NOT HISTORIC.

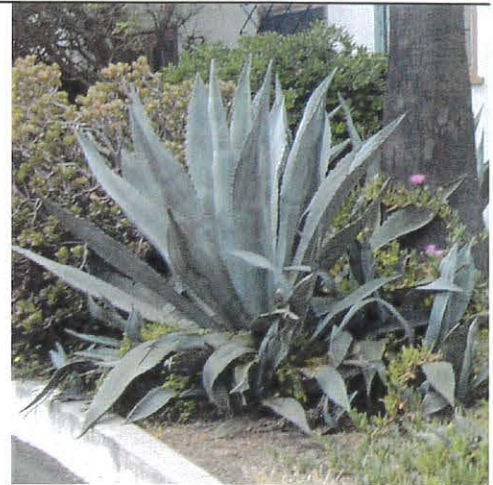
- A** -COMMON NAME CENTURY PLANT
A -PLANTING DATE NOT DOCUMENTED c.1930
-CURRENT CONDITION GOOD

-DESCRIPTION-THE AGAVE WERE A POPULAR ACCENT PLANT USED DURING THIS TIME PERIOD BOTH THE VARIEGATED AND THE SOLID GREY GREEN COLORED CENTURY PLANT ARE USED ON SITE.

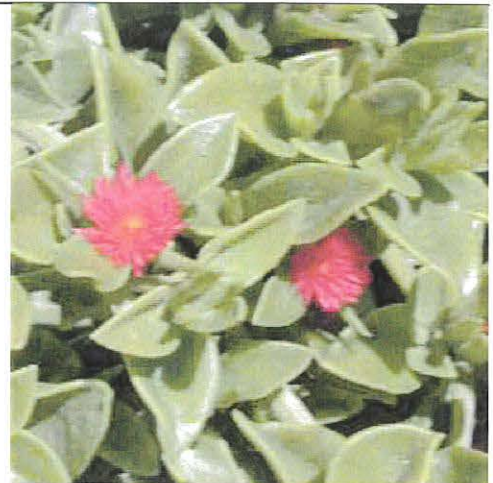
A APTENIA CORDIFOLIA

- C** -COMMON NAME TRAILING ICE PLANT
C -PLANTING DATE NOT DOCUMENTED
-CURRENT CONDITION POOR

-DESCRIPTION-THIS PLANT IS USED AS A GROUNDCOVER NEAR THE EDGE OF THE NORTH AND EAST GARDENS.

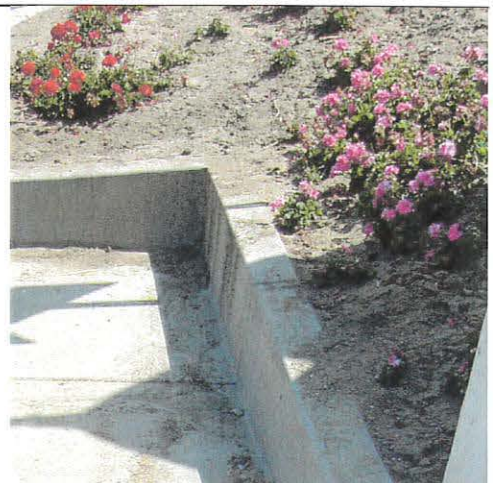
A ANNUAL COLOR

- N** -COMMON NAME ANNUAL COLOR
N -PLANTING DATE NEW
-CURRENT CONDITION FAIR

-DESCRIPTION-THE CURB AND GUTTER AT AVENIDA VICTORIA AND CAZADOR LANE HAS BEEN RECENTLY RECONFIGURED. CITY FORCES MAY HAVE ADDED PLANTING.

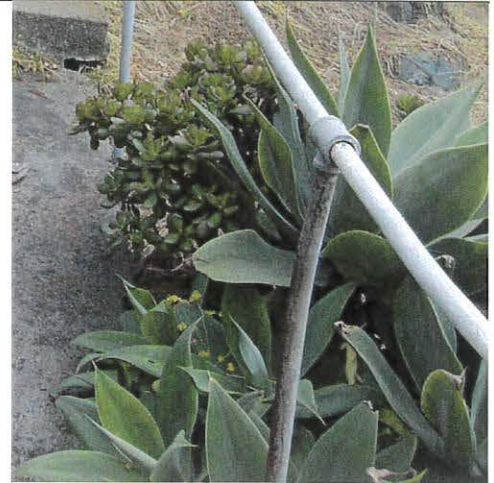
- T** -COMMON NAME FOXTAIL
-PLANTING DATE NOT DOCUMENTED
-CURRENT CONDITION GOOD

-DESCRIPTION-THIS SUCCULENT IS USED ON THE WEST SIDE BELOW THE PORCH AREA. THE SHRUB IS NOT LARGE AND MAY HAVE BEEN RECENTLY PLANTED.

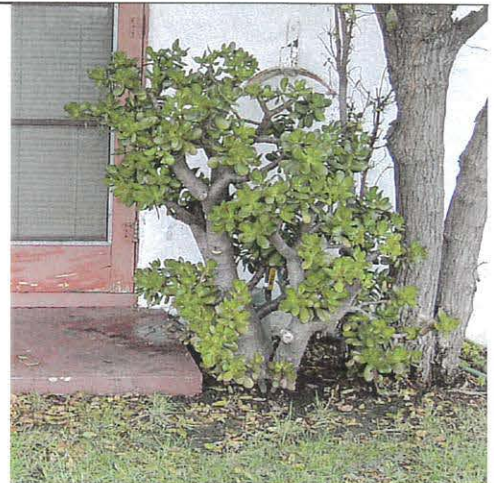
C CRASSULA ARGENTEA

- A** -COMMON NAME JADE PLANT
-PLANTING DATE NOT DOCUMENTED
-CURRENT CONDITION FAIR

-DESCRIPTION-THIS SUCCULENT WAS POPULARLY USED DURING THIS TIME PERIOD. IT IS LOCATED THROUGHOUT THE SITE. THE EXISTING PLANT MATERIAL ARE NOT LARGE AND MAY NOT DATE TO THE HISTORIC TIME PERIOD.

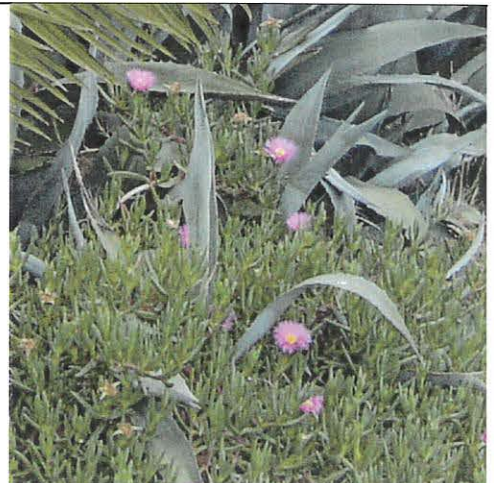
C CARPOBROTUS CHILENSIS

- C** -COMMON NAME ICE PLANT
-PLANTING DATE NOT DOCUMENTED c.1930
-CURRENT CONDITION GOOD

-DESCRIPTION-THIS GROUNDCOVER HAS BEEN USED THROUGHOUT THE SITE TO CONTROL EROSION AND DEVELOP AN AESTHETICALLY PLEASING GROUNDPLANE. ICE PLANT AND OTHER SUCCULENTS WERE POPULAR DURING THE HISTORIC TIME PERIOD.

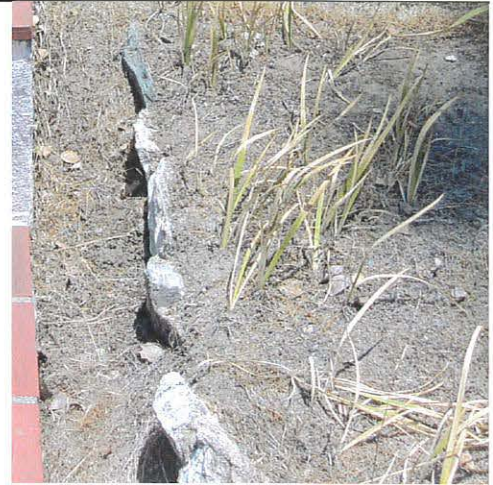
- M** -COMMON NAME CROCOSMIA
-PLANTING DATE NOT DOCUMENTED c.1930
-CURRENT CONDITION POOR

-DESCRIPTION-THIS PERENNIAL BULB WAS USED TO FILL THE LOWER SLOPE OF THE SOUTH GARDEN WITH A SHOWY DISPLAY OF COLOR.

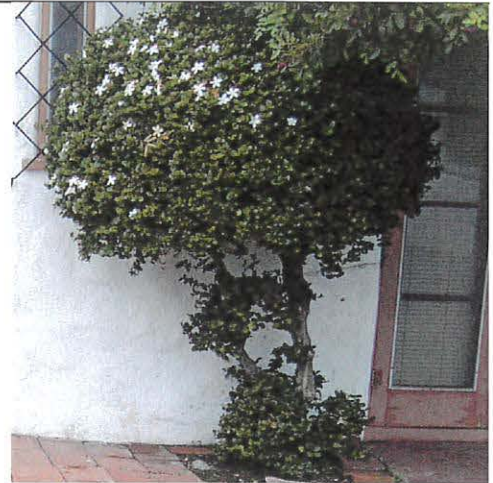
C CARISSA MACROCARPA

- R** -COMMON NAME NATAL PLUM
-PLANTING DATE NOT DOCUMENTED c.1930
-CURRENT CONDITION POOR SPECIMEN

-DESCRIPTION-NATAL PLUM WAS POPULARLY USED DURING THIS TIME PERIOD. THE PLANT HAS GROWN BEYOND IT'S ORIGINAL PURPOSE AS A FOUNDATION SHRUB.

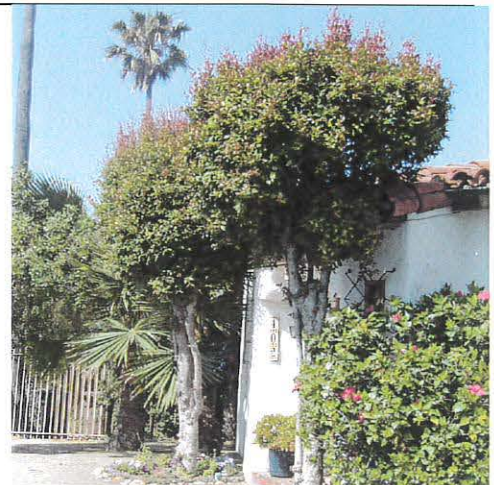
E EUGENIA PANICULATA

- P** -COMMON NAME BRUSH CHERRY
-PLANTING DATE NOT DOCUMENTED c.1930
-CURRENT CONDITION POOR SPECIMEN

-DESCRIPTION-EUGENIA WERE SYMMETRICALLY PLACED TO ACCENT THE ENTRY AND CREATE A FORMAL APPROACH.

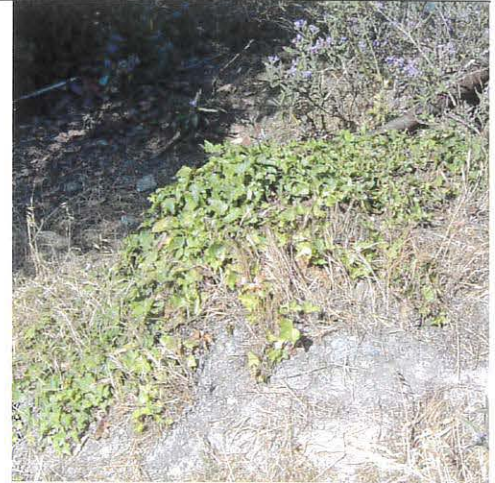
- H** -COMMON NAME ENGLISH IVY
- H** -PLANTING DATE NOT DOCUMENTED
- CURRENT CONDITION POOR

-DESCRIPTION-THIS INVASIVE PLANT IS NOT A PART OF THE PROPERTIES PLANTINGS.IT HAS GROWN OVER FROM AN ADJACENT YARD.

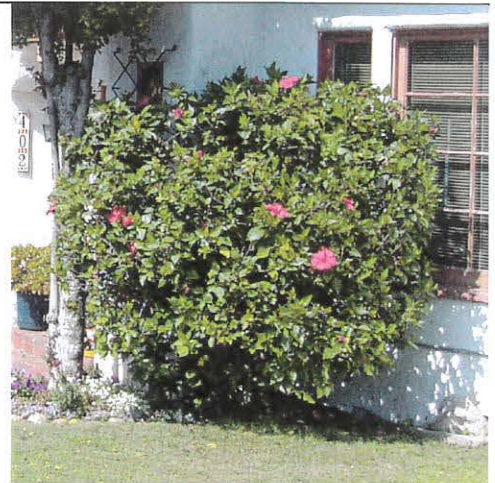
H HIBISCUS SPP.

- S** -COMMON NAME HIBISCUS
- PLANTING DATE NOT DOCUMENTED
- CURRENT CONDITION GOOD

-DESCRIPTION-THIS PLANT IS USED AS A FOUNDATION PLANTING AND TO ADD INTEREST TO THE FRONT ELEVATION.

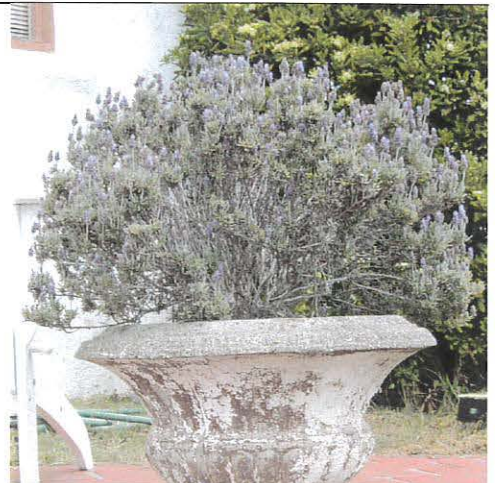
L LAVENDULA SPP.

- A** -COMMON NAME LAVENDER
- PLANTING DATE NOT DOCUMENTED
- CURRENT CONDITION GOOD

-DESCRIPTION-USED ONLY IN THE URN.

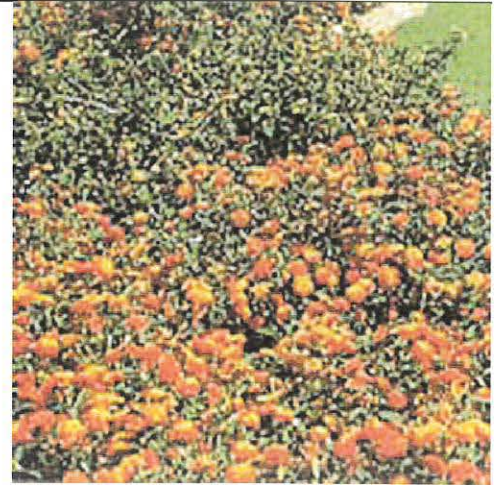
L LANTANA SPP.

- S** -COMMON NAME LANTANA
- PLANTING DATE NOT DOCUMENTED
- CURRENT CONDITION POOR
- DESCRIPTION-THIS PLANT WAS USED TO LINE THE REAR GARDEN PATH AND HELP STABILIZE THE SLOPE.

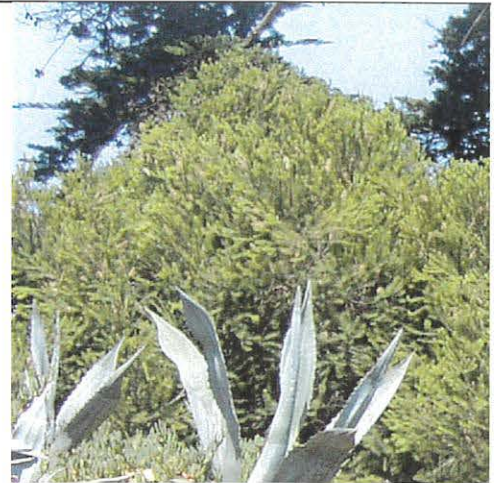
M MELALEUCA ARMILLARIS

- A** -COMMON NAME DROOPING MELALEUCA
- PLANTING DATE NOT DOCUMENTED
- CURRENT CONDITION GOOD, OVERGROWN
- DESCRIPTION-THIS LARGE MASSING OF PLANTS IS USED FOR SLOPE PLANTING IN THE NORTH GARDEN.

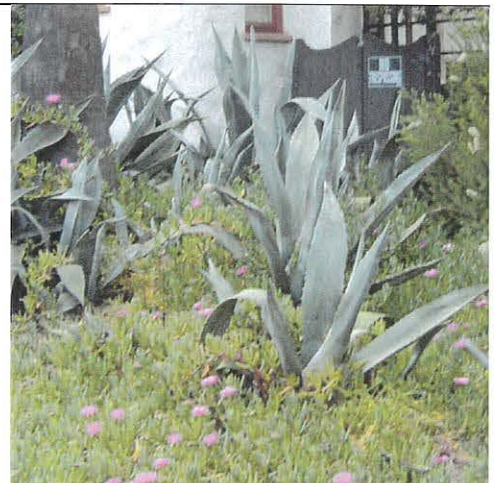
M MIXED VEGETATION

- I** -COMMON NAME CENTURY PLANT/ ICE PLANT
- PLANTING DATE NOT DOCUMENTED
- X** -CURRENT CONDITION GOOD

-DESCRIPTION-IN MANY SITE LOCATIONS THERE ARE ZONES OF MIXED VEGETATION WHERE AN INVASIVE PLANT MATERIAL HAS GROWN INTO THE PLANTING ZONE OF ANOTHER. BOTH CENTURY PLANT AND ICEPLANT CAN BE INVASIVE.

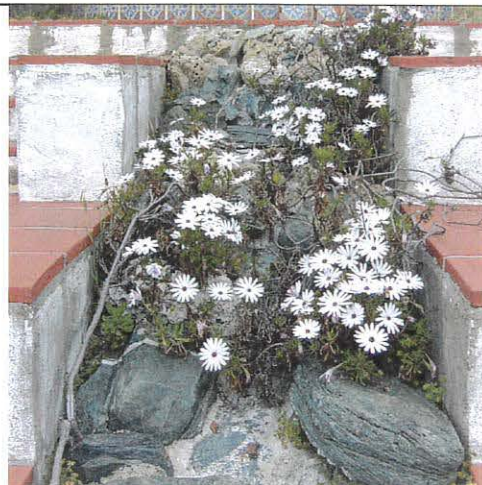
- F** -COMMON NAME TRAILING AFRICAN DAISY
-PLANTING DATE NOT DOCUMENTED c.1930
-CURRENT CONDITION POOR

-DESCRIPTION-USED TO LINE THE EDGES OF THE WATER CASCADE. AFRICAN DAISY WERE USED IN SOUTHERN CALIFORNIA DURING THE HISTORIC TIME PERIOD. OTHER HISTORIC GARDENS IN LOS ANGELES ALSO USED AFRICAN DAISY IN WATER CASCADES.

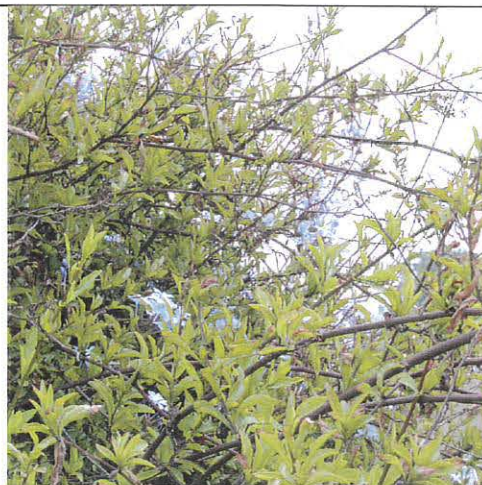
P PLUMBAGO AURICULATA

- A** -COMMON NAME CAPE PLUMBAGO
-PLANTING DATE NOT DOCUMENTED c.1930
-CURRENT CONDITION POOR-GOOD

-DESCRIPTION-THIS PLANT HAS BEEN USED THROUGHOUT THE SITE AS A BORDER PLANTING NEAR WALLS.

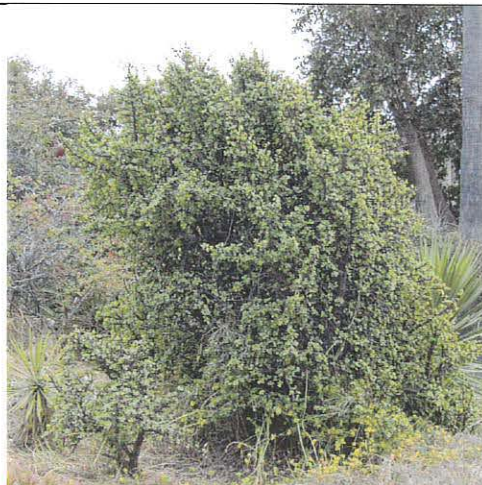
P PORTULACARIA AFRA

- O** -COMMON NAME ELEPHANTS FOOD
-PLANTING DATE NOT DOCUMENTED c.1930
-CURRENT CONDITION GOOD

-DESCRIPTION-THIS SPECIMEN PLANT IS LARGE AND OLD. SUCCULENTS WERE A POPULAR PLANT MATERIAL USED DURING THIS TIME PERIOD. THE PLANT WAS ONE OF SEVERAL SUCCULENTS USED TO ADD INTEREST TO THE SLOPE PLANTING.

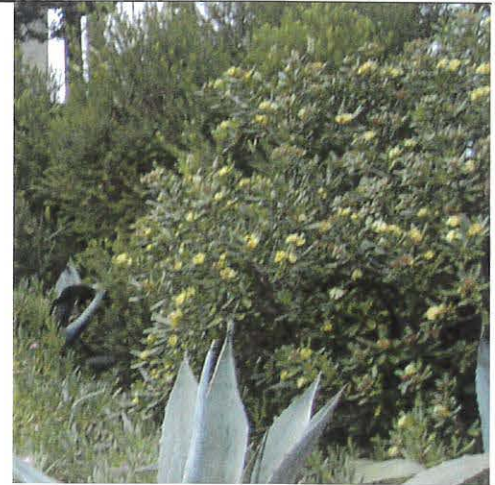
- T** -COMMON NAME PITTOSPORUM
-PLANTING DATE NOT DOCUMENTED
-CURRENT CONDITION FAIR-GOOD

-DESCRIPTION-THE PLANT IS VERY HARDY AND IS USED IN BOTH SLOPE PLANTINGS AND IN A FORMAL PLANTING SCHEME TO ACCENTUATE THE REAR "WALL FOUNTAIN". THEY WERE ALSO POPULARLY USED DURING THE HISTORIC TIME PERIOD.

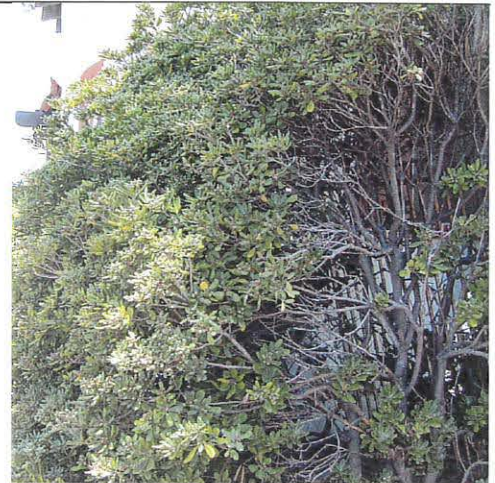
P PITTOSPORUM UNDULATUM

- U** -COMMON NAME VICTORIAN BOX
-PLANTING DATE NOT DOCUMENTED c.1930
-CURRENT CONDITION GOOD

-DESCRIPTION-THESE PLANTS OCCUR IN VARIOUS LOCATIONS. SOME OF THE SPECIMENS ARE SMALL TREES AND OTHERS ARE OF SHRUB HEIGHT. VICTORIAN BOX ARE SLOW GROWING AND WERE USED AS AN ACCENT TREE AND AS A HEDGE DURING THE PERIOD OF SIGNIFICANCE. THEY MAY HAVE BEEN USED PRIMARILY FOR THEIR FOLIAGE AS A BACKGROUND TO THE WALL FOUNTAIN.

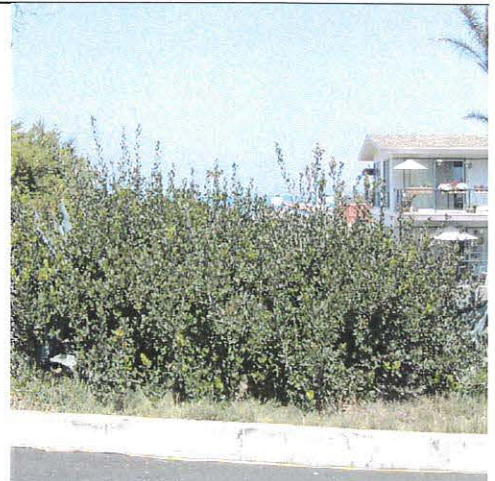
R RHUS INTEGRIFOLIA

- I** -COMMON NAME LEMONADE BERRY
-PLANTING DATE NOT DOCUMENTED c.1930
-CURRENT CONDITION POOR-GOOD

-DESCRIPTION-LEMONADE BERRY IS A NATIVE COASTAL CHAPARRAL PLANT. THE SHRUB IS LOCATED THROUGHOUT THE SITE.

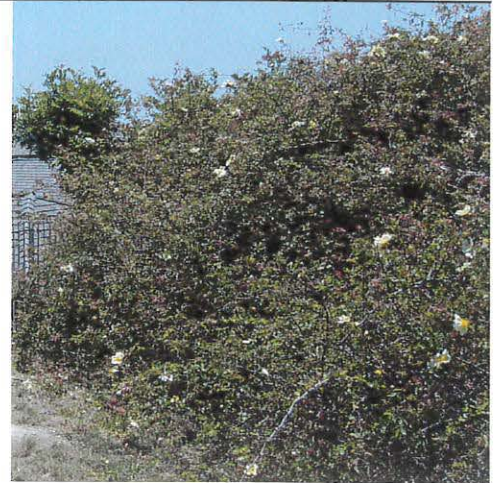
R ROSA SPP.

- S** -COMMON NAME ROSE
- S** -PLANTING DATE NOT DOCUMENTED c.1930
- CURRENT CONDITION GOOD,OVERGROWN
- DESCRIPTION-ENORMOUS MASSING OF A FIVE PETAELED ROSE.

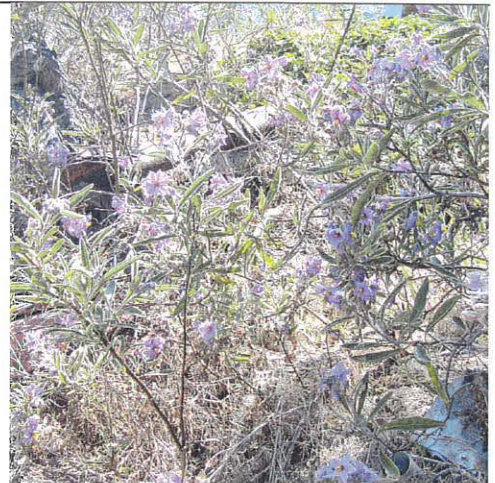
S SOLANUM SPP.

- S** -COMMON NAME BLUE POTATO SHRUB
- S** -PLANTING DATE NOT DOCUMENTED
- CURRENT CONDITION FAIR
- DESCRIPTION-THIS SHRUB OCCURS ON THE LOWER TIERS OF THE SITE WHERE IT IS THE PRIMARY PLANT MATERIAL.

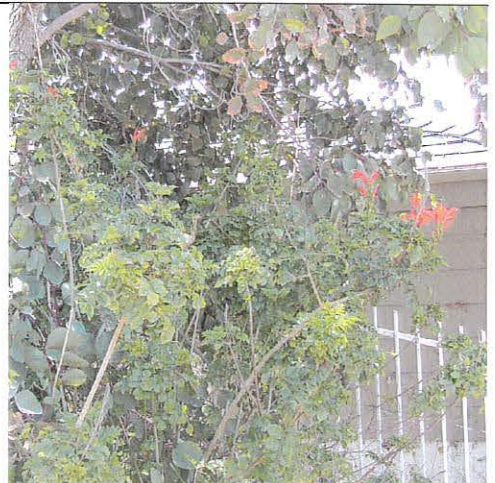
T TECOMARIA CAPENSIS

- C** -COMMON NAME CAPE HONEYSUCKLE
- C** -PLANTING DATE NOT DOCUMENTED c.1930
- CURRENT CONDITION POOR-FAIR
- DESCRIPTION-CAPE HONEYSUCKLE WERE USED AS AN ACCENT FOR THE GARDEN WITH THEIR BRIGHT SHOWY FLOWERS.
