Qualls Engineering

Project: Miramar Events Center
1700 N. El Camino Real,
San Clemente, CA, 92672`

Subject: Existing Finish Preservation Feasibility

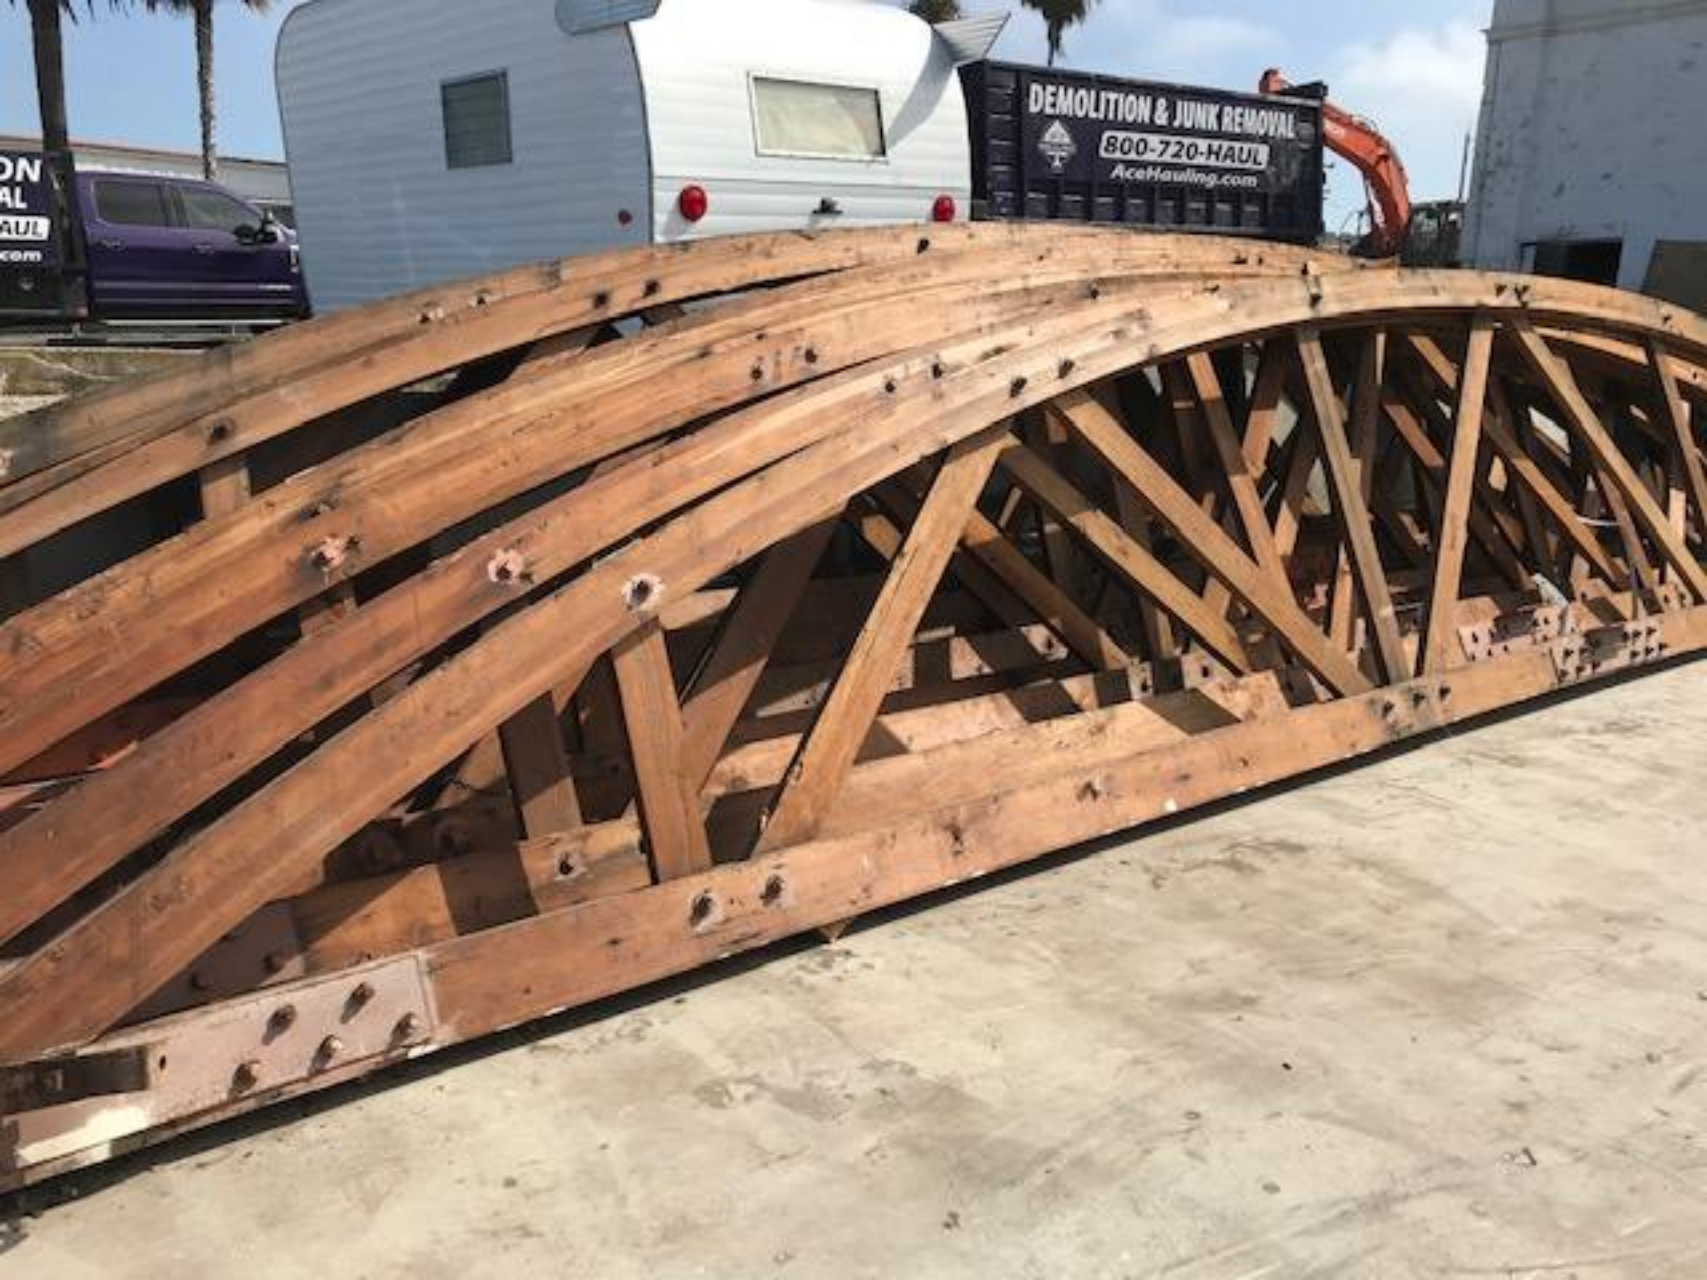
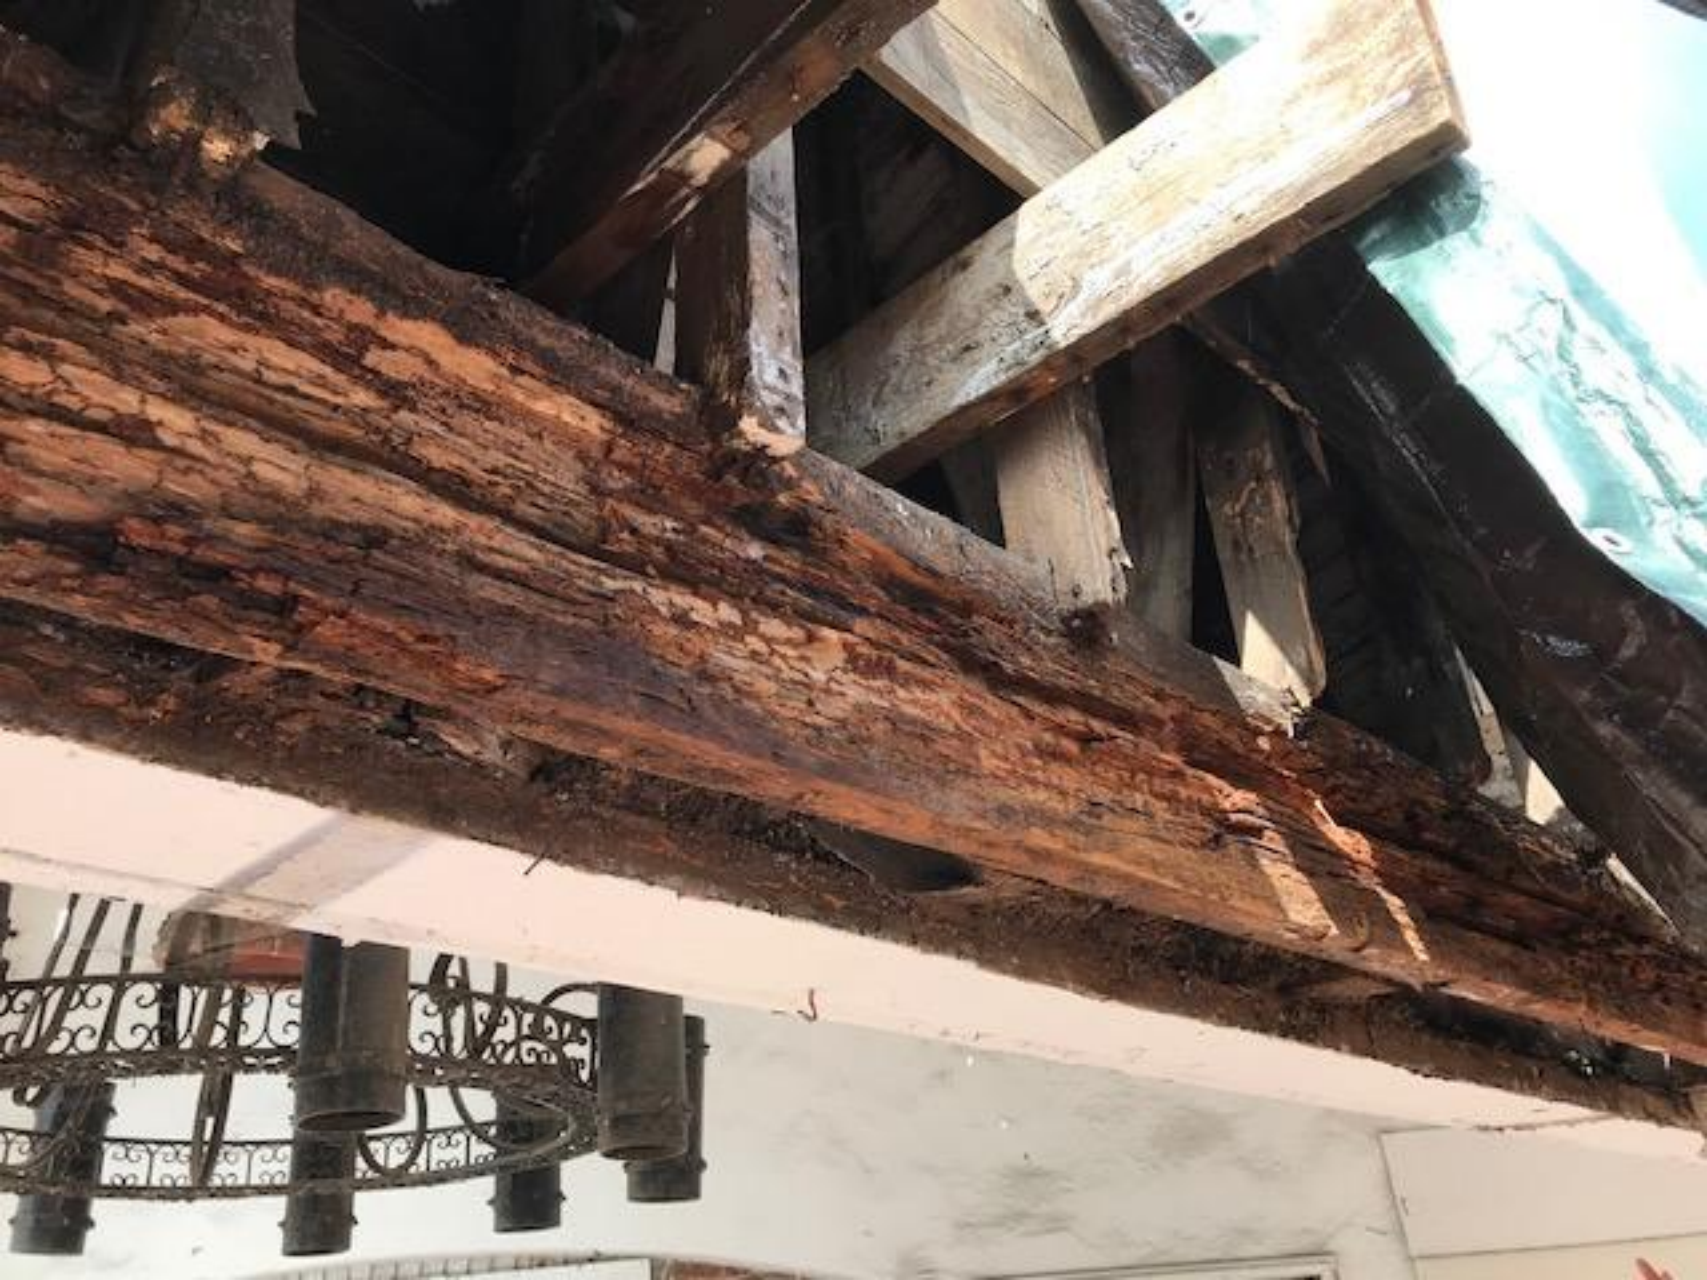
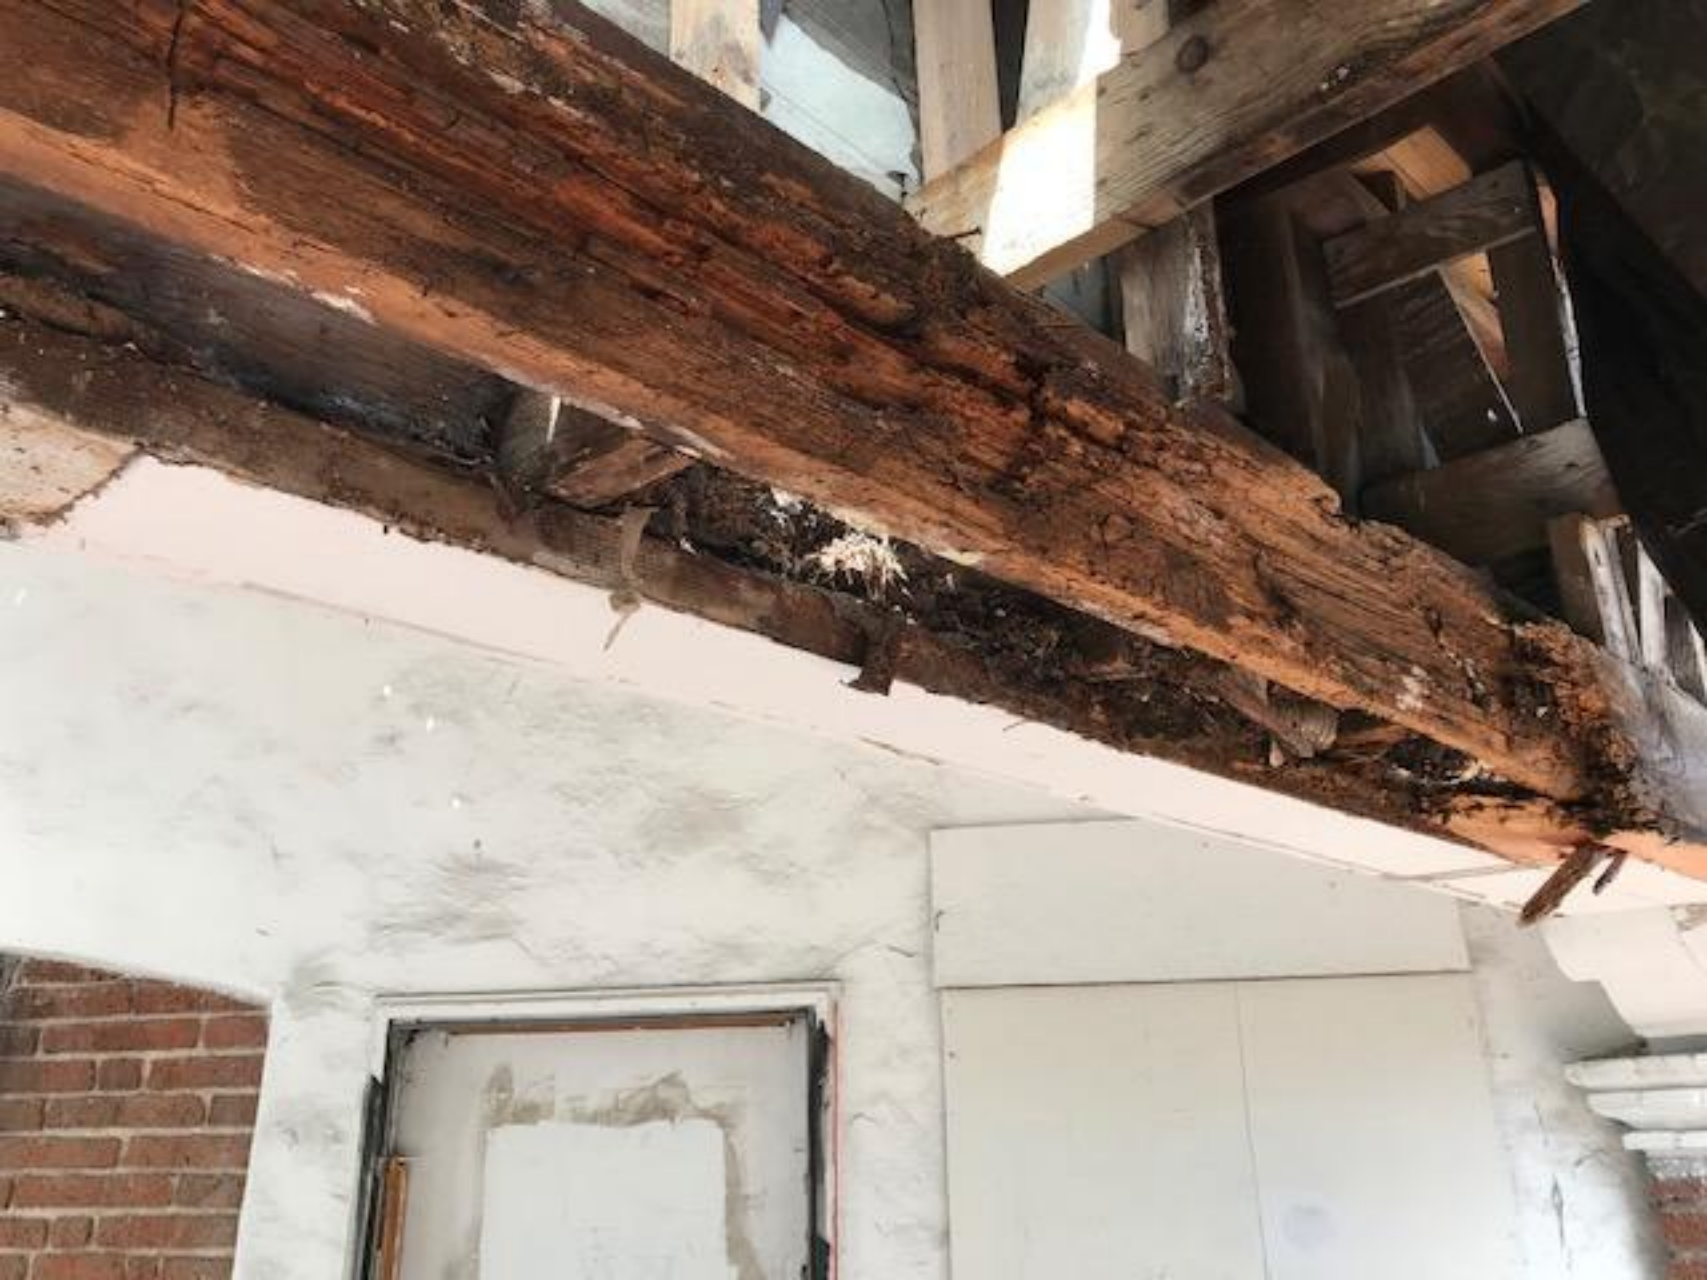
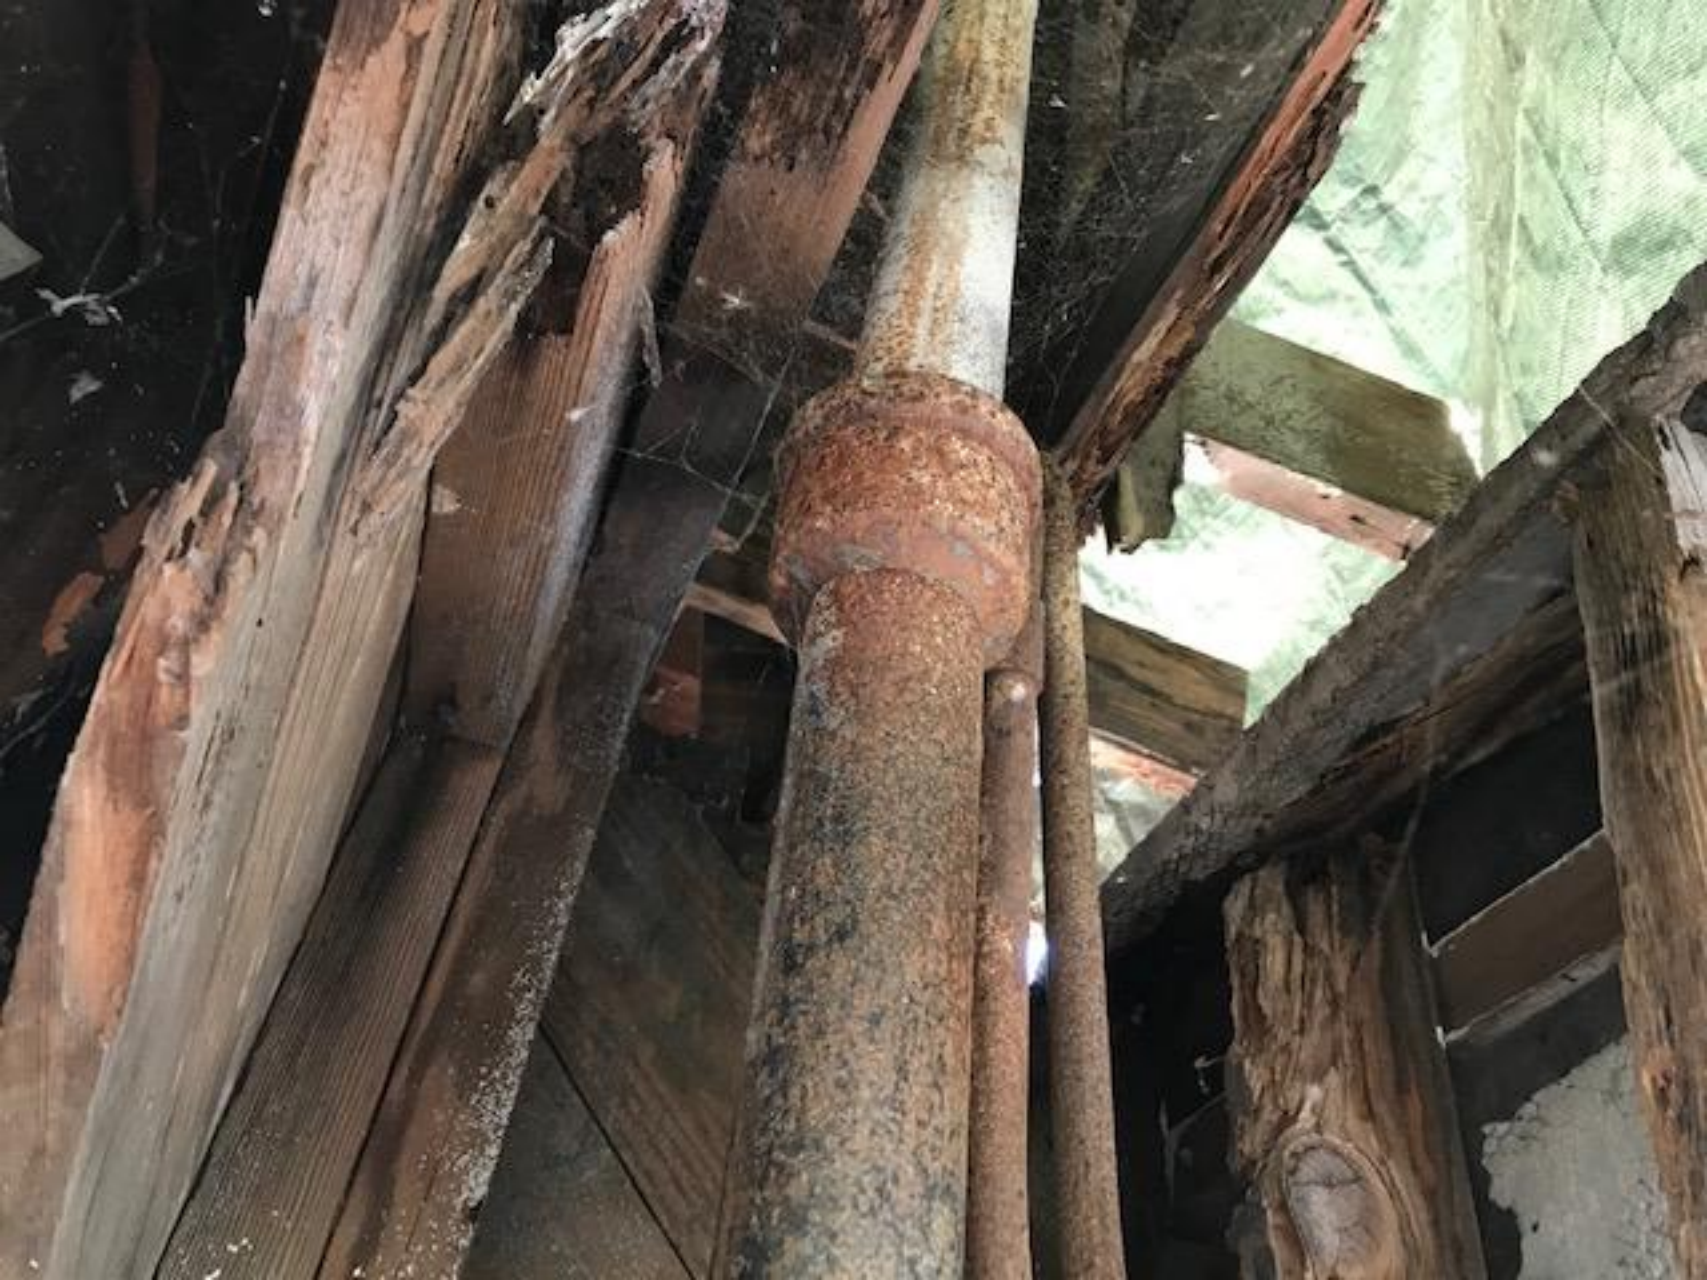
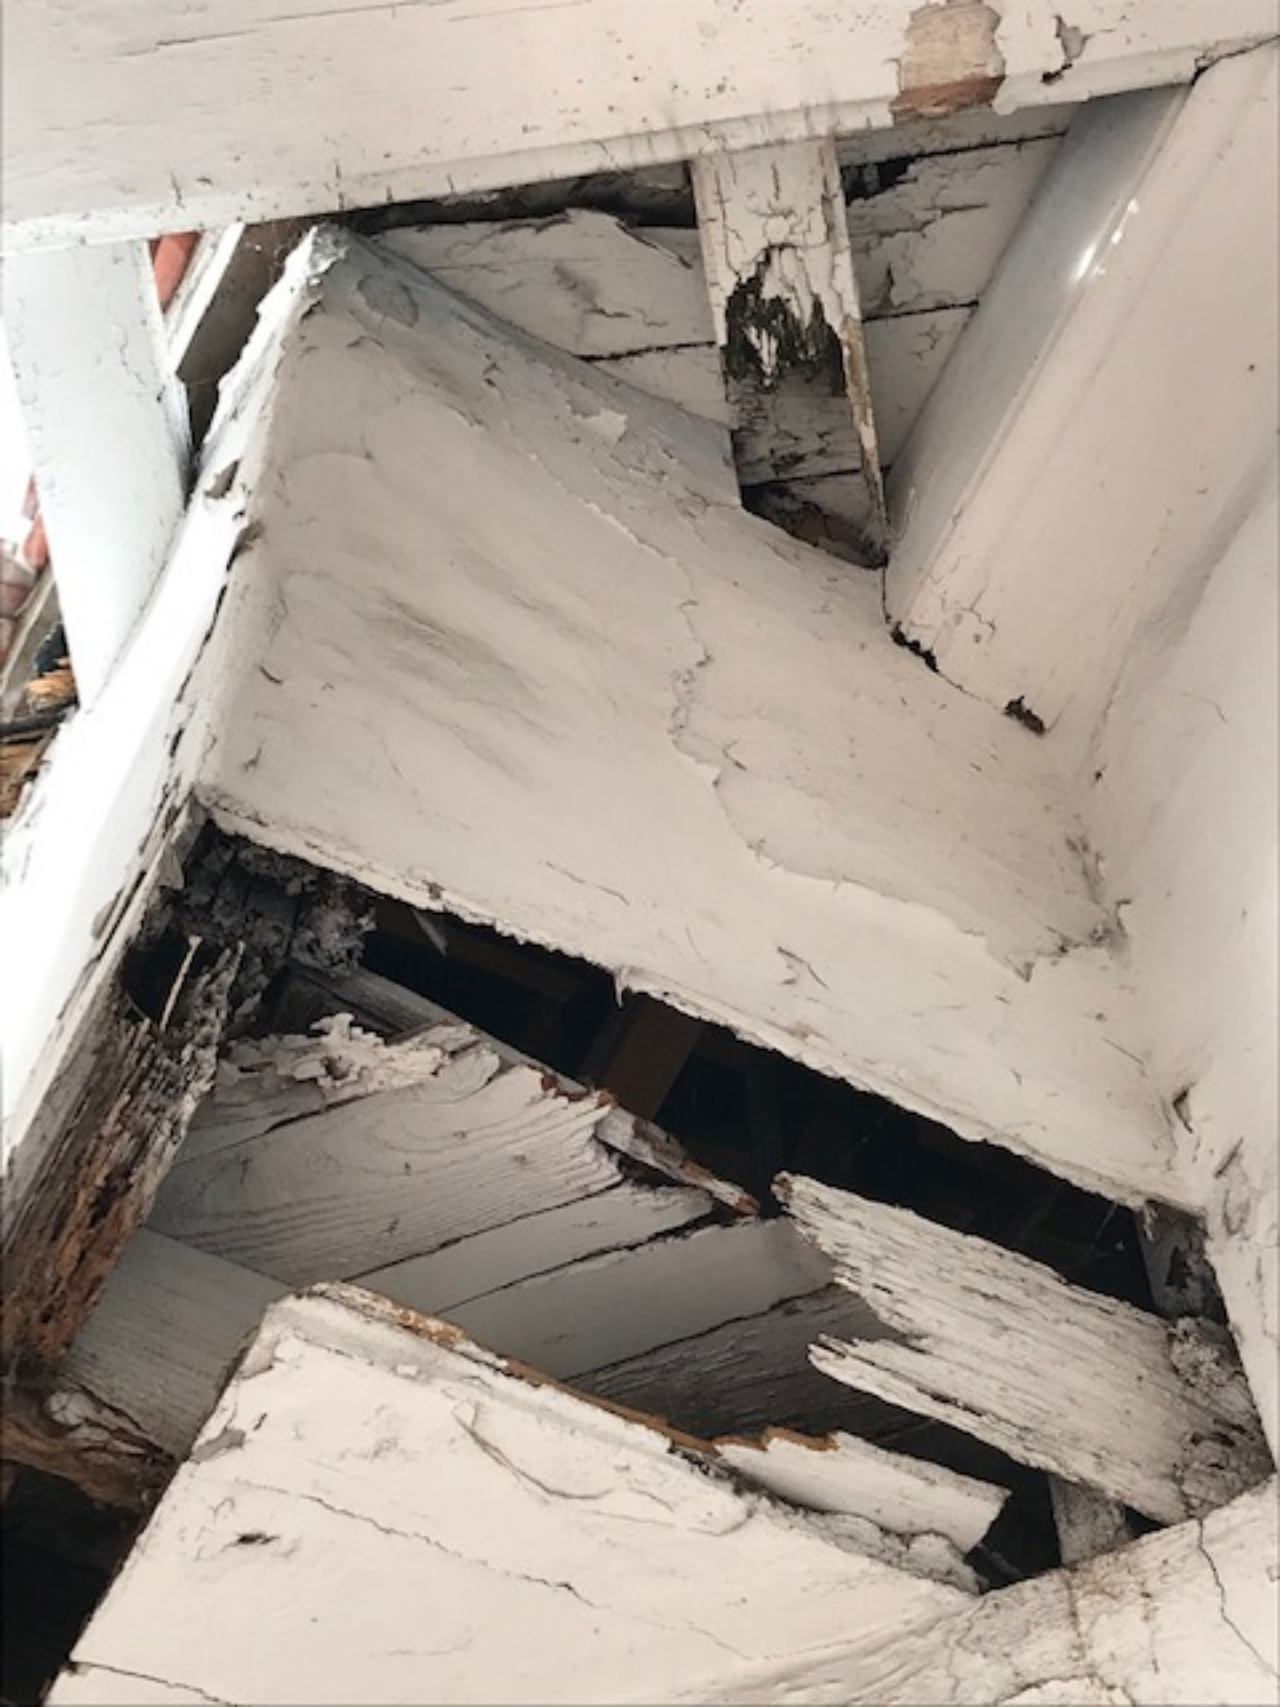
- Mold – The existing interior finishes appear to be heavily affected by what appears to be black mold. Although we are not black mold specialists, it seems that this would pose significant health concerns if not appropriately abated.

- Wood – The existing wood stud wall, including the sill plates, has significant rot damage in the visible areas along the bottoms of the walls. The wood walls need to be replaced, which necessarily makes the preservation of the exterior finish extremely difficult and costly.

Based on our review, we have determined that there is a very low feasibility to preserve the existing building finishes. We recommend pursuing alternatives, such as recreating the existing finishes and texture with the new finishes.
