PRIMARY RECORD

Resource Name or #: 1411 CALLE MIRADOR

City of San Clemente Historic
Resources Survey Update

BUILDING, STRUCTURE, AND OBJECT RECORD

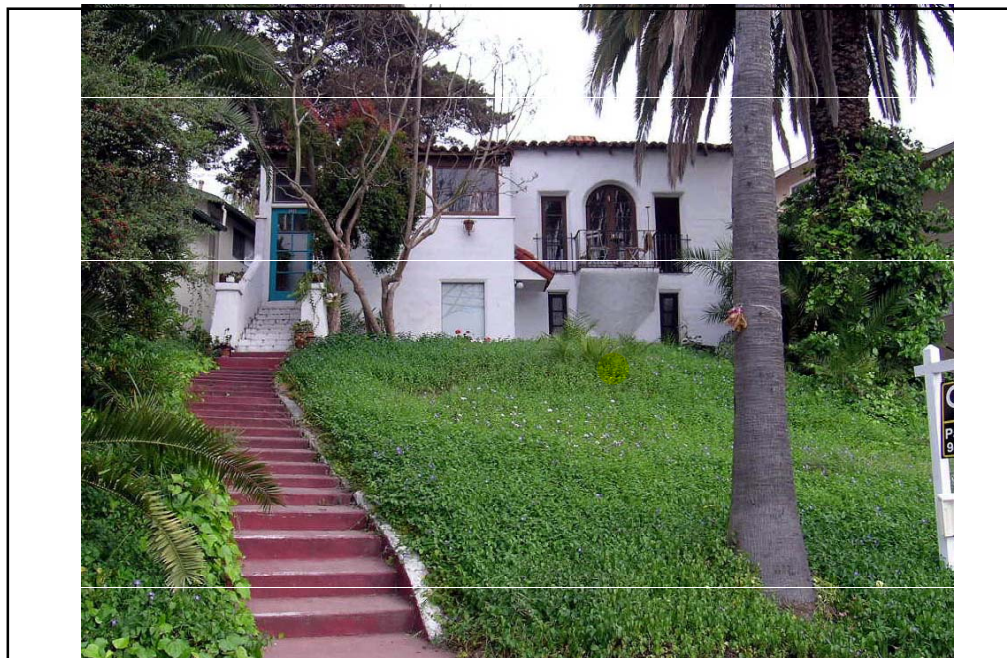
P5b. Description of Photo:

The property contains a two-story single family residence with a rectangular plan and wood-frame construction. Designed in the Spanish Colonial Revival style, it has a low-pitch side-gable roof with clay tiles over the main entrance as well as a shed roof with clay tiles over the entry. The exterior walls are clad with smooth stucco. The residence is asymmetrically aligned on the eastern portion of the primary (north) elevation, while the western portion of the north elevation is symmetrically aligned in both fenestration and decoration. The fenestration consists of original wood casement and fixed windows throughout the residence. One window has been replaced. Decorative features of the residence include stucco walls ending in piers with slanted sides leading to the main entrance, and original steps leading to the entryway. On the western end of the primary elevation a large arched window centered on the western bay is flanked on the lower and upper levels with vertically aligned narrow windows. A rounded balcony projects underneath the window and includes a decorative metal balustrade. Spanish Colonial Revival elements include exposed rafter tails and a stucco chimney. The residence is in good condition. Its integrity is good.

North elevation, south view. May 2006.
