ARBORIST TREE ASSESSMENT REPORT

**MEMORIAL CARE
SENIOR RESIDENTIAL DEVELOPMENT PROJECT
SAN CLEMENTE, CALIFORNIA**

LSA Project No. MEA2203

August 2022

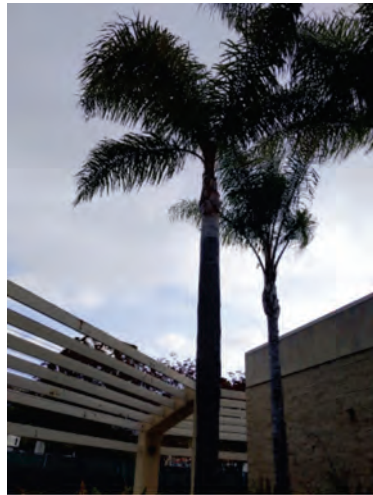
Tree 6 – Thirty-foot-tall queen palm in good condition.

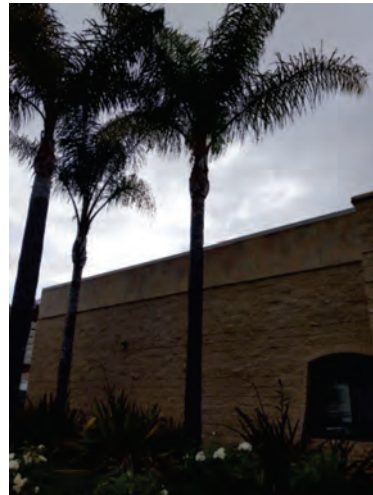
Tree 7 – Thirty-foot-tall queen palm in good condition.

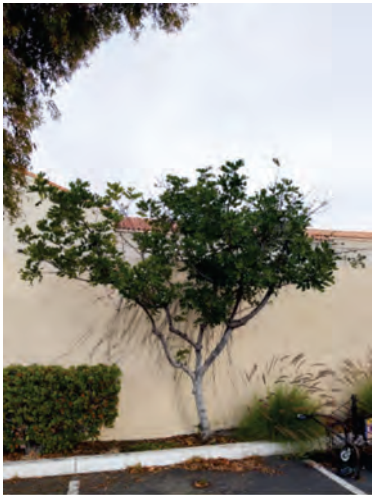
Tree 13 – Ten-foot-tall carrotwood tree in fair condition.

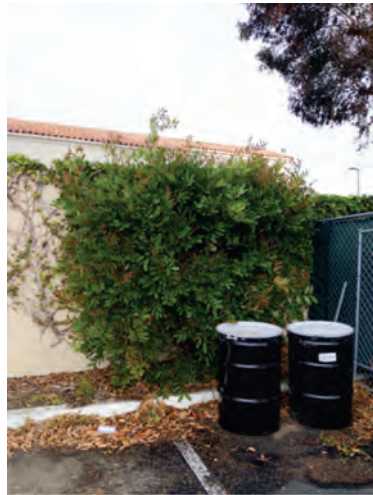
Tree 14 – Topped carrotwood tree in poor condition.

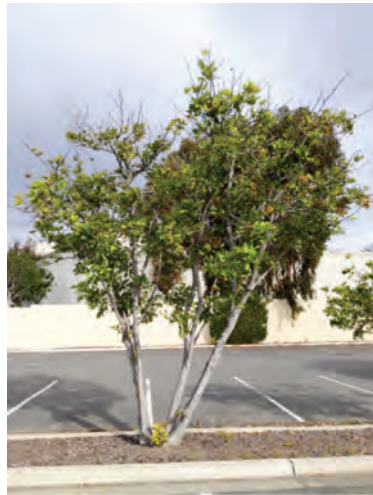
Tree 22 – Twelve-foot-tall carrotwood tree in poor condition.

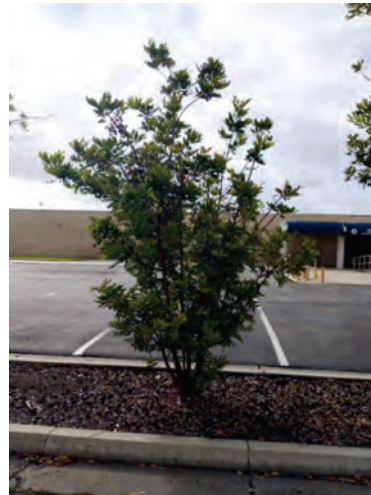
Tree 23 – Topped carrotwood tree in poor condition.

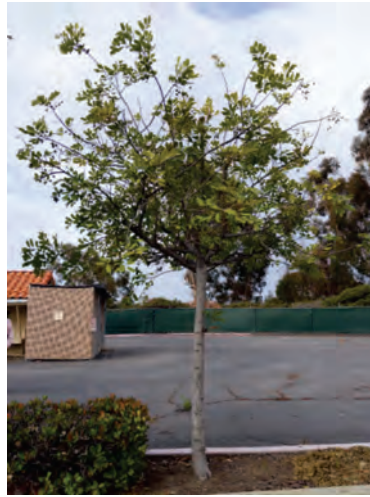
Tree 26 – Nine-foot-tall carrotwood tree in poor condition.

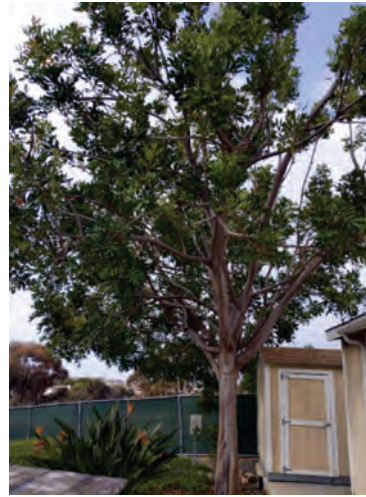
Tree 27 – Twenty-foot-tall carrotwood tree in fair condition.

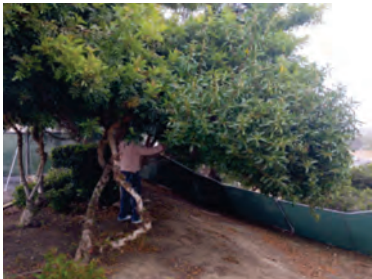
Tree 29 – Fifteen-foot-tall Mousehole tree in fair condition. Cal-IPC invasive species list.

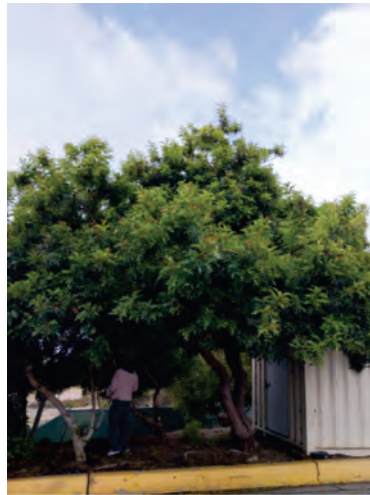
Tree 30 – Twenty-foot-tall Brazilian pepper tree in good condition.

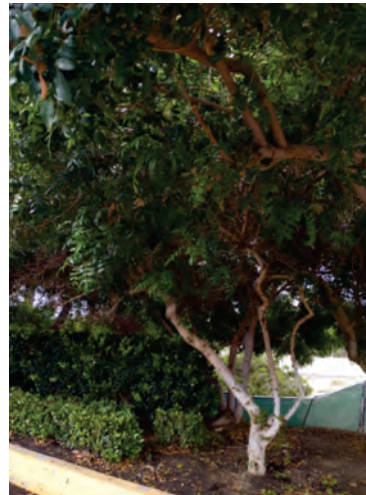
Tree 31 – Six-foot-tall Mousehole tree in fair condition. Cal-IPC invasive species list.

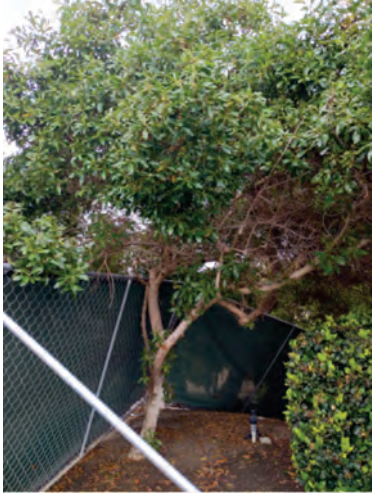
Tree 33 – Ten-foot-tall Mousehole tree in fair condition. Cal-IPC invasive species list.

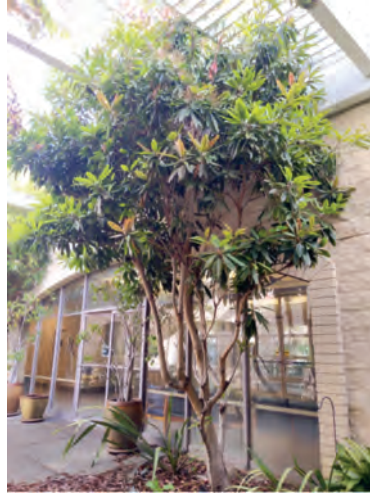
Tree 34 – Twenty-foot-tall loquat tree in good condition.

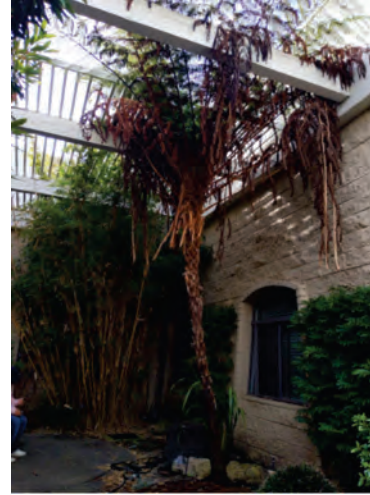
Tree 35 – Twenty-foot-tall New Zealand tree fern in poor condition.

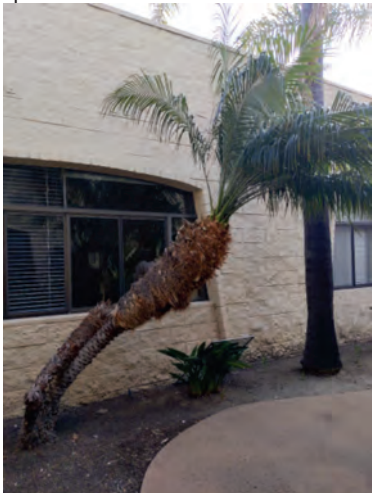
Tree 37 – Eight-foot-tall queen palm in poor condition.

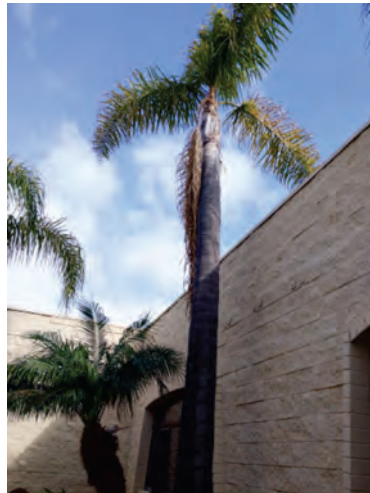
Tree 39 – Thirty-foot-tall queen palm in good condition.

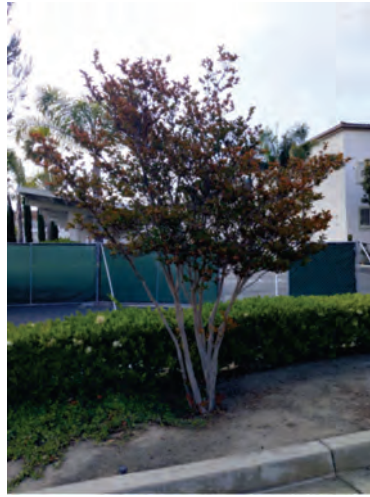
Tree 52 – Eight-foot-tall crape myrtle tree in fair condition.

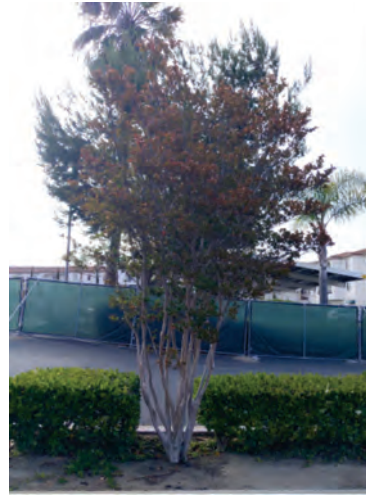
Tree 53 – Ten-foot-tall crape myrtle tree in fair condition.

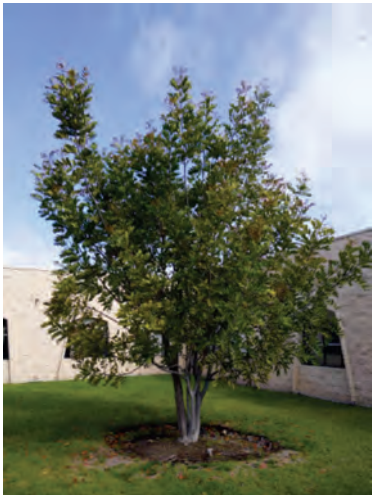
Tree 55 – Fifteen-foot-tall carrotwood tree in fair condition.

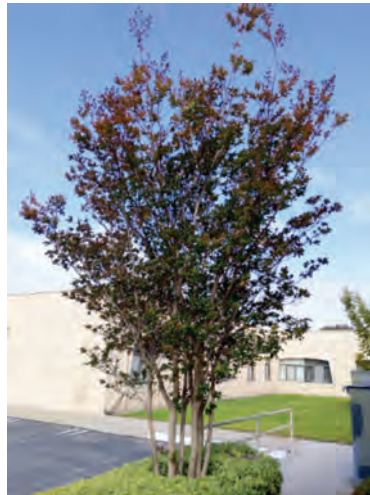
Tree 56 – Fifteen-foot-tall crape myrtle tree in fair condition.

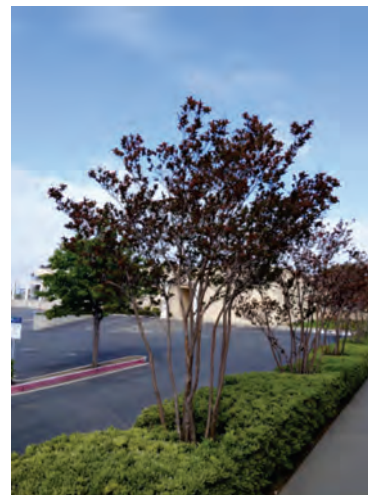
Tree 61 – Eight-foot-tall crape myrtle tree in fair condition.

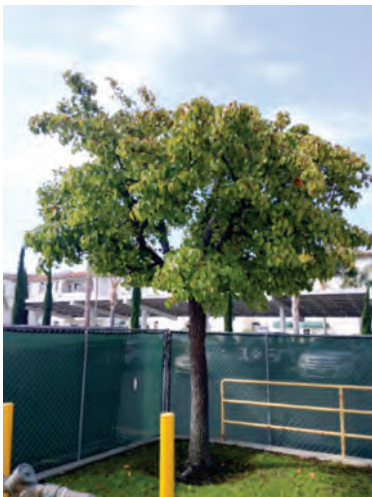
Tree 63 – Fifteen-foot-tall flowering pear tree in fair condition.

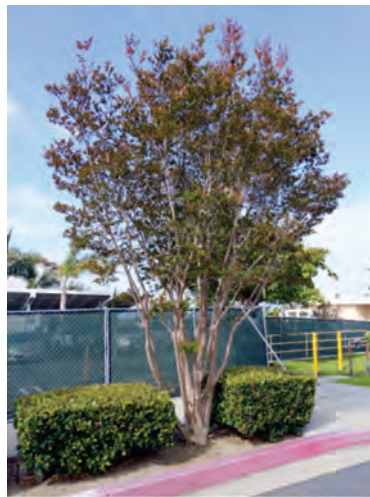
Tree 64 – Fifteen-foot-tall crape myrtle tree in fair condition.

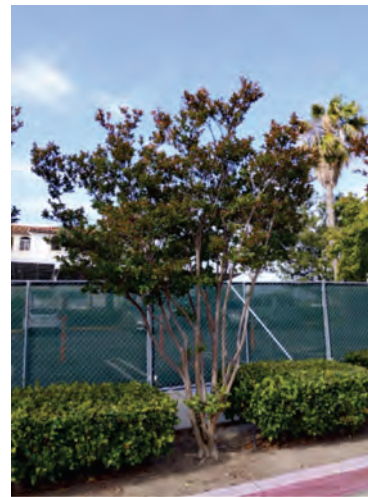
Tree 65 – Eight-foot-tall crape myrtle tree in fair condition.

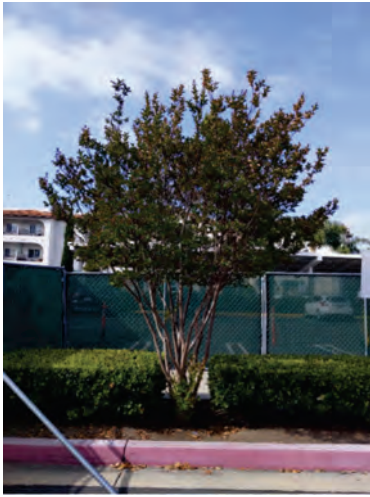
Tree 67 – Ten-foot-tall crape myrtle tree in fair condition.

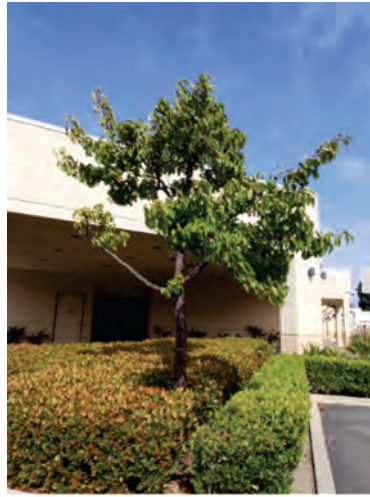
Tree 68 – Ten-foot-tall flowering pear tree in poor condition.

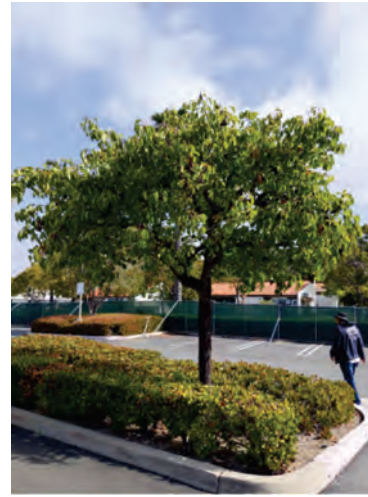
Tree 69 – Ten-foot-tall flowering pear tree in fair condition.

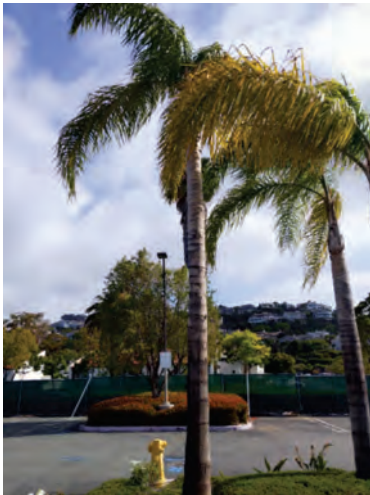
Tree 71 – Twenty-foot-tall queen palm in fair condition.

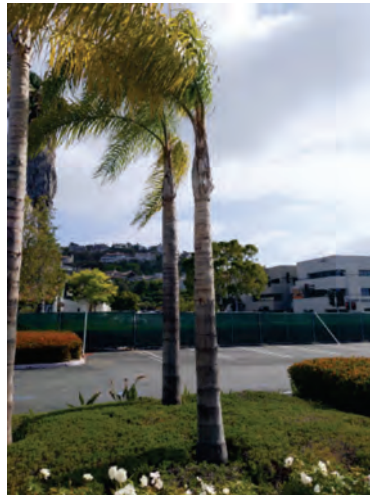
Tree 72 – Twenty-foot-tall queen palm in fair condition.

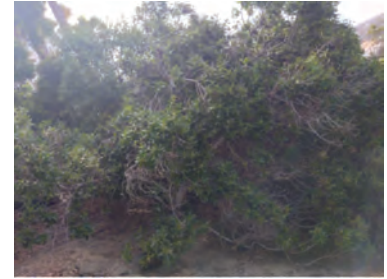
Tree 77 – Thirty-foot-tall Sydney golden wattle in good condition. Cal-IPC invasive species list.

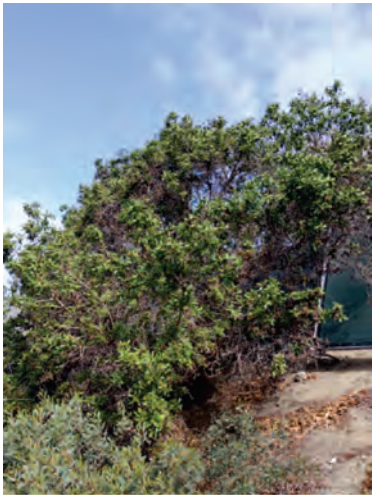
Tree 78 – Eight-foot-tall Mousehole tree in fair condition. Cal-IPC invasive species list.

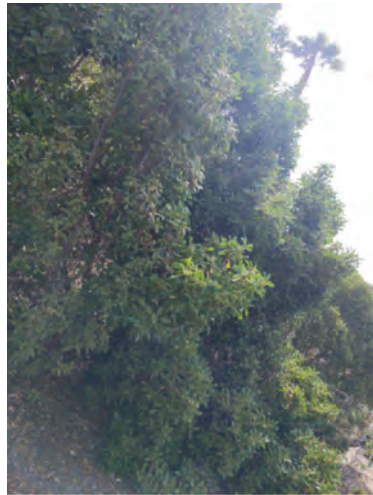
Tree 79 – Ten-foot-tall Mousehole tree in fair condition. Cal-IPC invasive species list.

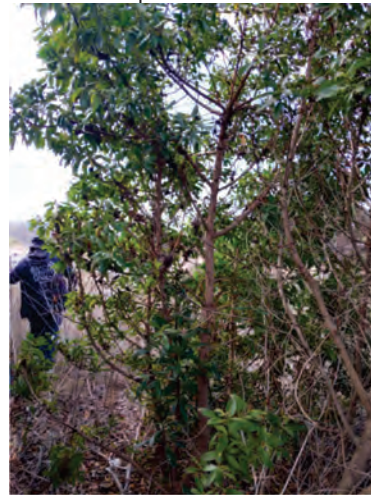
Tree 80 – Ten-foot-tall Mousehole tree in fair condition. Cal-IPC invasive species list.

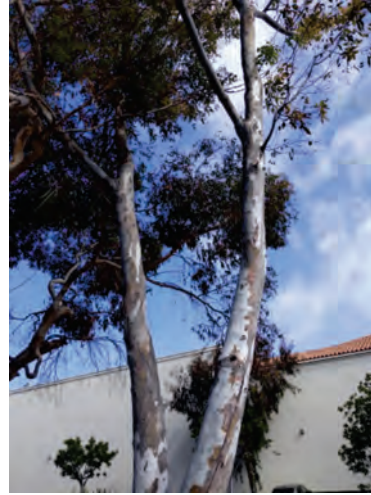
Tree 84 – Forty-foot-tall spotted gum tree in fair condition.

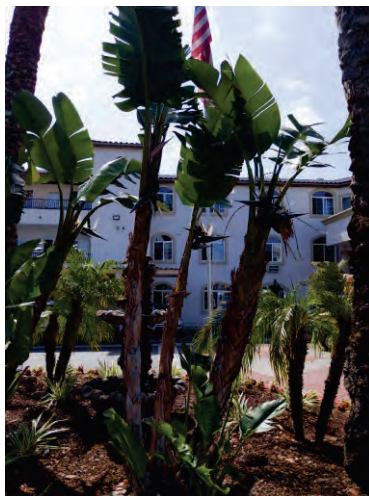
Tree 96 – Ten-foot-tall traveler's palm in good condition.

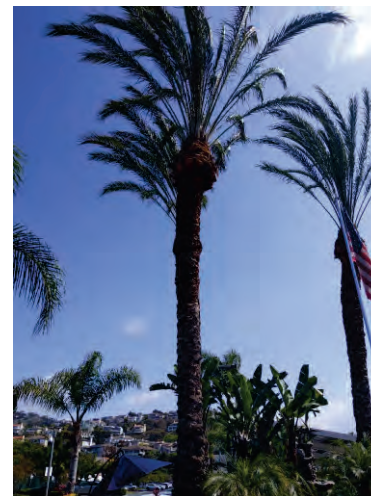
Tree 97 – Ten-foot-tall traveler's palm in good condition.

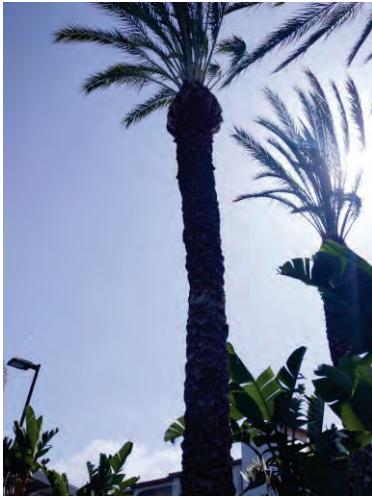
Tree 98 – Thirty-five-foot-tall date palm in good condition.

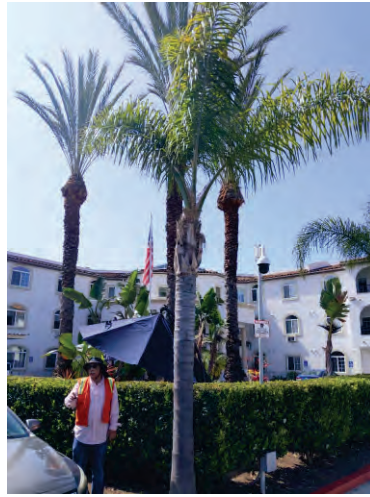
Tree 99 – Thirty-five-foot-tall date palm in good condition.

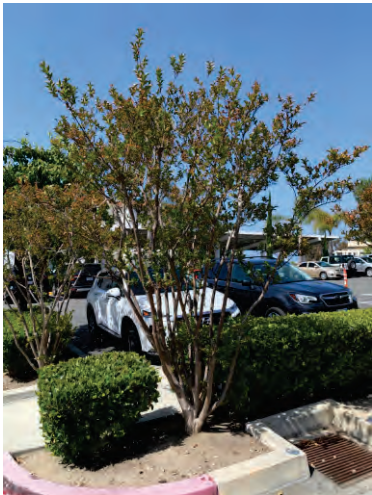
Tree 102 – Eight-foot-tall crape myrtle tree in poor condition.

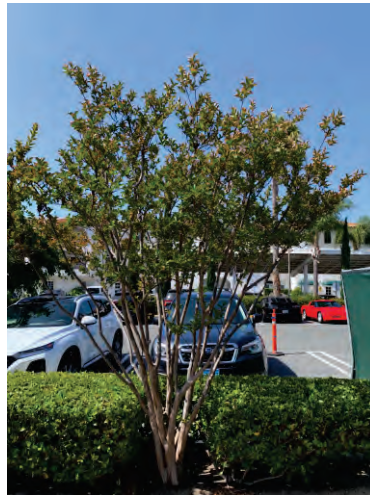
Tree 103 – Eight-foot-tall crape myrtle tree in fair condition.

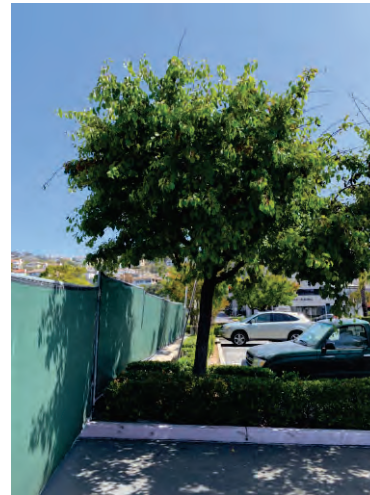
Tree 104 – Ten-foot-tall crape myrtle tree in fair condition.

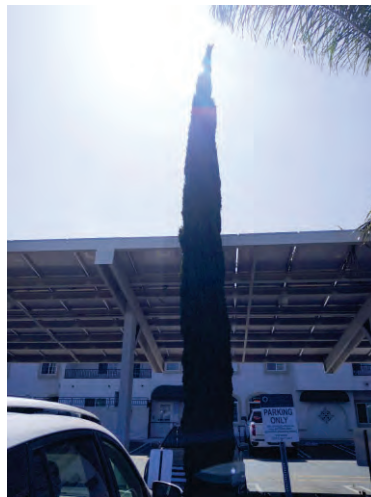
Tree 112 – Thirty-foot-tall Italian cypress in good condition.

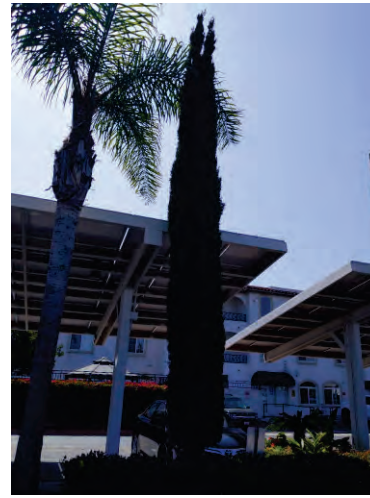
Tree 117 – Twenty-five-foot-tall Italian cypress in good condition.

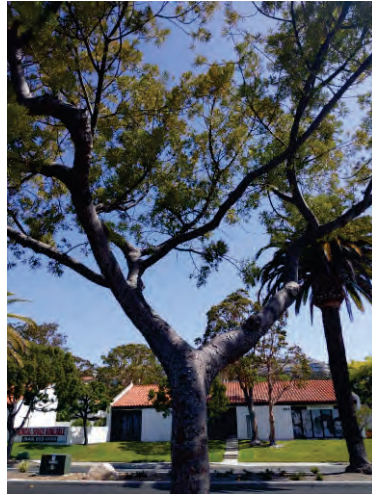
Tree 128 – Twenty-five-foot-tall yew pine in fair condition.

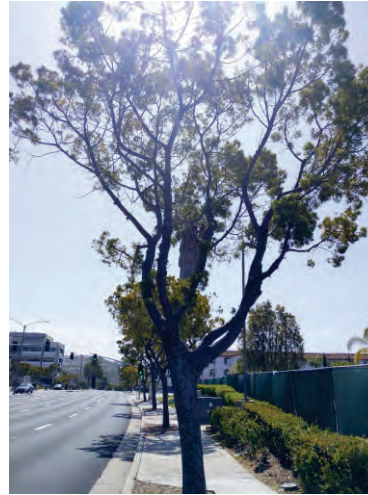
Tree 129 – Twenty-five-foot-tall yew pine in good condition.

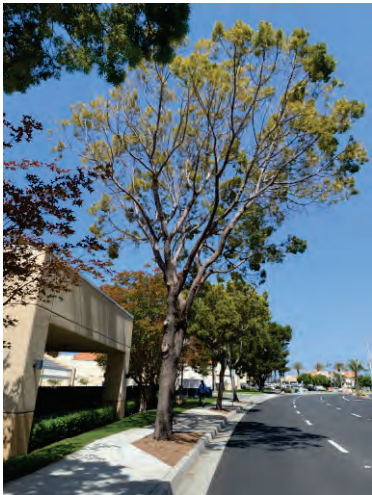
Tree 135 – Fifteen-foot-tall crape myrtle tree in good condition.

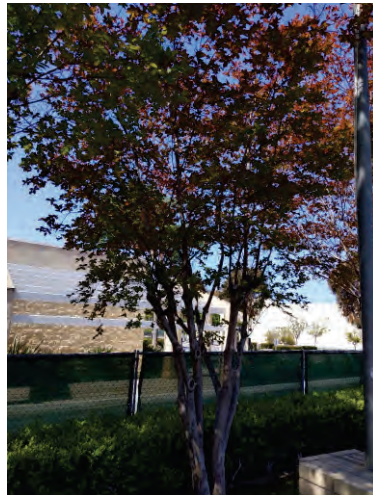
Tree 137 – Twenty-foot-tall crape myrtle tree in good condition.

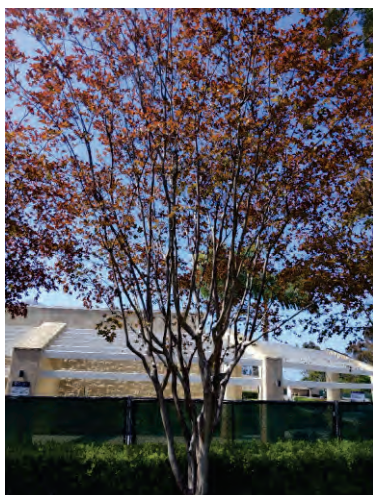
Tree 140 – Twenty-foot-tall crape myrtle tree in good condition.

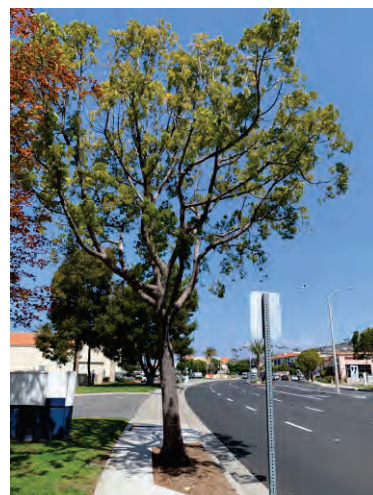
Tree 143 – Forty-five-foot-tall yew pine in fair condition.

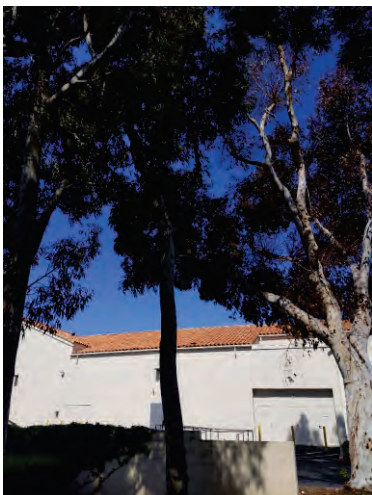
Tree 144 – Forty-foot-tall spotted gum tree in fair condition.

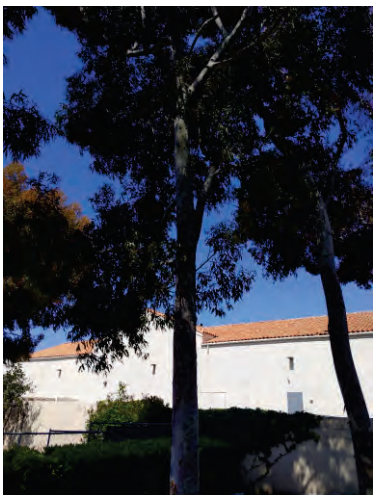
Tree 145 – Forty-foot-tall spotted gum tree in fair condition.

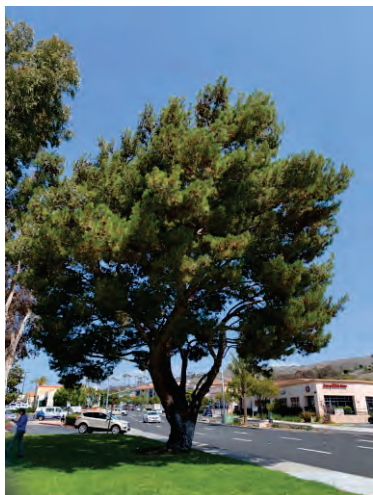
Tree 146 – Seventy-foot-tall Aleppo pine in good condition. Large specimen tree.

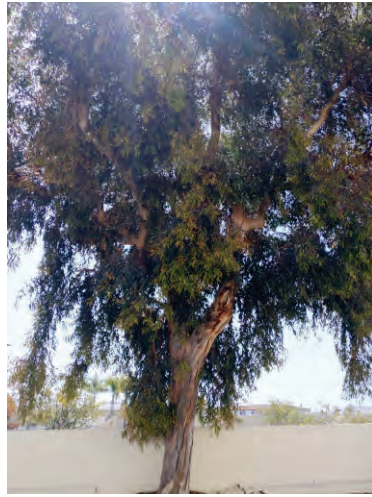
Tree 149 – Forty-foot-tall spotted gum tree in fair condition.

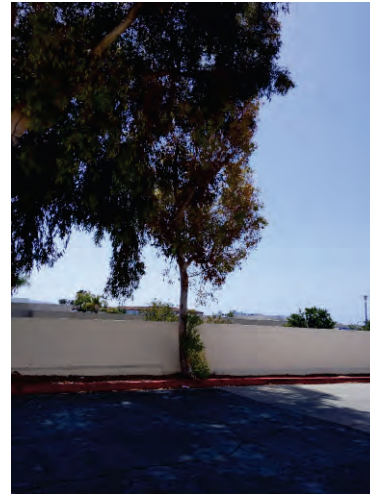
Tree 150 – Twenty-five-foot-tall spotted gum tree in fair condition.

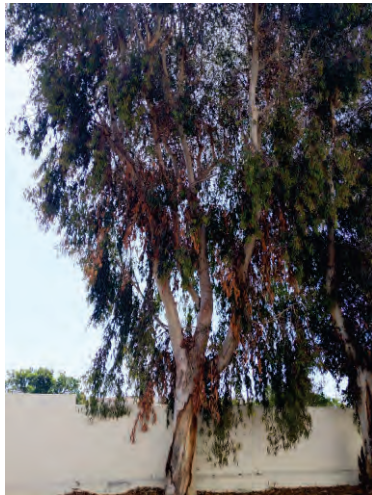
Tree 152 – Forty-foot-tall spotted gum tree in fair condition.

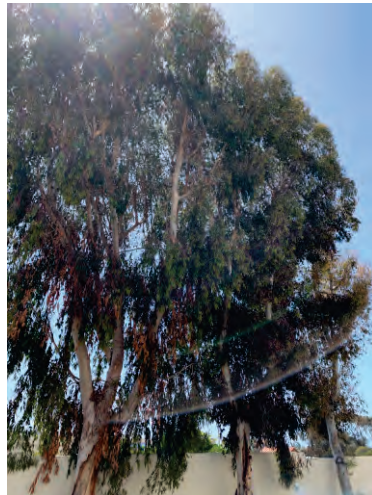
Tree 153 – Seventy-foot-tall spotted gum tree in fair condition.

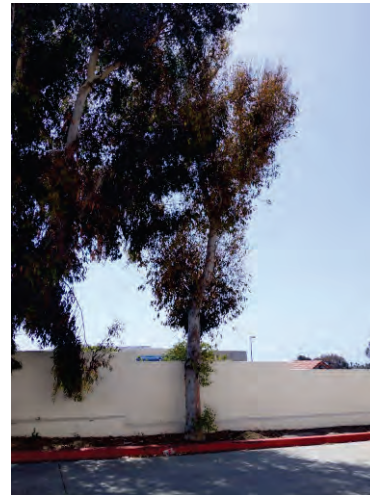
Tree 154 – Thirty-foot-tall spotted gum tree in poor condition, topped.

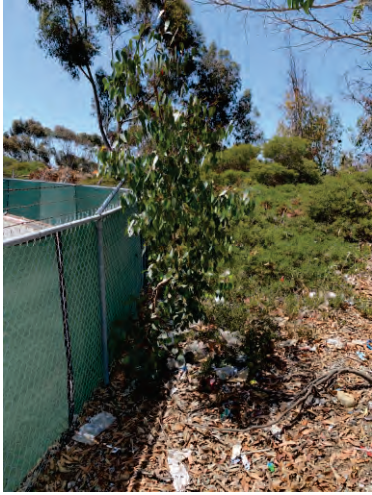
Tree 156 – Eight-foot-tall spotted gum tree in poor condition, sapling.

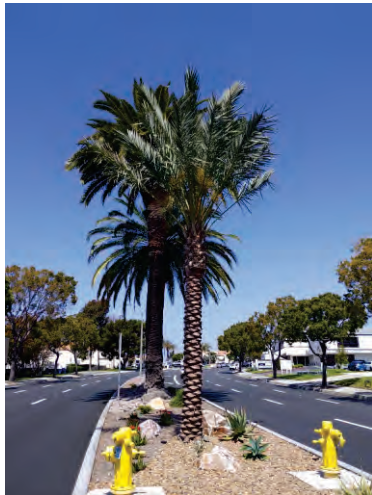
Tree 160 – Twenty-foot-tall date palm in good condition.

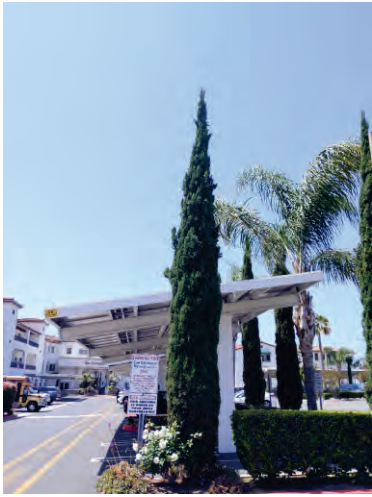
Tree 164 – Twenty-five-foot-tall Italian cypress in good condition.

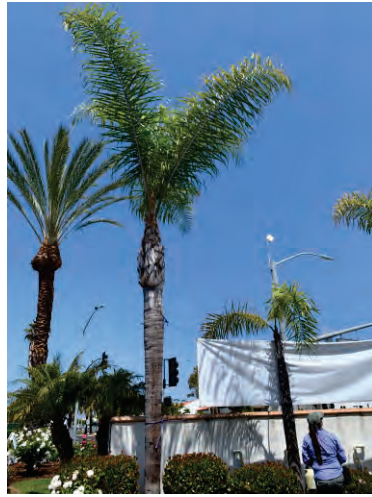
Tree 165 – Thirty-foot-tall queen palm in good condition.

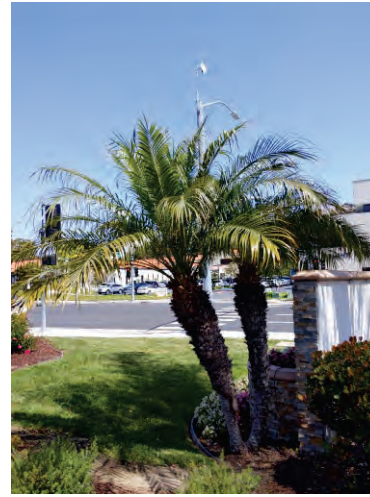
Tree 166 – Seven-foot-tall pigmy date palm in good condition.

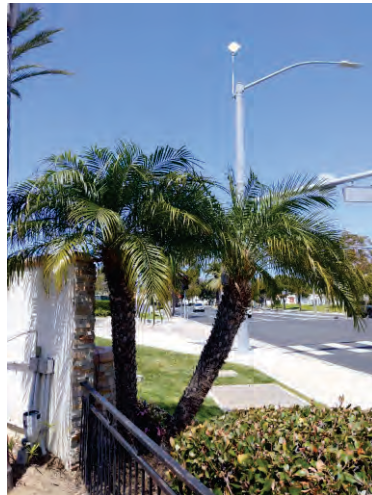
Tree 169 – Eight-foot-tall pigmy date palm in good condition.

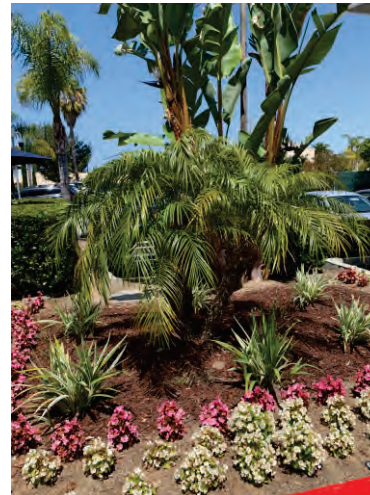
Tree 170 – Six-foot-tall pigmy date palm in good condition.

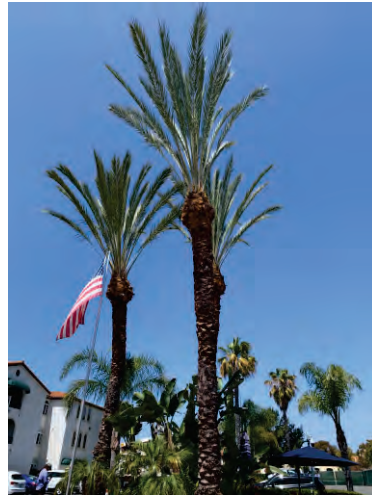
Tree 173 – Forty-foot-tall date palm in good condition.
